Periodic Survey Evaluation: Ocean View Beach Fall 2018

City of Norfolk

March 2019

moffatt & nichol

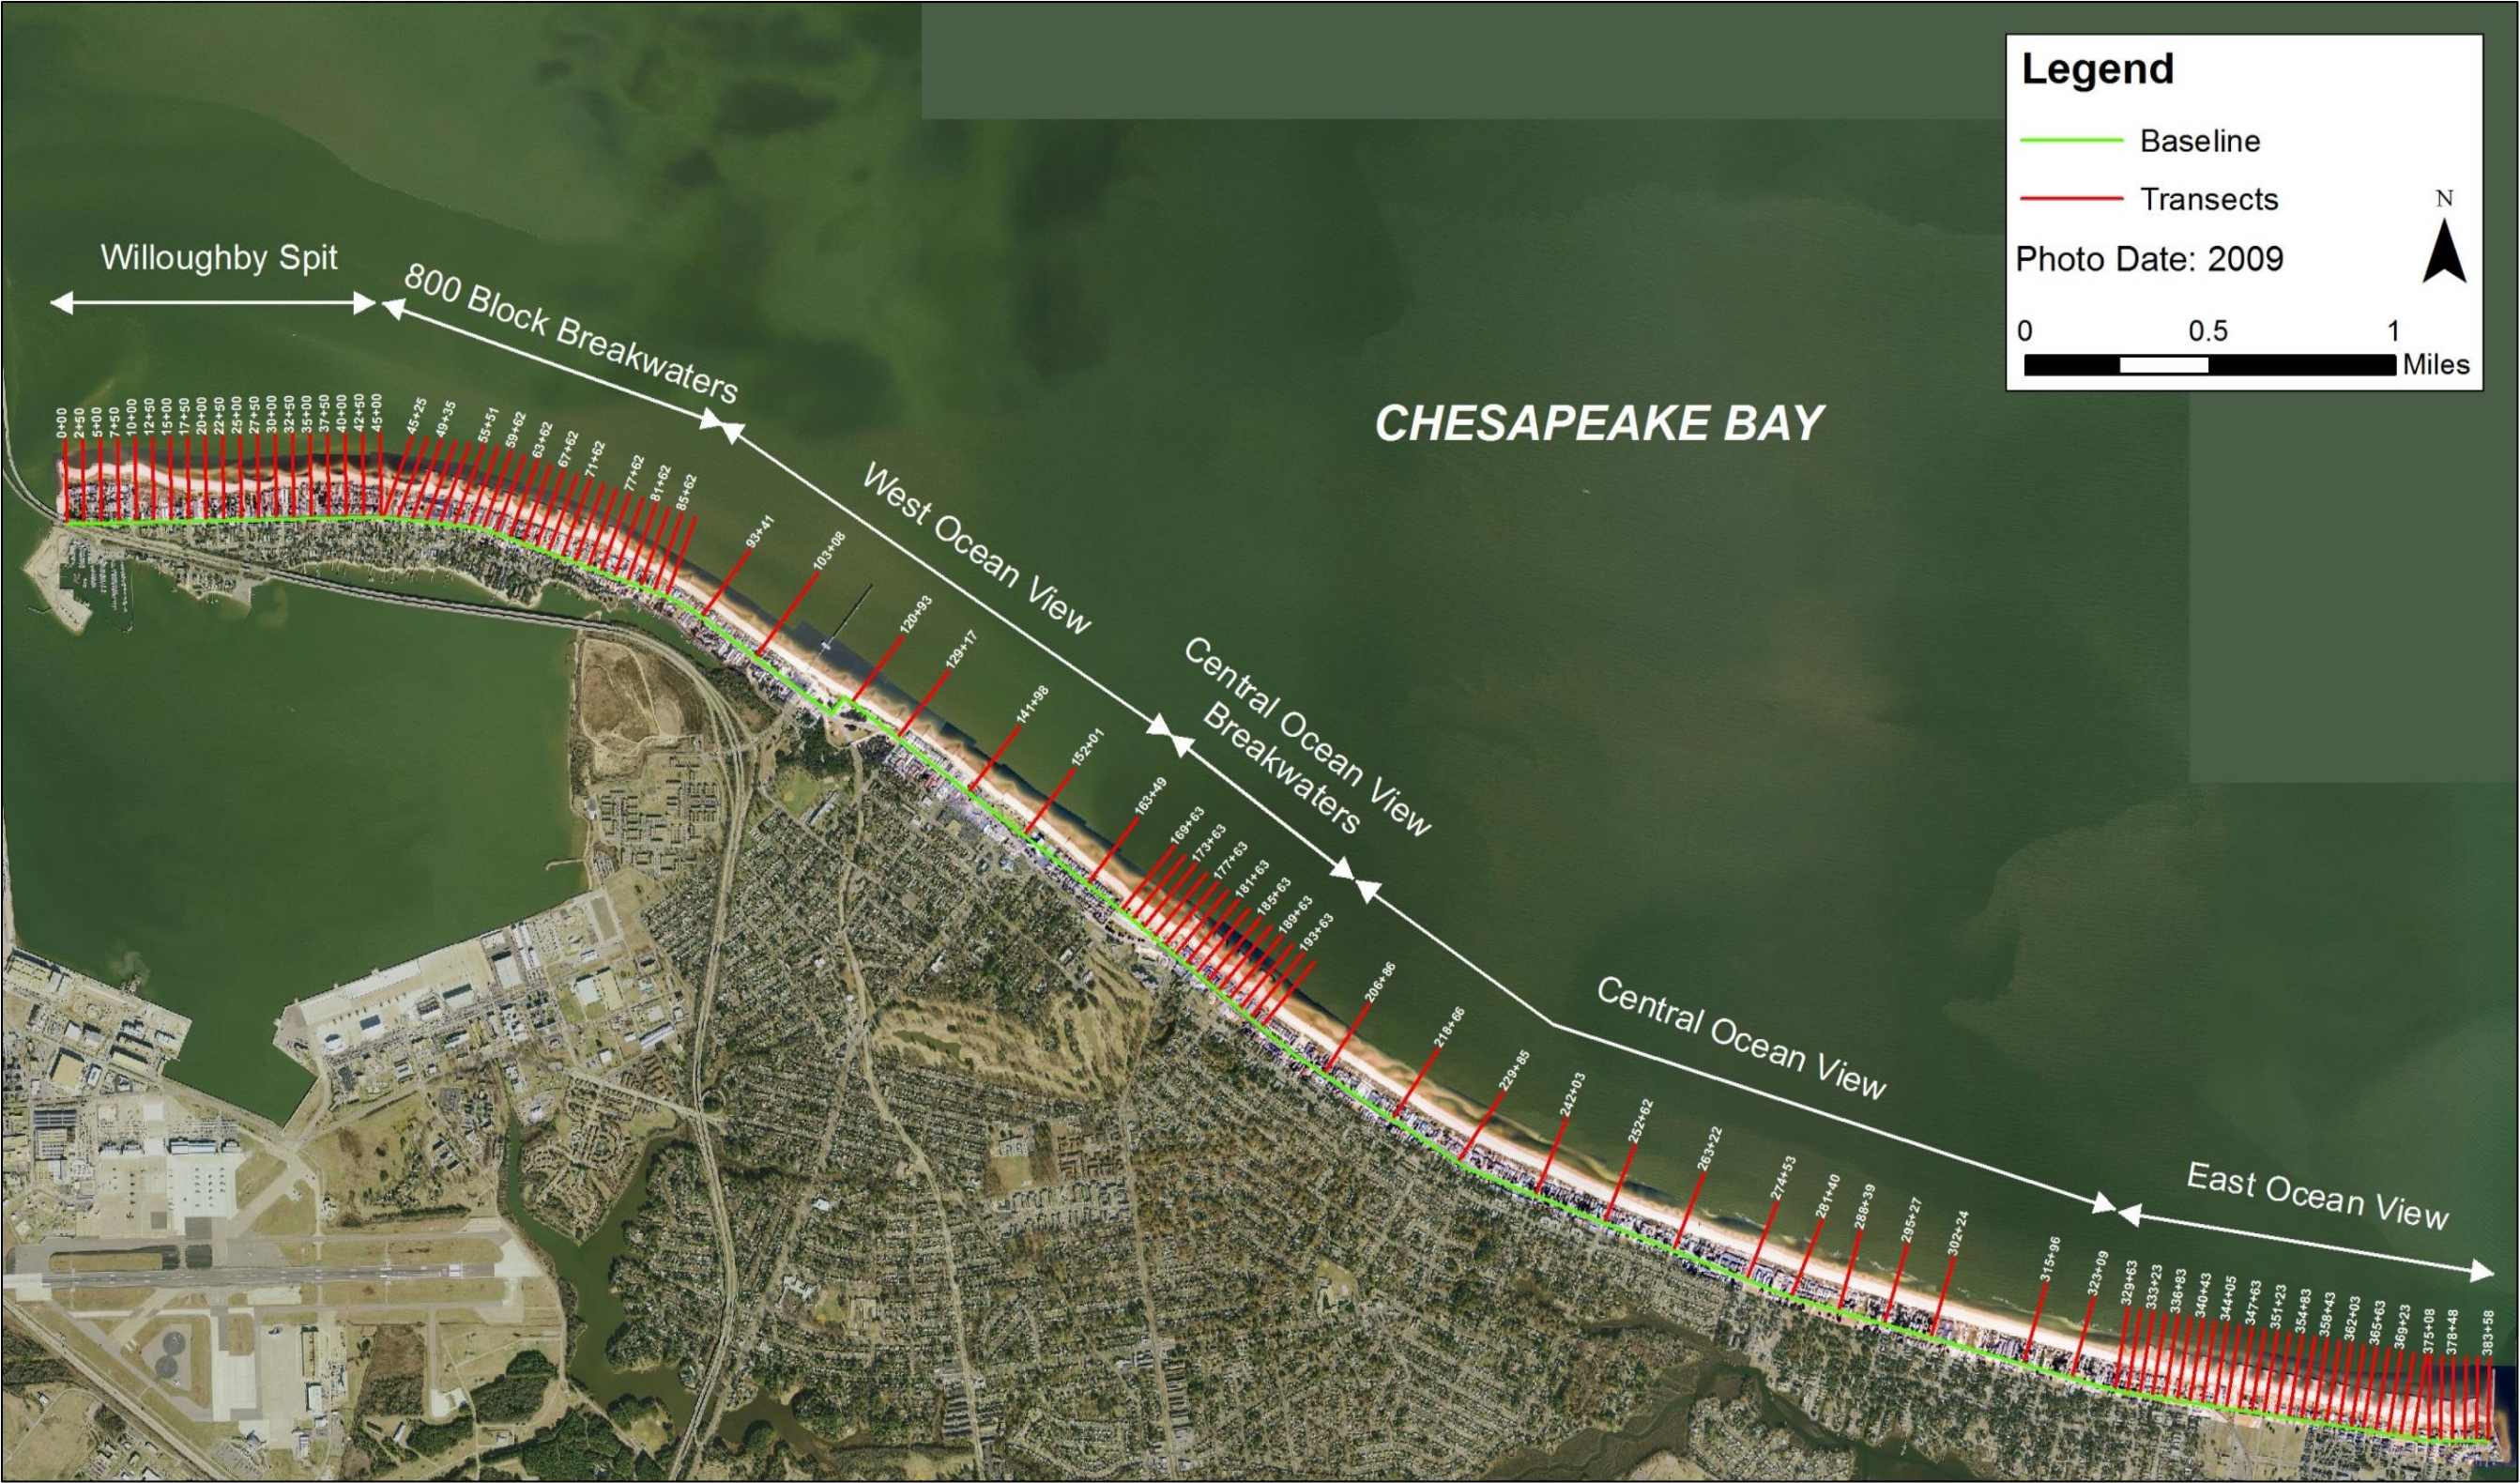
Figure 3-1: Survey Baseline and Transects

Geodynamics, LLC, conducted the most recent survey of Ocean View Beach on November 5-8, 2018. The baseline and transects established for the September 2005 survey were used for the most recent survey. Figure 3-1 shows the location of the baseline, transects and the stationing applied by Geodynamics for the surveying. As shown in Figure 3-1, transects were stationed from west to east along the Ocean View shoreline. The survey data were provided in xyz and shapefile formats allowing for compatibility with multiple programs.

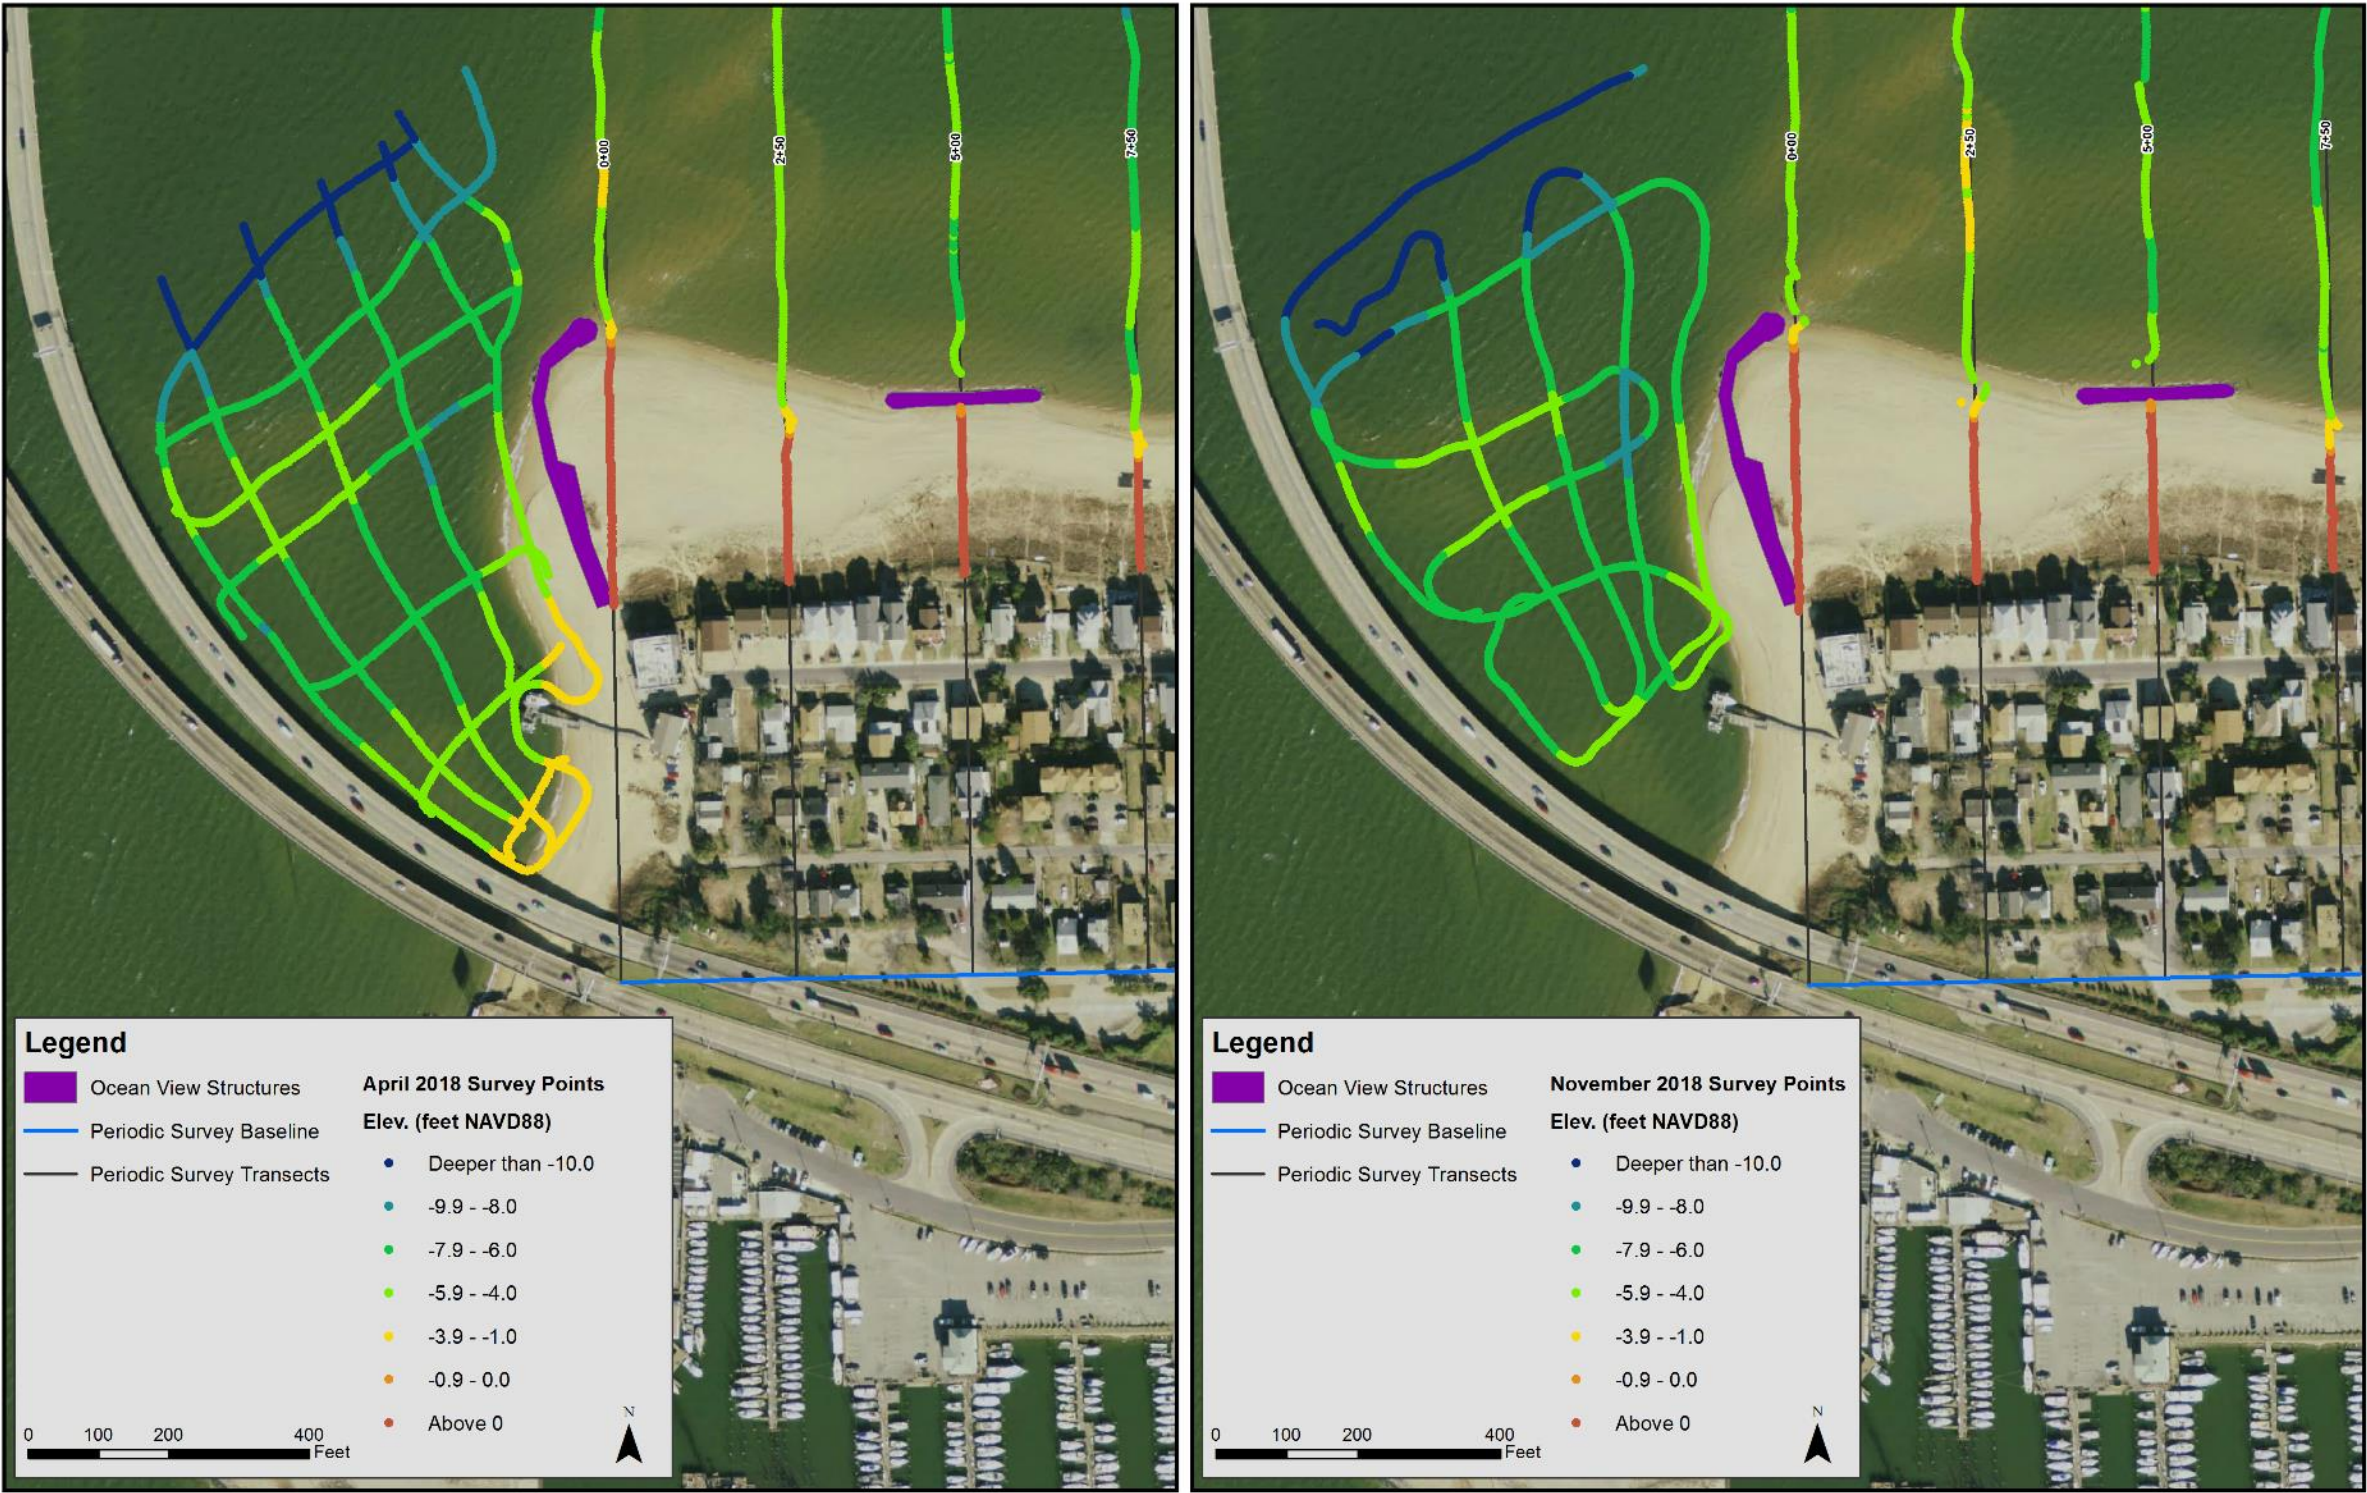
Figure 6-1: Spring 2018 and Fall 2018 Survey Depths West of the Willoughby Spit Terminal Groin

While this area west of the terminal groin has not historically been part of the regular periodic survey coverage, the past two surveys have included vessel tracks, as shown in Figure 6-1, to evaluate the depths near the pier. The left and right panels of Figure 6-1 show the April 2018 and November 2018 survey point depths, respectively, between the terminal groin and the pier and the relatively deeper waters near the Hampton Roads Bridge Tunnel. In both surveys, depths near the pier were deeper than -4.0 feet NAVD88, which is approximately 2.5 feet deeper than local Mean Low Water (MLW). Bed elevations were consistently at or deeper than this elevation from the pier to the deeper water at the end of the spit.

In addition, not significant change in bed elevation is seen between the April 2018 and November 2018 survey data. Thus, the surveys indicate that the depths between the terminal groin and the pier are presently relatively stable.

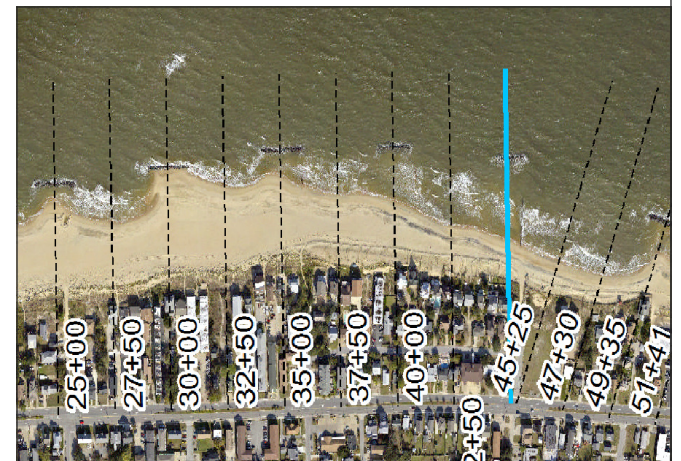
Survey Transect 45+25	NOV 2018 - OCT 2017	NOV 2018 - APR 2018
Shoreline Change at MHW (0.98 ft NAVD88)	-69.95 ft	-36.18 ft
Volume Change Above -15 ft NAVD88	-14.40 cy/ft	-6.53 cy/ft
Volume Change Above 0 ft NAVD88	-8.02 cy/ft	-7.02 cy/ft
Distance from USACE Design Template @ 3.5 feet NAVD88:

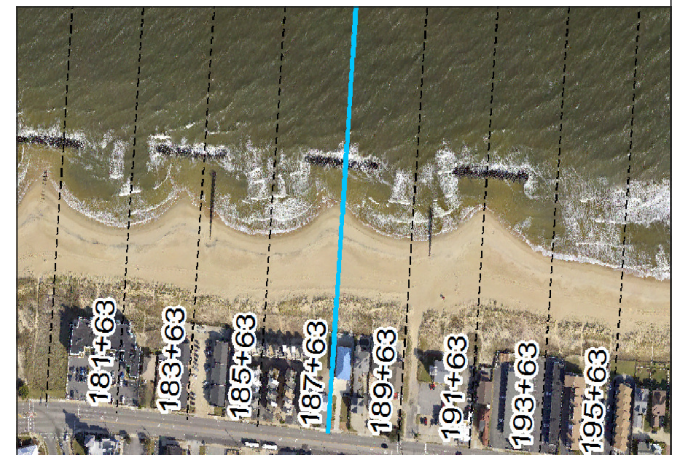
Survey Transect 189+63	NOV 2018 - OCT 2017	NOV 2018 - APR 2018
Shoreline Change at MHW (0.98 ft NAVD88)	-18.08 ft	-8.36 ft
Volume Change Above -15 ft NAVD88	3.96 cy/ft	2.32 cy/ft
Volume Change Above 0 ft NAVD88	0.16 cy/ft	1.44 cy/ft
Distance from USACE Design Template @ 3.5 feet NAVD88:

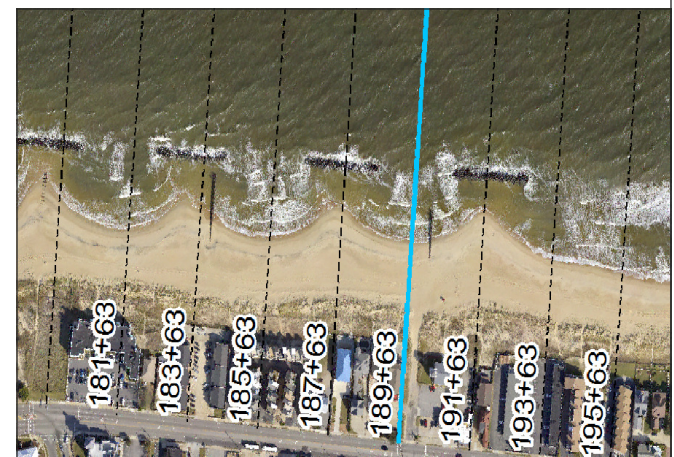
Survey Transect 191+63	NOV 2018 - OCT 2017	NOV 2018 - APR 2018
Shoreline Change at MHW (0.98 ft NAVD88)	-7.94 ft	-21.49 ft
Volume Change Above -15 ft NAVD88	9.41 cy/ft	9.36 cy/ft
Volume Change Above 0 ft NAVD88	3.85 cy/ft	3.98 cy/ft
Distance from USACE Design Template @ 3.5 feet NAVD88:

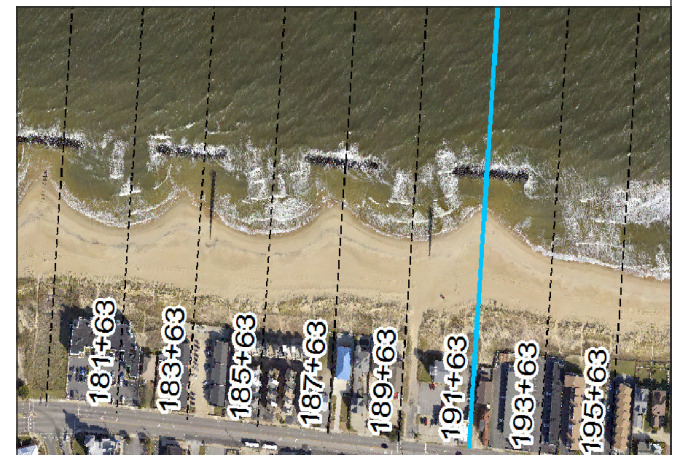
Survey Transect 193+63	NOV 2018 - OCT 2017	NOV 2018 - APR 2018
Shoreline Change at MHW (0.98 ft NAVD88)	-11.95 ft	20.79 ft
Volume Change Above -15 ft NAVD88	4.75 cy/ft	15.36 cy/ft
Volume Change Above 0 ft NAVD88	2.92 cy/ft	8.36 cy/ft
Distance from USACE Design Template @ 3.5 feet NAVD88:

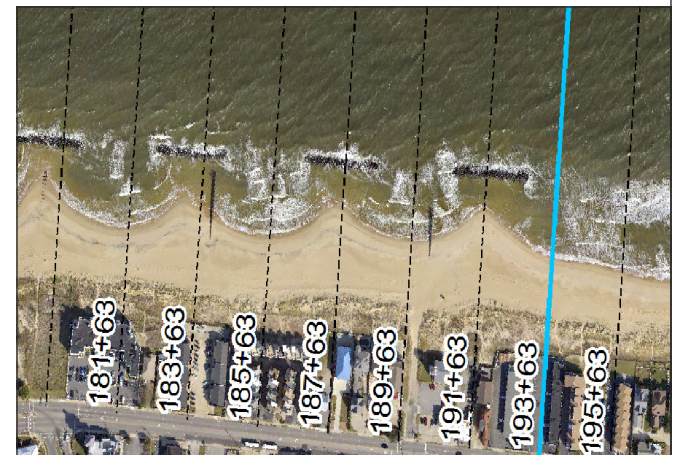
Survey Transect 195+63	NOV 2018 - OCT 2017	NOV 2018 - APR 2018
Shoreline Change at MHW (0.98 ft NAVD88)	-13.79 ft	14.96 ft
Volume Change Above -15 ft NAVD88	-0.40 cy/ft	10.90 cy/ft
Volume Change Above 0 ft NAVD88	1.96 cy/ft	6.76 cy/ft
Distance from USACE Design Template @ 3.5 feet NAVD88:

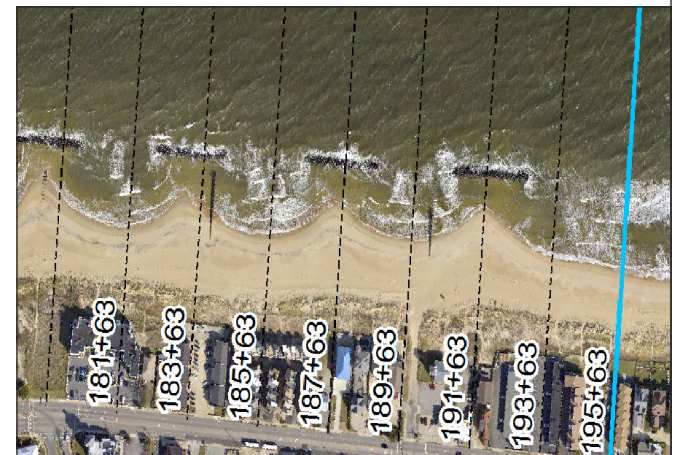
Survey Transect 206+86	NOV 2018 - OCT 2017	NOV 2018 - APR 2018
Shoreline Change at MHW (0.98 ft NAVD88)	-9.14 ft	-0.11 ft
Volume Change Above -15 ft NAVD88	-0.19 cy/ft	8.45 cy/ft
Volume Change Above 0 ft NAVD88	1.83 cy/ft	2.46 cy/ft
Distance from USACE Design Template @ 3.5 feet NAVD88:

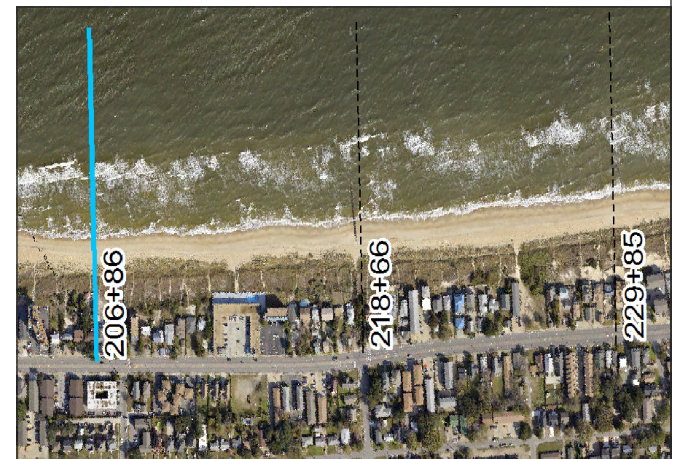
Survey Transect 218+66	NOV 2018 - OCT 2017	NOV 2018 - APR 2018
Shoreline Change at MHW (0.98 ft NAVD88)	40.34 ft	28.94 ft
Volume Change Above -15 ft NAVD88	12.16 cy/ft	7.85 cy/ft
Volume Change Above 0 ft NAVD88	6.87 cy/ft	3.45 cy/ft
Distance from USACE Design Template @ 3.5 feet NAVD88:

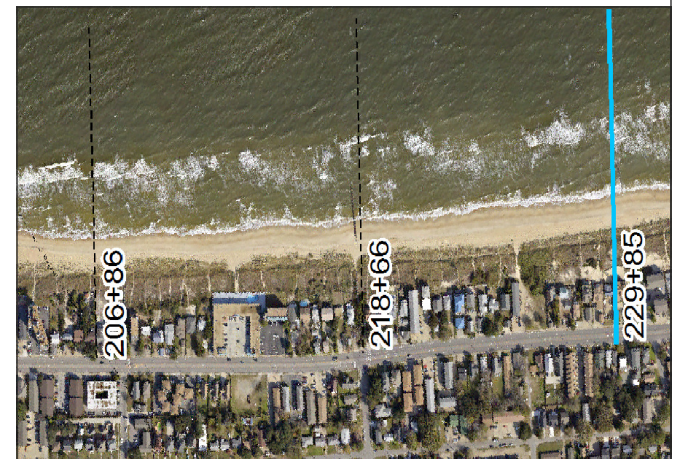
Survey Transect 242+03	NOV 2018 - OCT 2017	NOV 2018 - APR 2018
Shoreline Change at MHW (0.98 ft NAVD88)	-9.07 ft	2.76 ft
Volume Change Above -15 ft NAVD88	2.18 cy/ft	7.03 cy/ft
Volume Change Above 0 ft NAVD88	3.80 cy/ft	2.99 cy/ft
Distance from USACE Design Template @ 3.5 feet NAVD88:

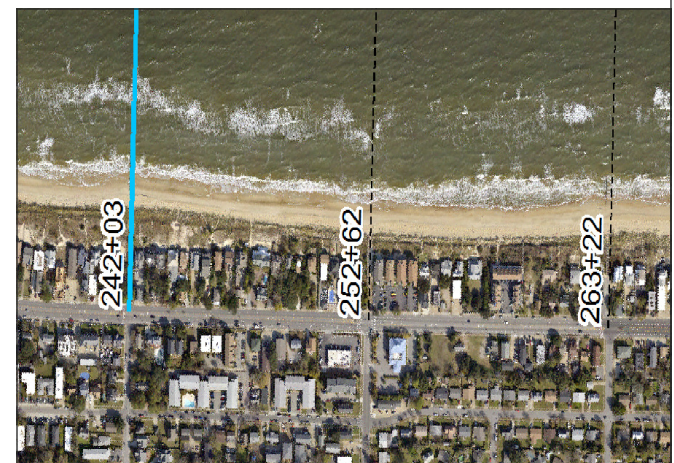
Survey Transect 252+62	NOV 2018 - OCT 2017	NOV 2018 - APR 2018
Shoreline Change at MHW (0.98 ft NAVD88)	7.78 ft	-12.67 ft
Volume Change Above -15 ft NAVD88	14.91 cy/ft	0.22 cy/ft
Volume Change Above 0 ft NAVD88	6.51 cy/ft	-0.58 cy/ft
Distance from USACE Design Template @ 3.5 feet NAVD88:
