PERIODIC SURVEY EVALUATION: OCEAN VIEW BEACH

City of Norfolk, Virginia | Fall 2020 | PN: 10390-21

Periodic Survey Evaluation: Ocean View Beach Fall 2020

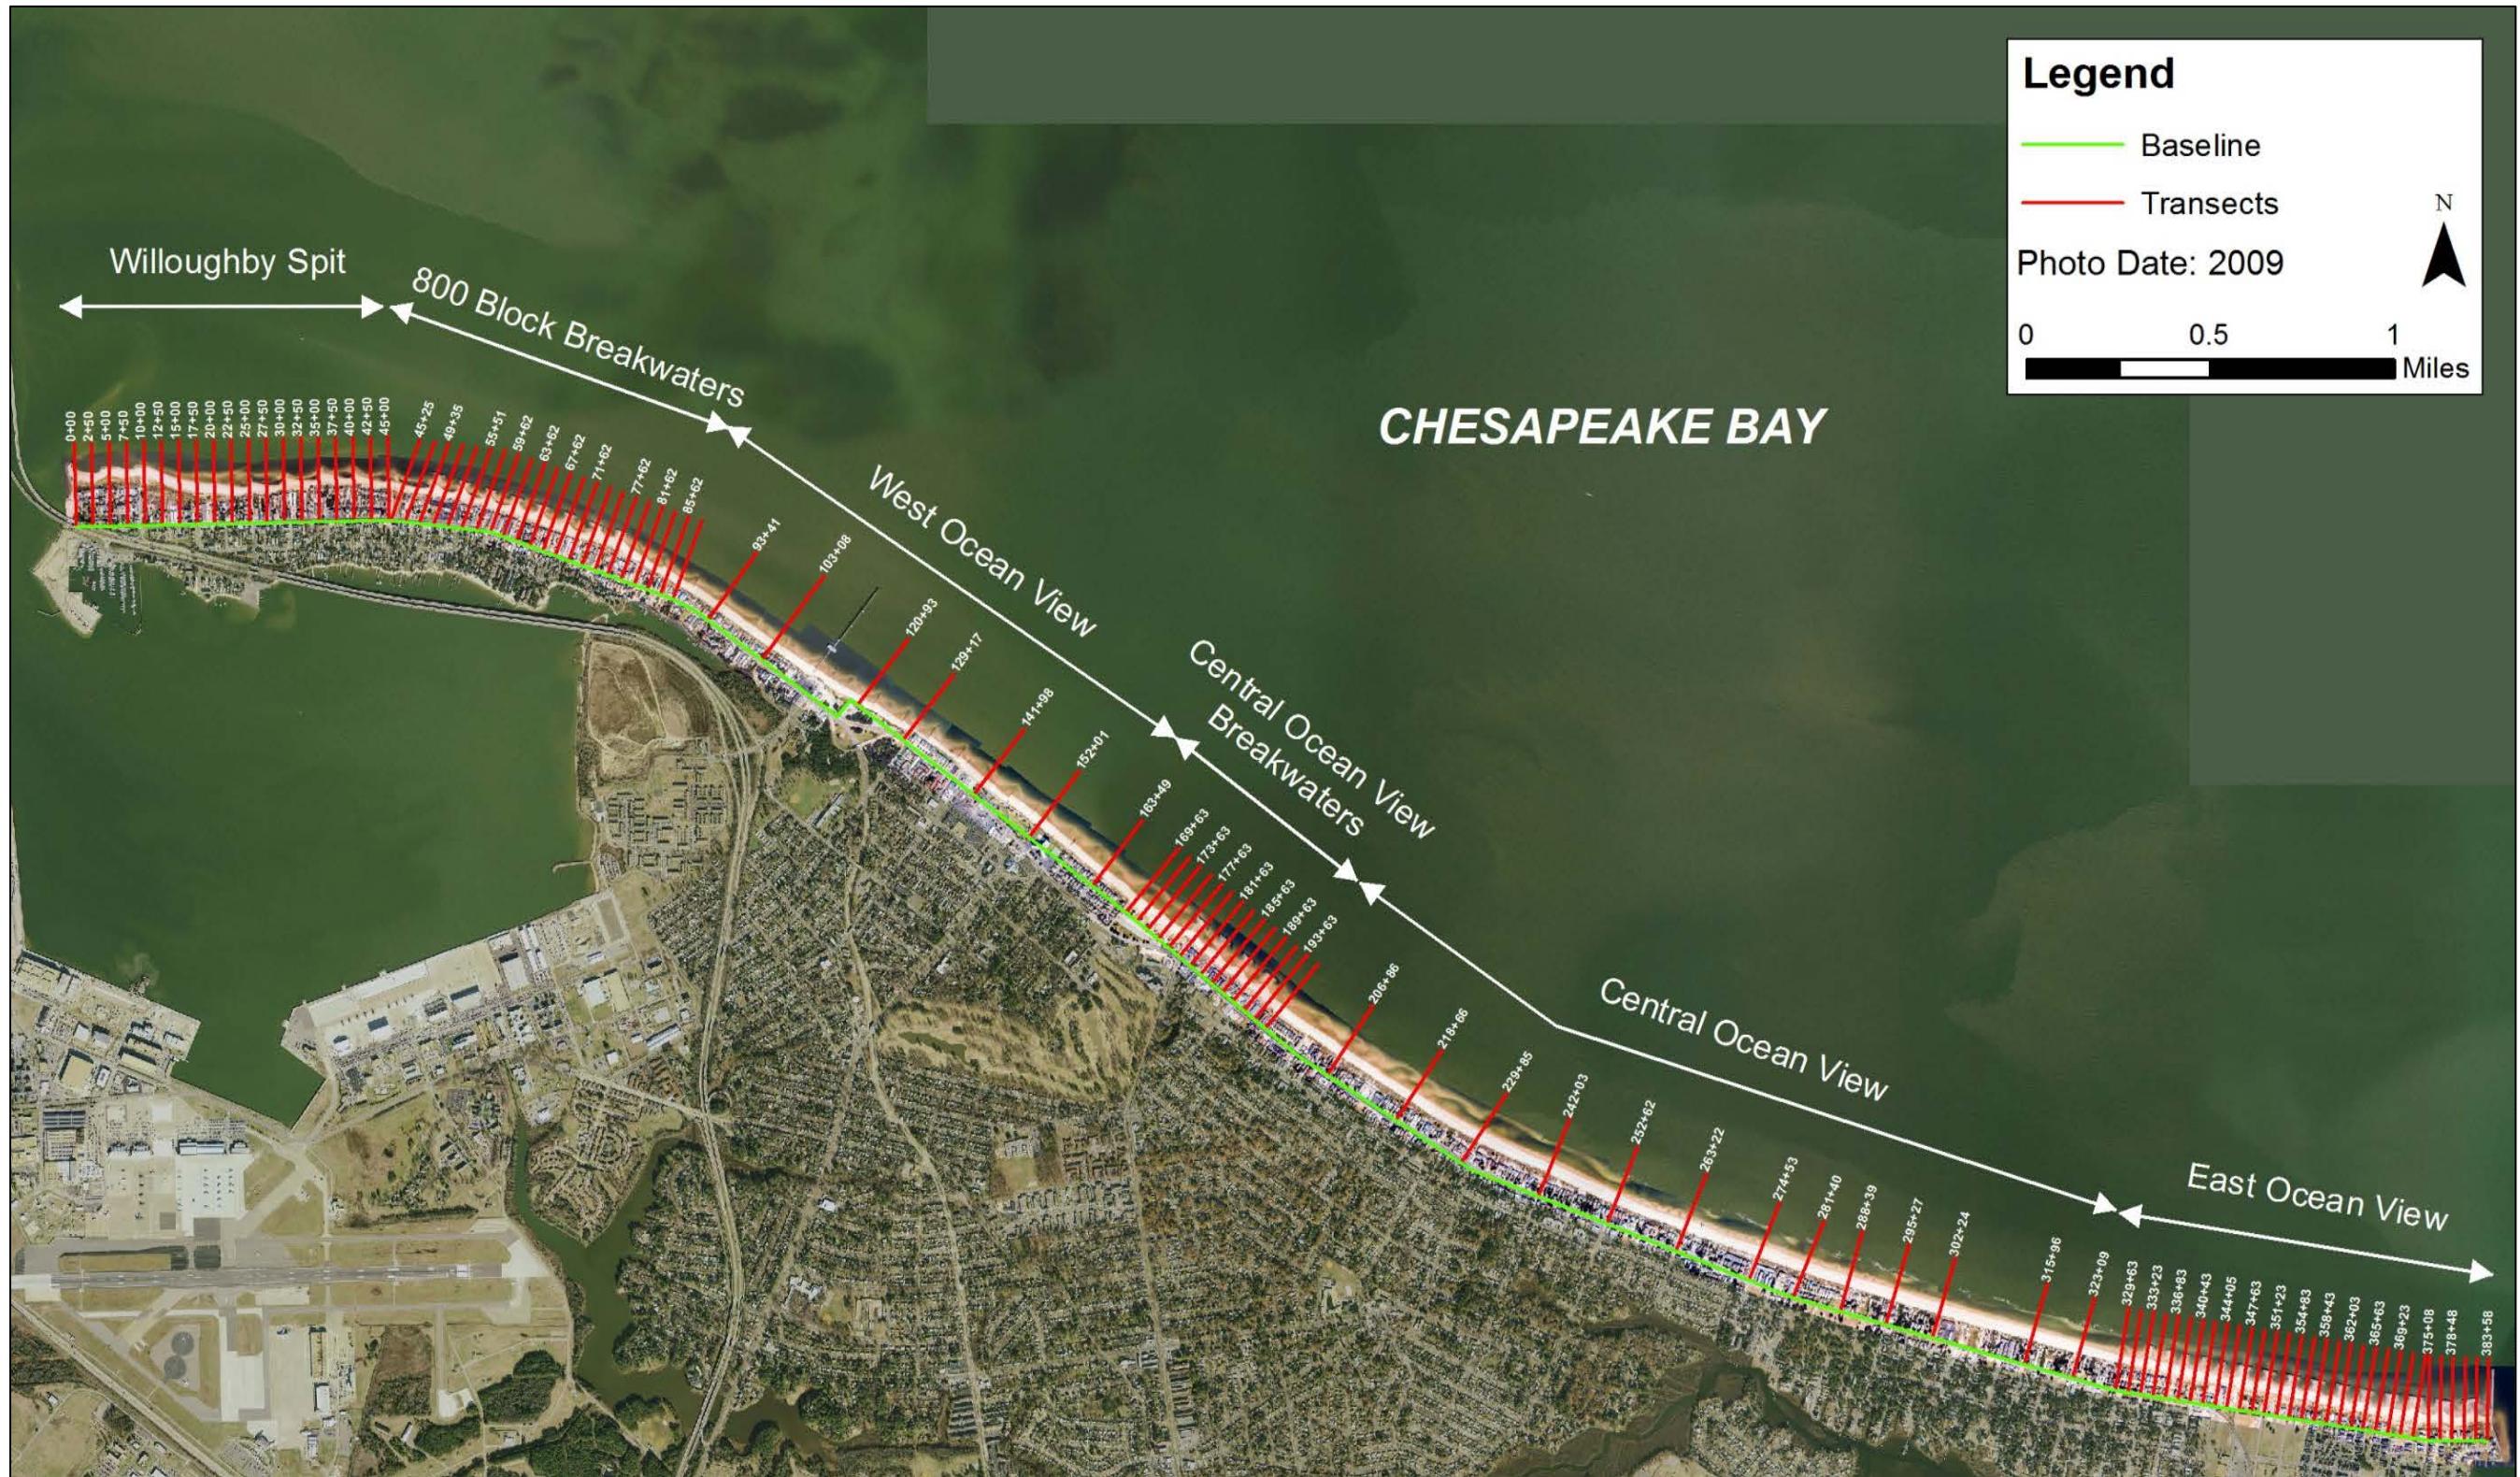
Figure 3-1: Survey Baseline and Transects

Geodynamics, LLC, conducted the most recent survey of Ocean View Beach from October 26 to October 28, 2020. The baseline and transects established for the September 2005 survey were used for the most recent survey. Figure 3-1 shows the location of the baseline, transects and the stationing applied by Geodynamics for the surveying. As shown in Figure 3-1, transects were stationed from west to east along the Ocean View shoreline. The survey data were provided in xyz and shapefile formats allowing for compatibility with multiple programs.

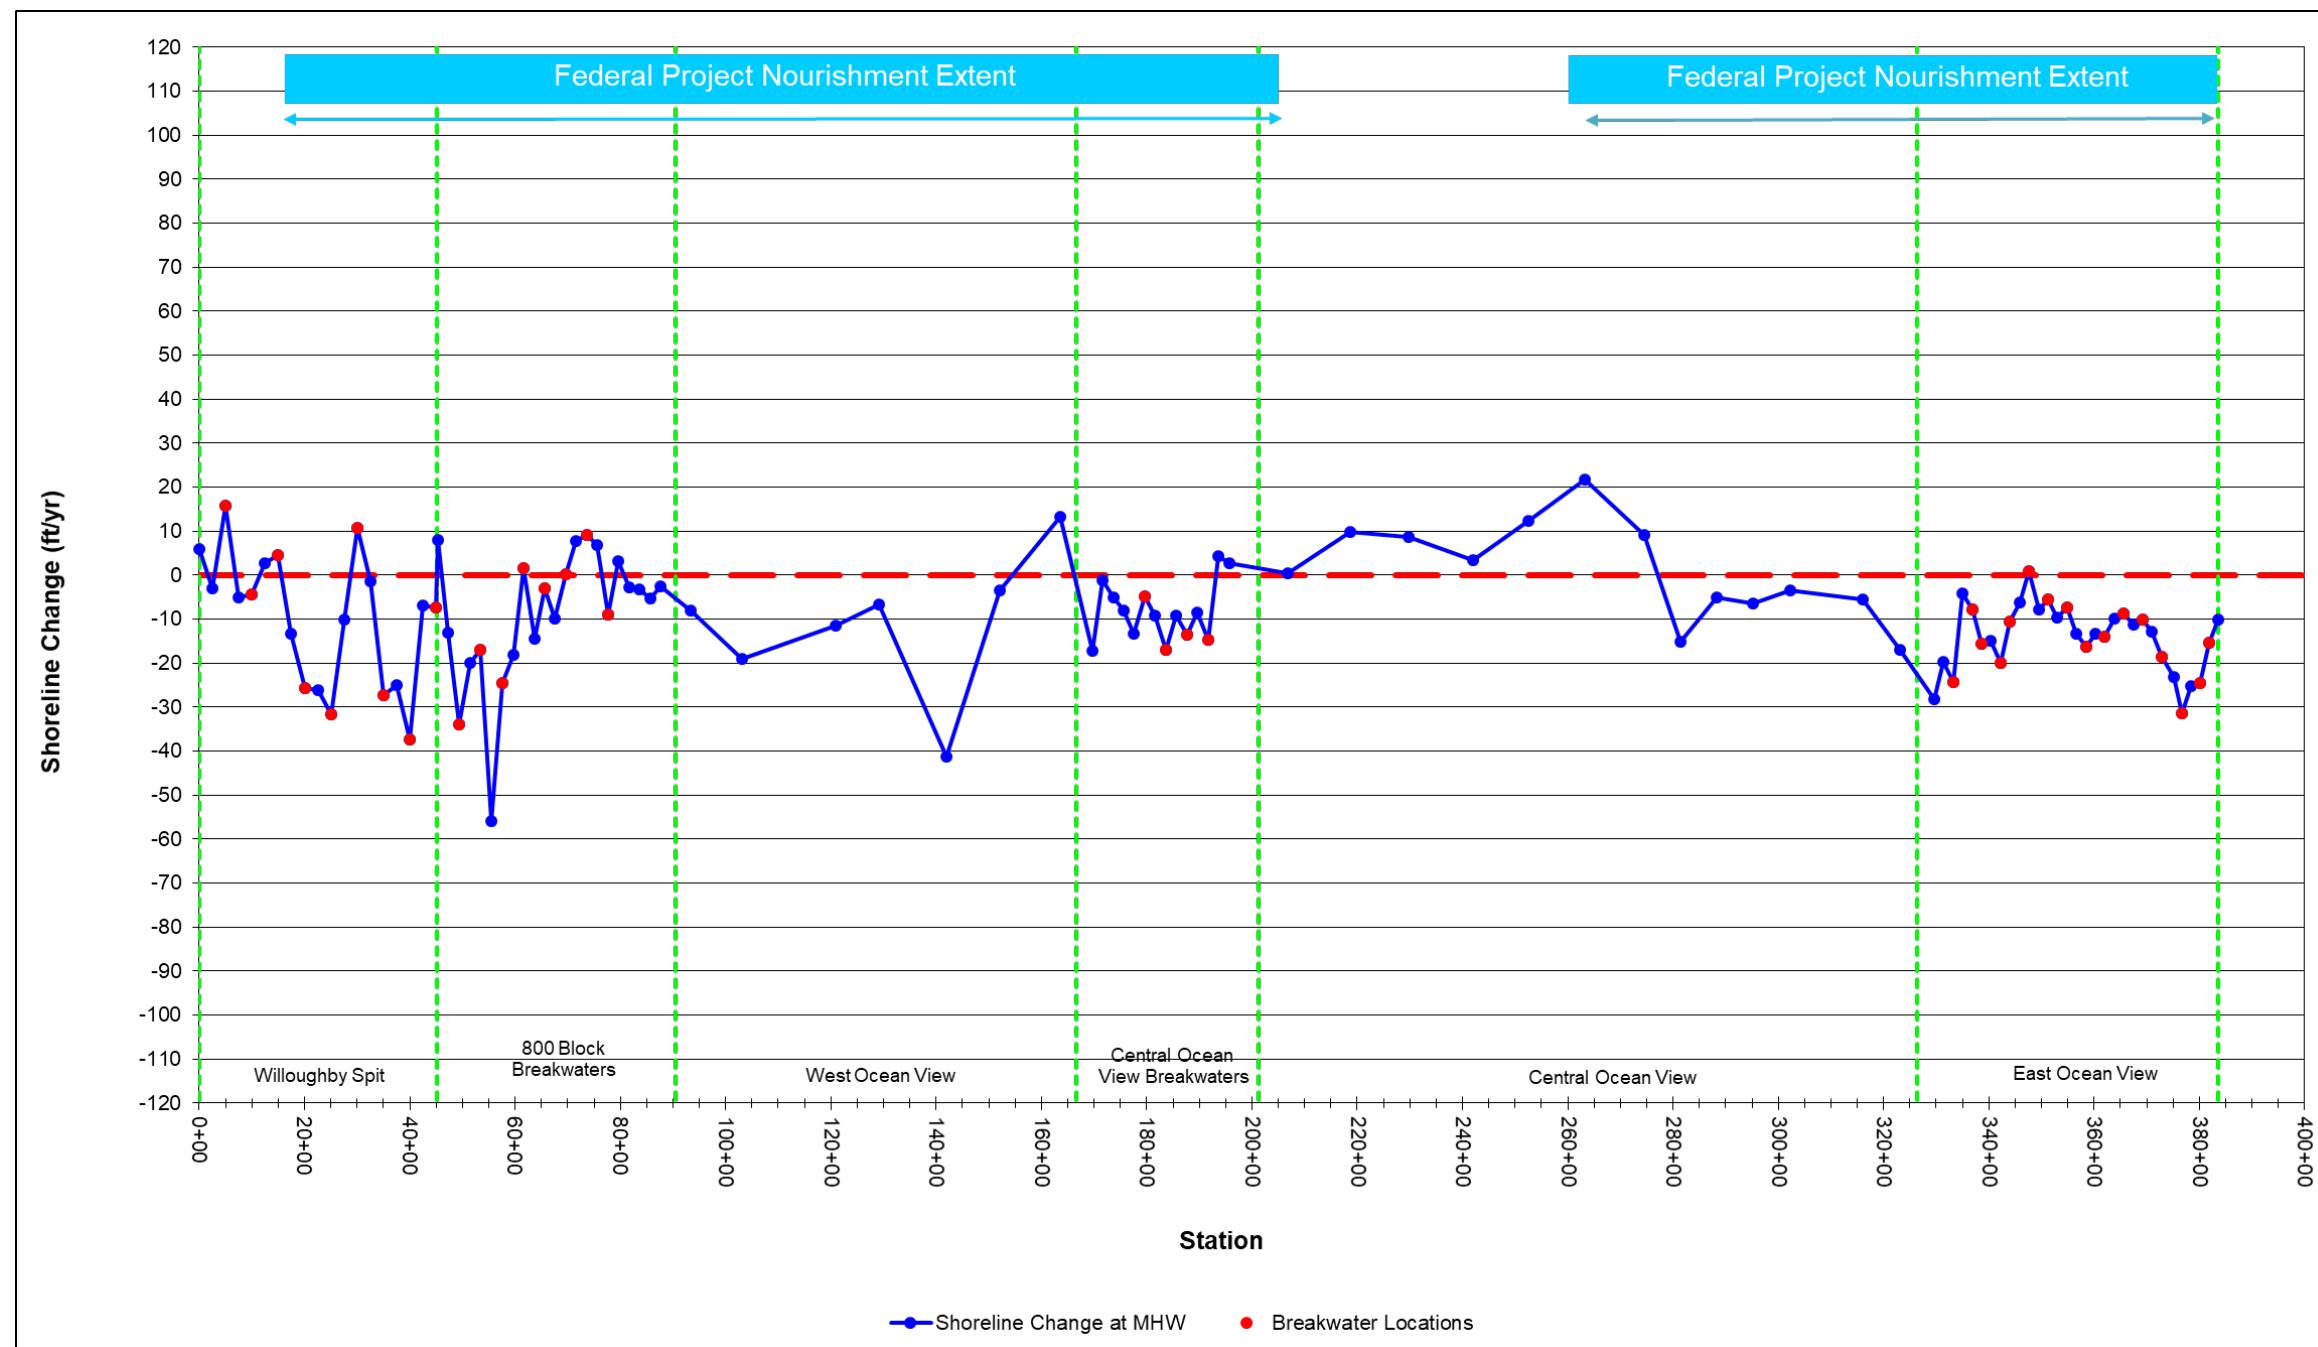
Figure 5-34: Shoreline Change Rate (ft/yr) at Mean High Water (+0.98 ft NAVD88) for November 2019 to October 2020 (Note: Positive = Accretion, Negative = Erosion)

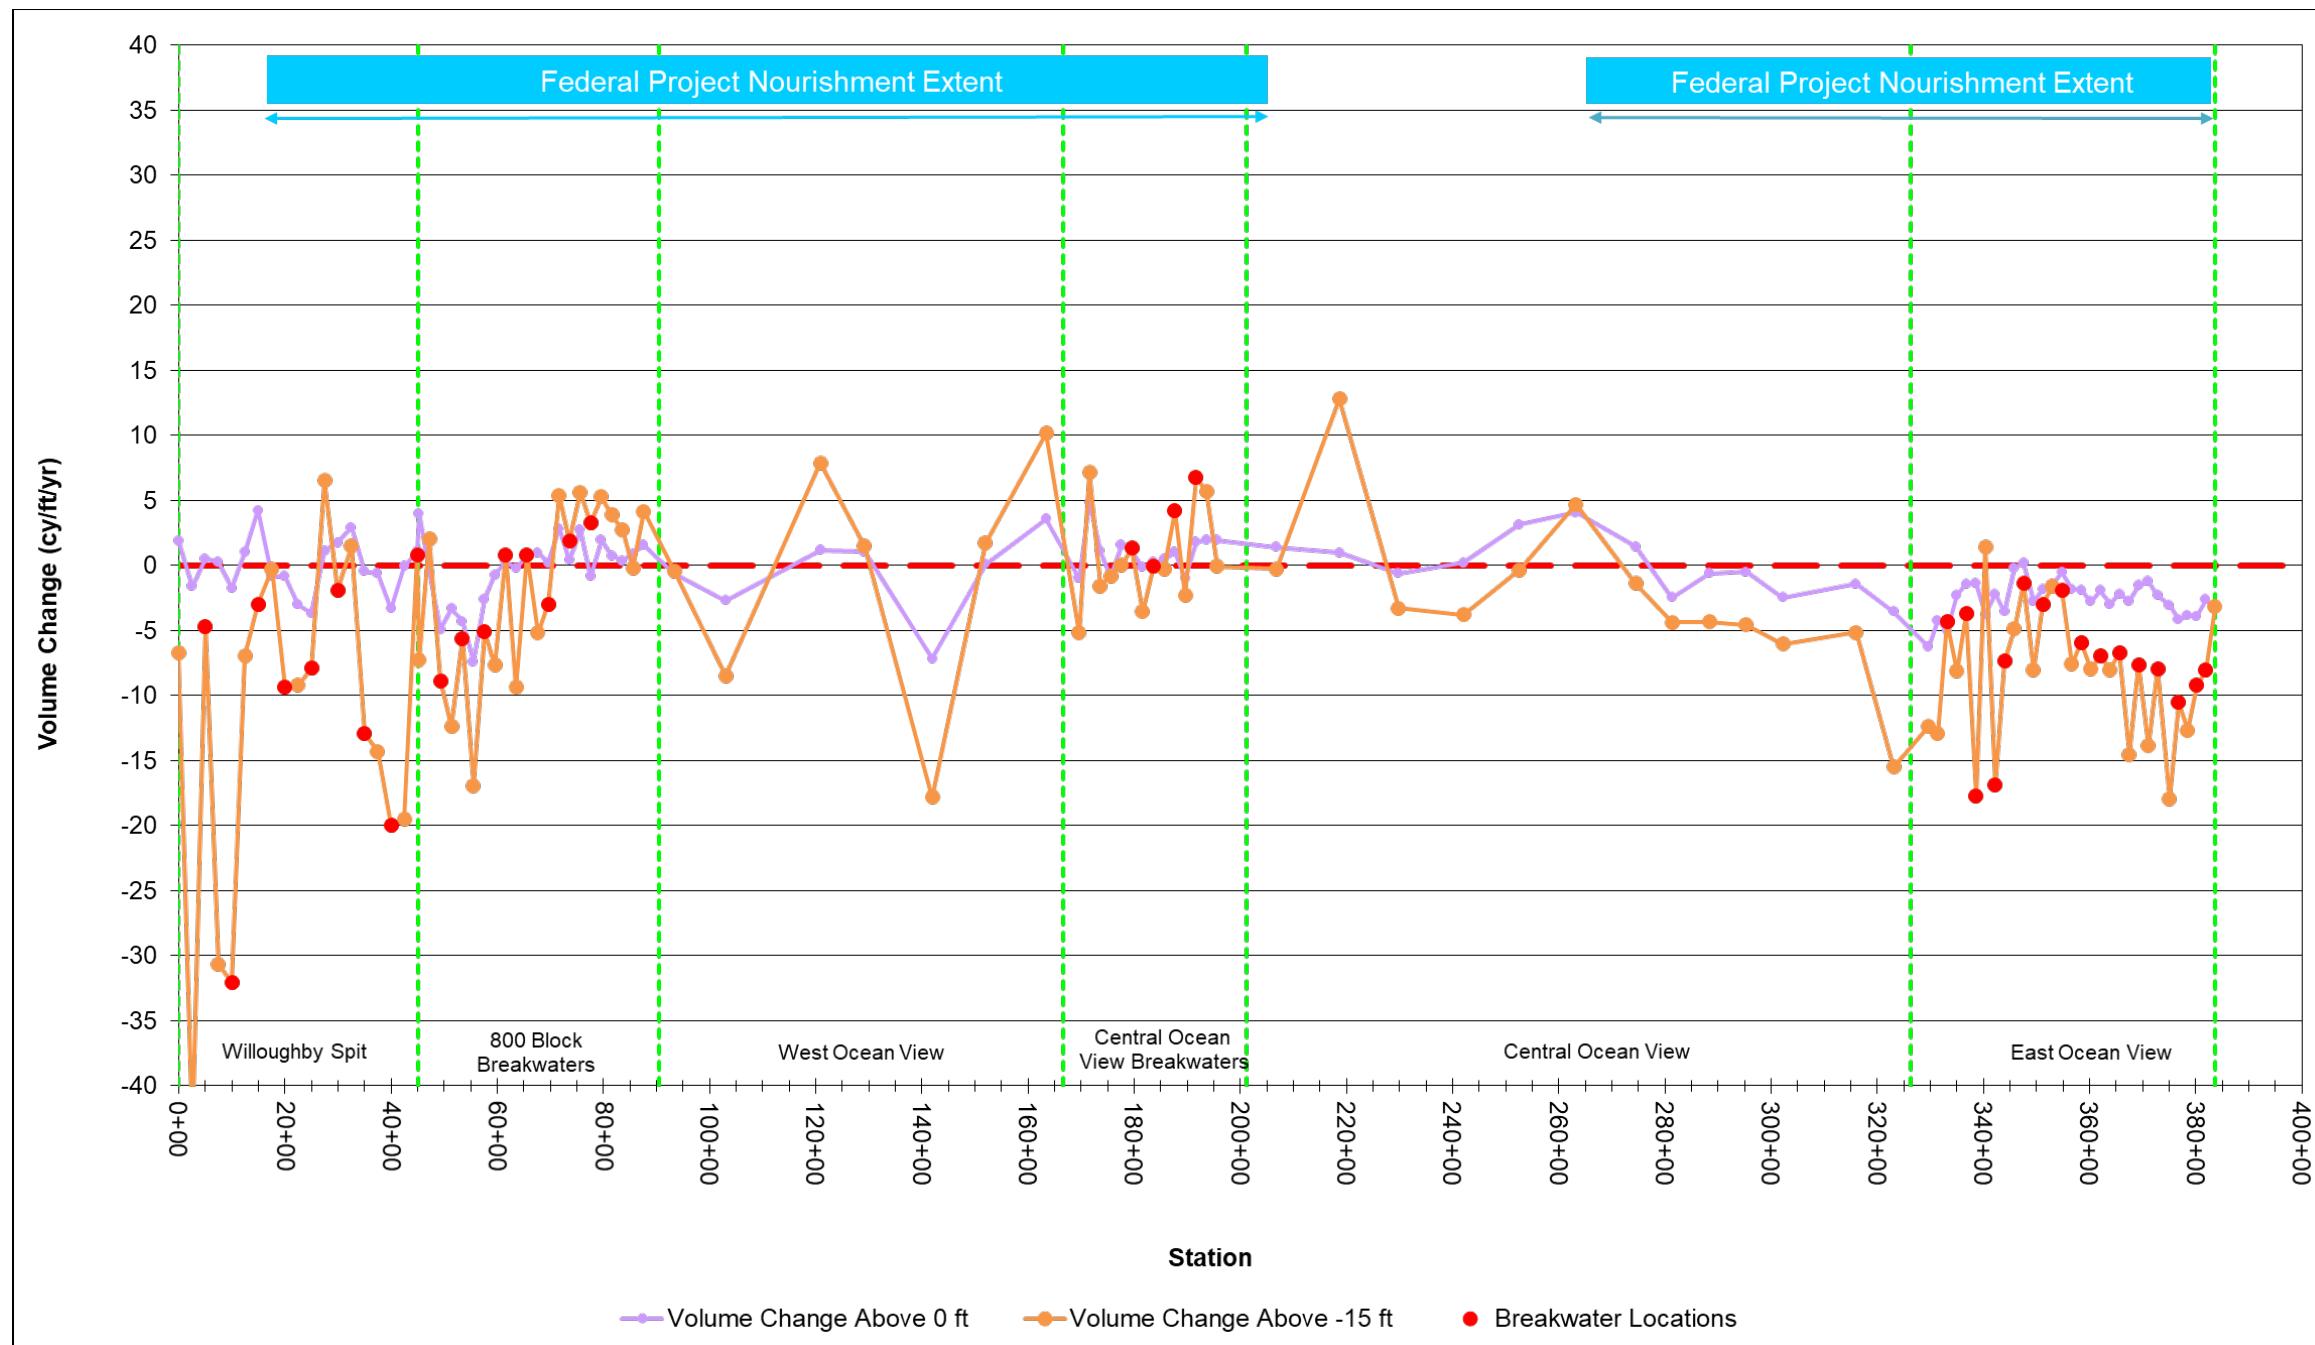
Figure 5-35: Volume Change Rate Above 0 ft NAVD88 and -15 ft NAVD88 (cy/ft/yr) for November 2019 to October 2020 (Note: Positive = Accretion, Negative = Erosion)

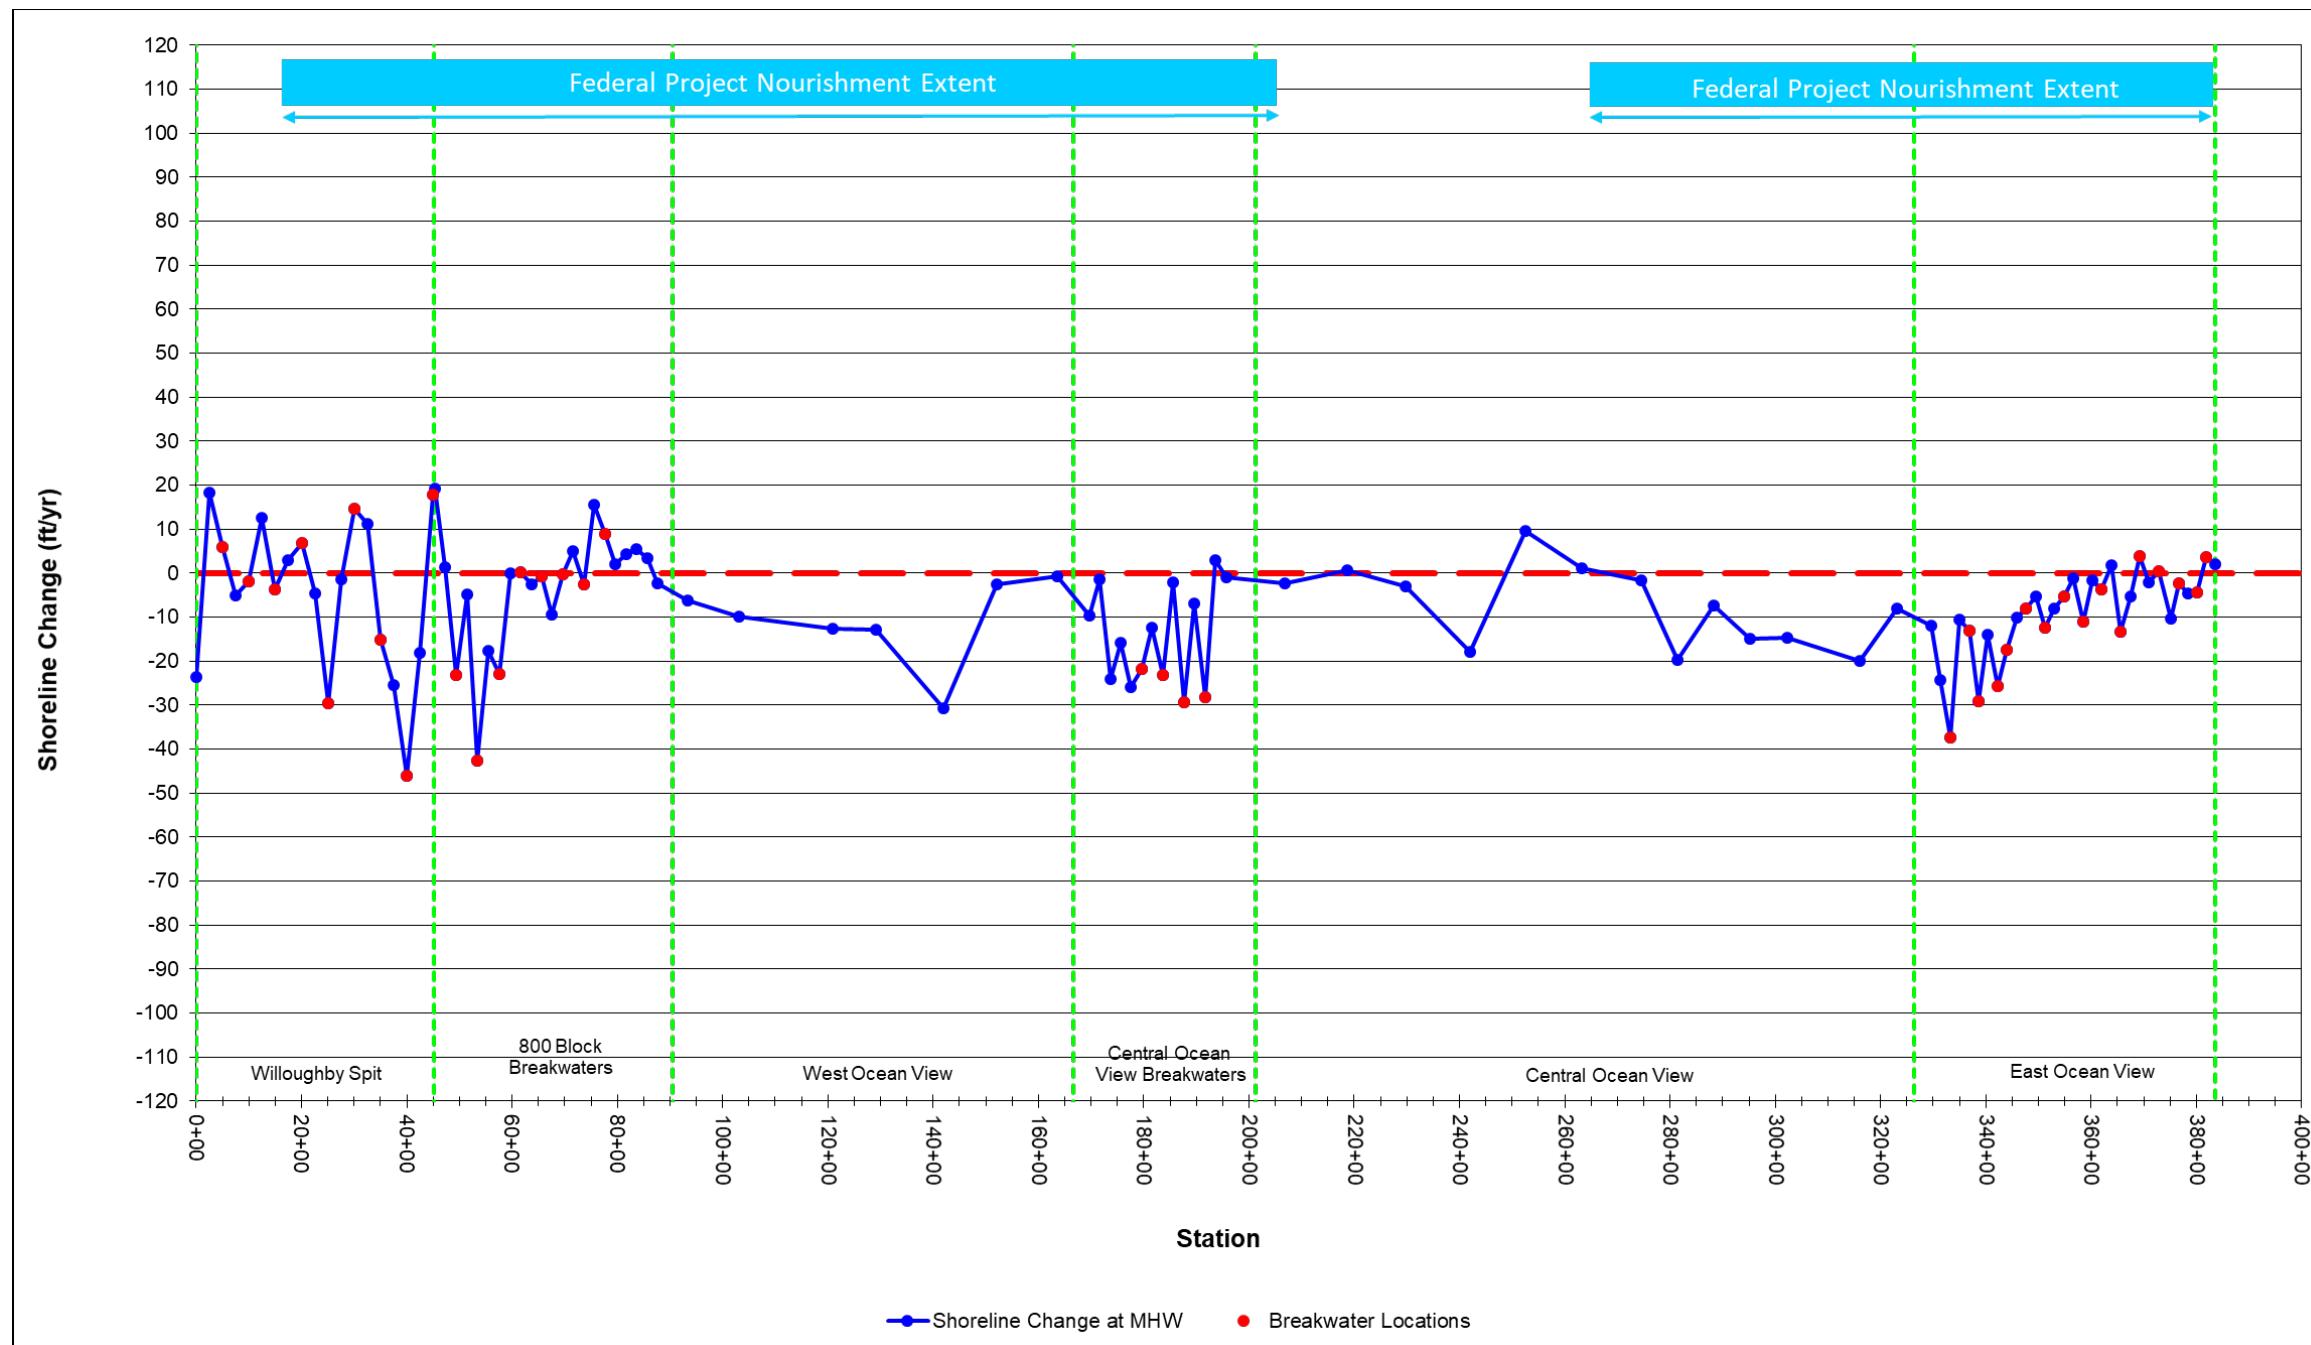
Figure 5-36: Shoreline Change (ft) at Mean High Water (+0.98 ft NAVD88) for June 2020 to October 2020 (Note: Positive = Accretion, Negative = Erosion)

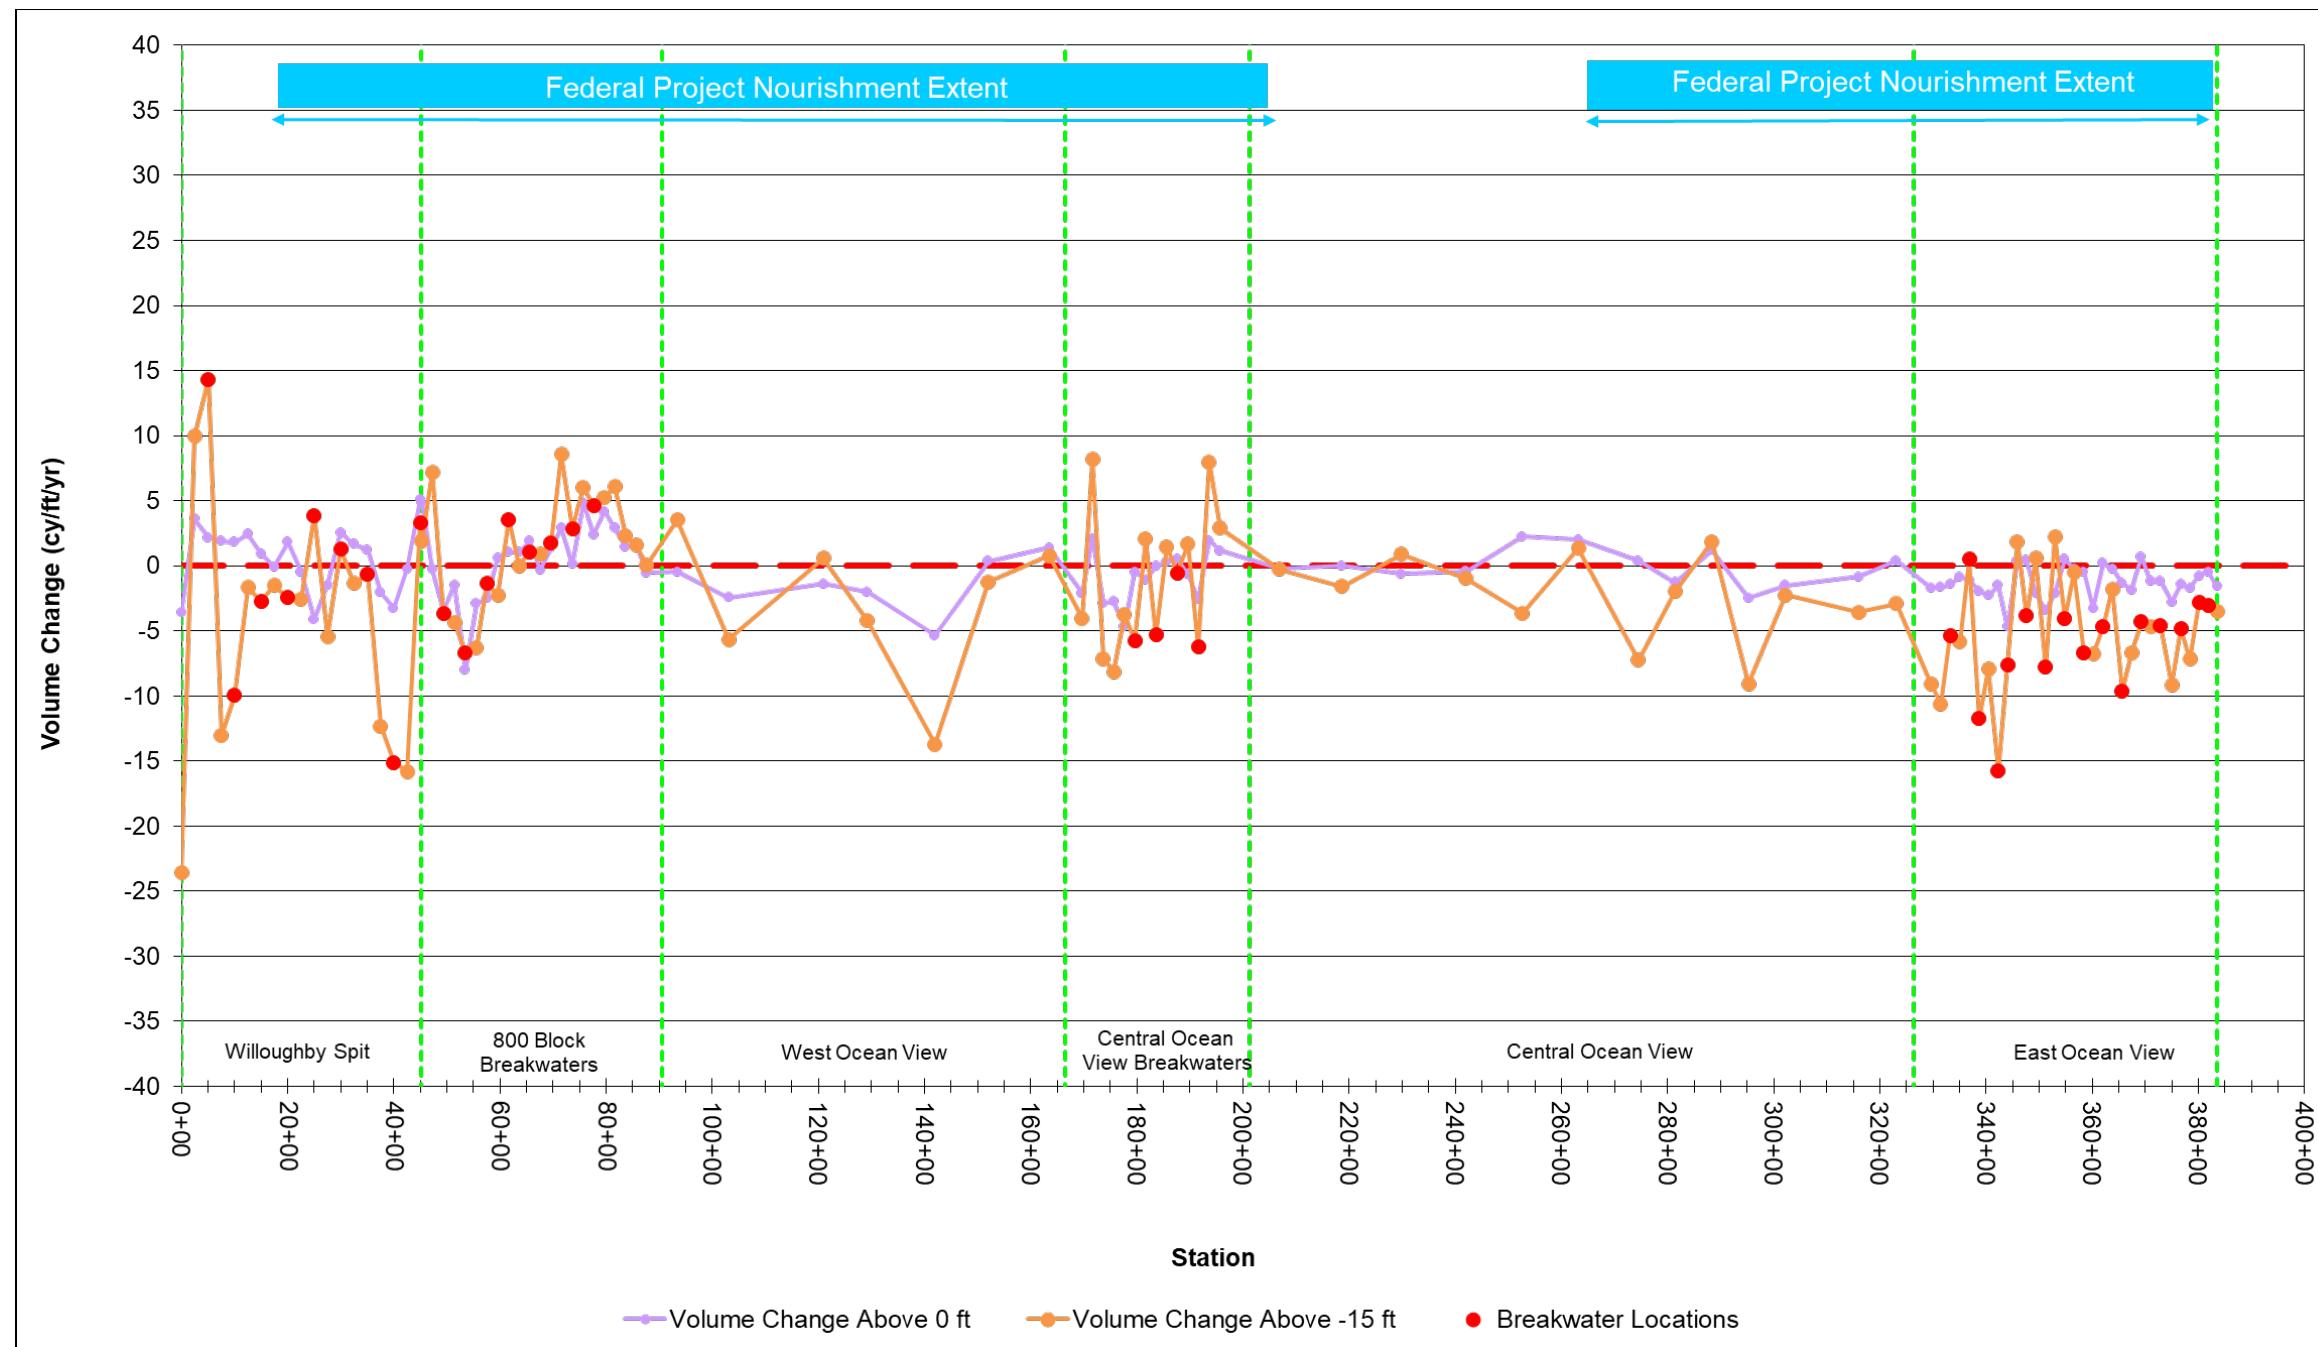
Figure 5-37: Volume Change above 0 ft NAVD88 and -15 ft NAVD88 (cy/ft) for June 2020 to October 2020 (Note: Positive = Accretion, Negative = Erosion)

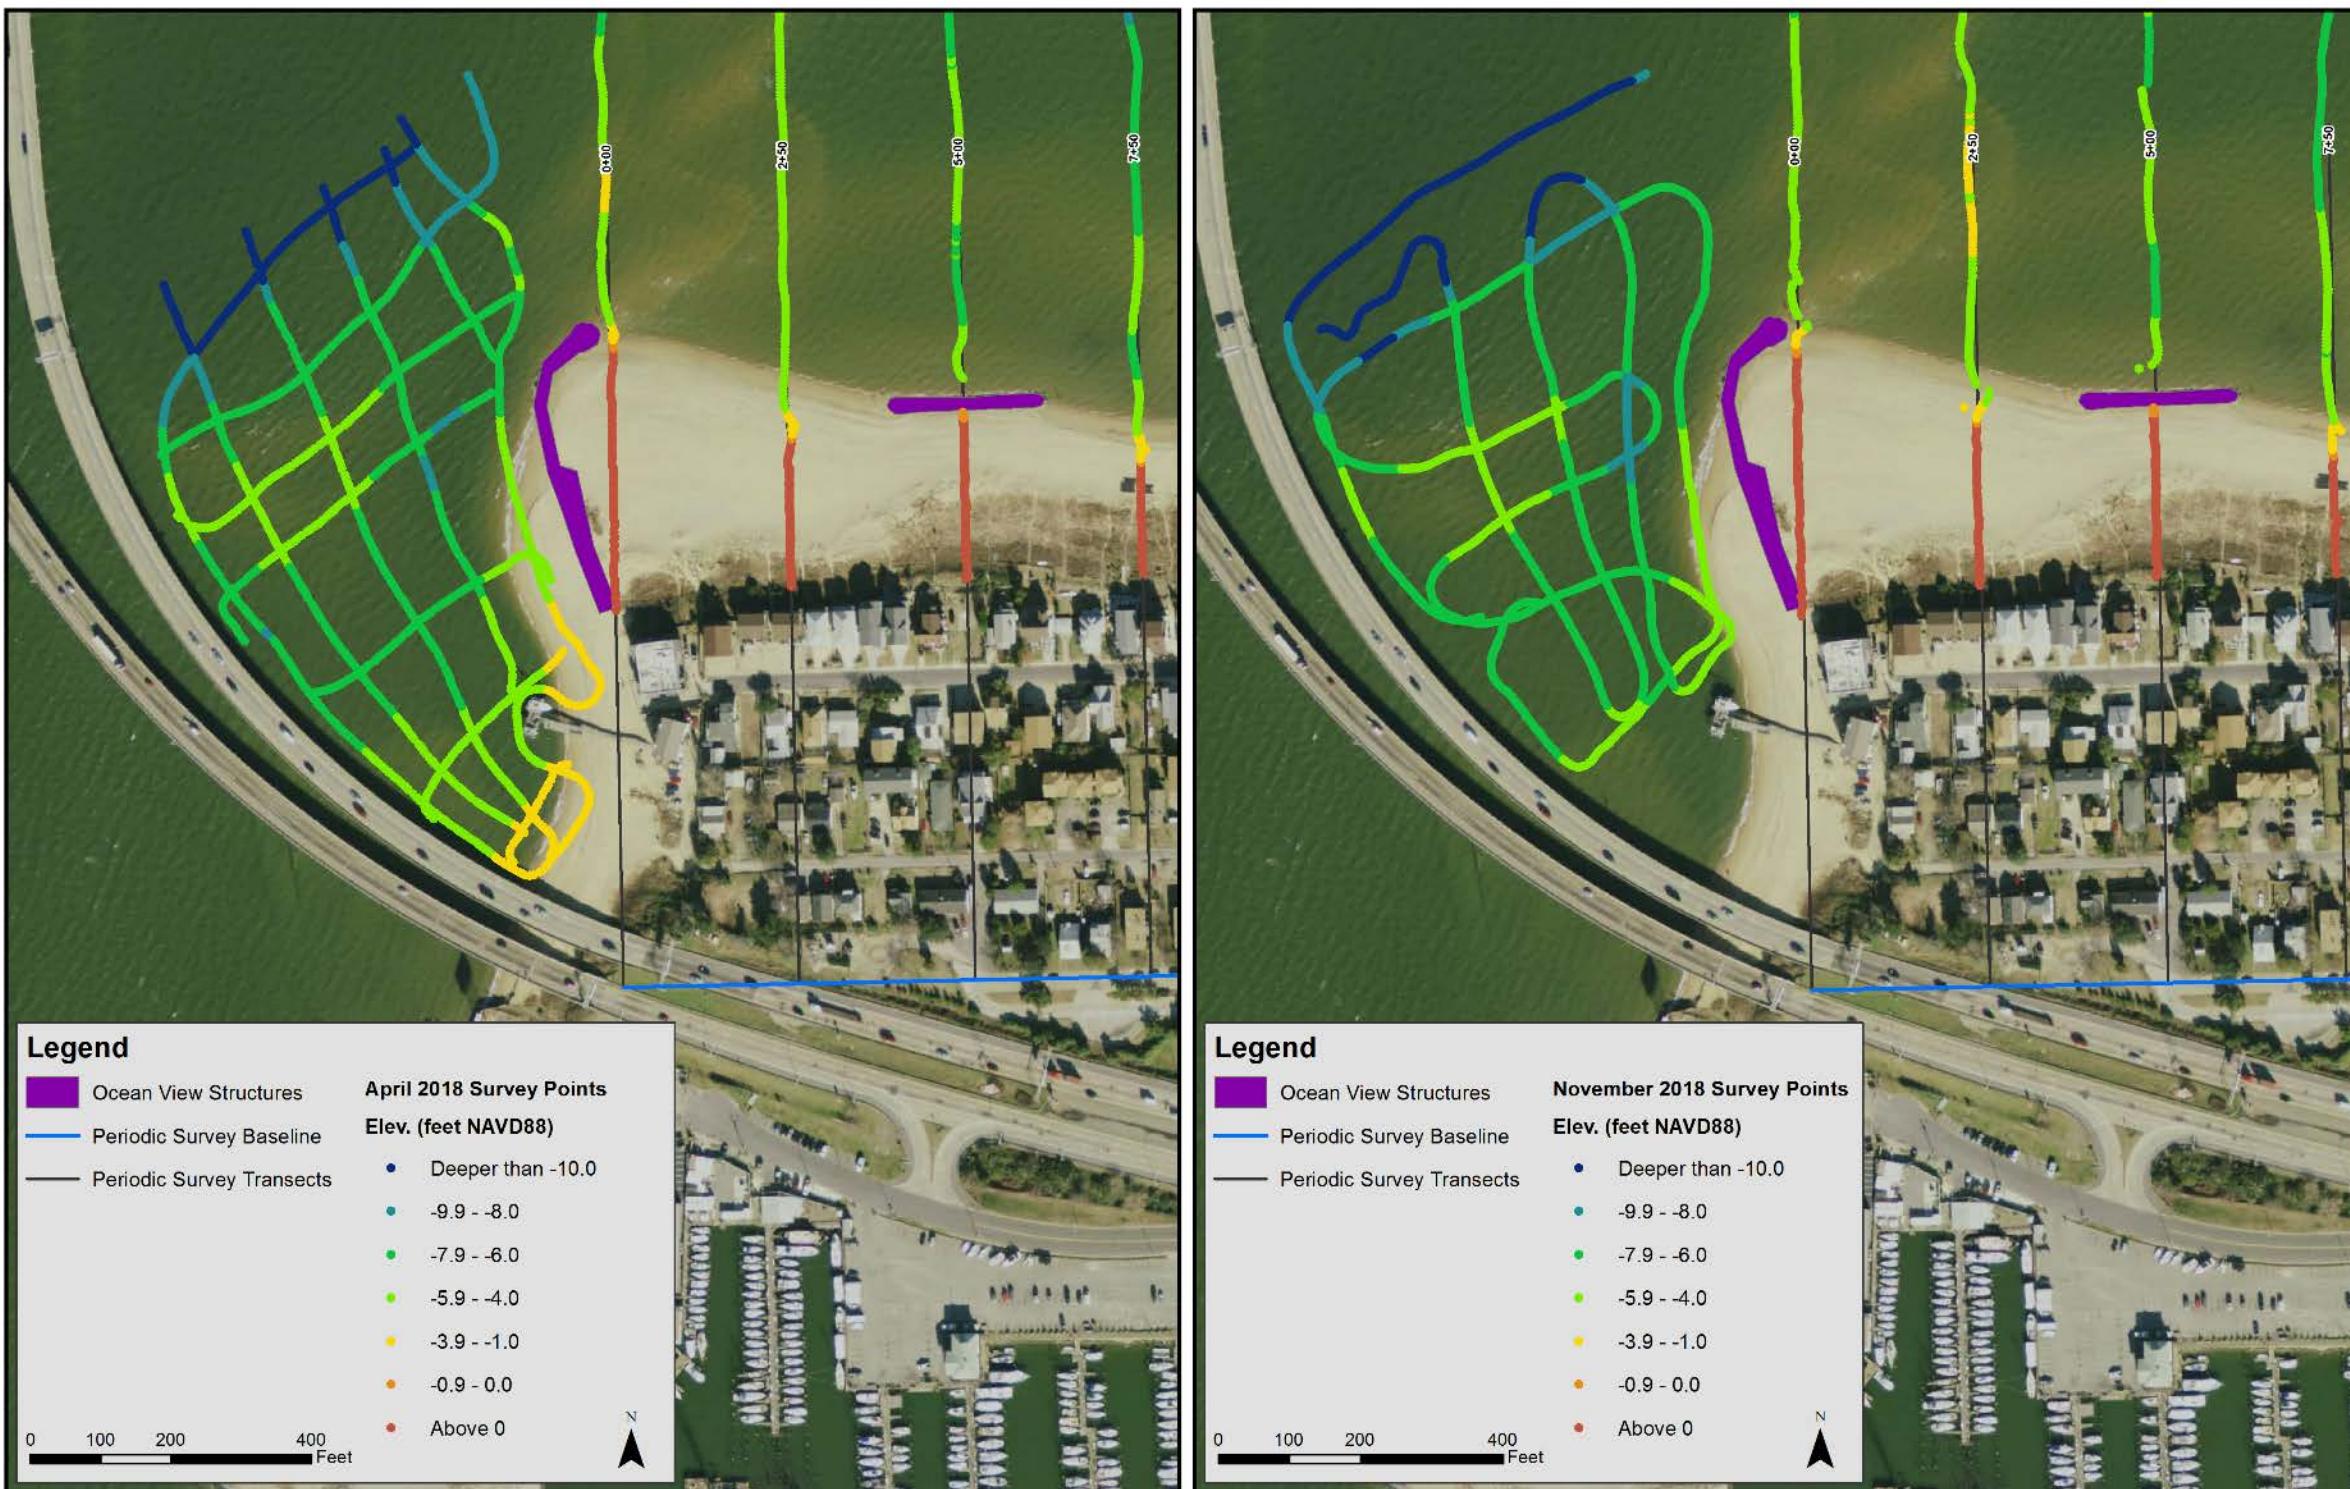
While this area west of the terminal groin has not historically been part of the regular periodic survey coverage, the past two surveys have included vessel tracks, as shown in Figure 6-1, to evaluate the depths near the pier. The left and right panels of Figure 6-1 show the April 2018 and November 2018 survey point depths, respectively, between the terminal groin and the pier and the relatively deeper waters near the Hampton Roads Bridge Tunnel. In both surveys, depths near the pier were deeper than -4.0 feet NAVD88, which is approximately 2.5 feet deeper than local Mean Low Water (MLW). Bed elevations were consistently at or deeper than this elevation from the pier to the deeper water at the end of the spit.

In addition, no significant change in bed elevation was seen between the April 2018 and November 2018 survey data. Thus, the surveys indicate that the depths between the terminal groin and the pier were relatively stable at that time.

Figure 6-1: Spring 2018 and Fall 2018 Survey Depths West of the Willoughby Spit Terminal Groin

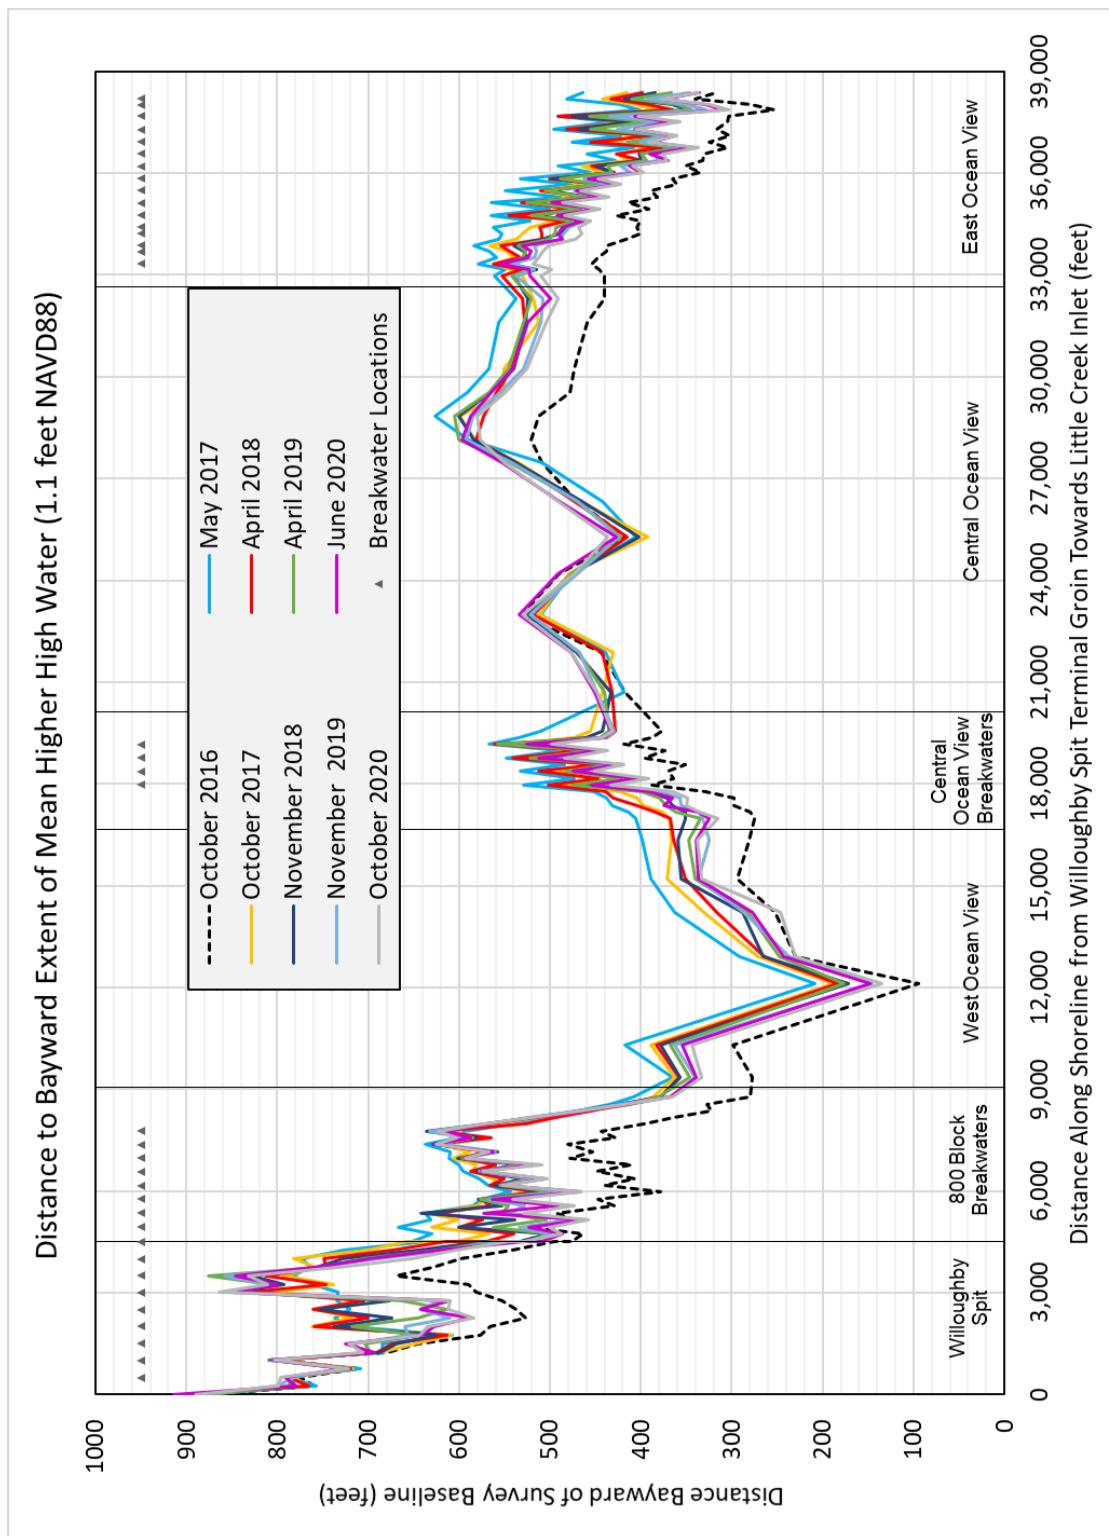
The movement of the shoreline is consistent with the shoreline changes tabulated by Ocean View region earlier in this report (Table 1-2). The chart in Figure 7-1 shows shoreline position rather than shoreline change rate as a means of illustrating the beach planform remaining in the project relative to its construction design. The chart illustrates that the MHHW contour changed less in both the six months from June 2020 and October 2020 and over the year from November 2019 to October 2020, compared to the changes observed in the first year post-construction (May 2017 to April 2018). This is consistent with typical expectations of a beach nourishment project's evolution.

Figure 7-1: Position of the Mean Higher High Water (+1.1 ft NAVD88) Contour Relative to Pre- and Post-Construction of the Federal Project
