PERIODIC SURVEY EVALUATION: OCEAN VIEW BEACH

City of Norfolk, Virginia | Fall 2020 | PN: 10390-21

Periodic Survey Evaluation: Ocean View Beach Fall 2020

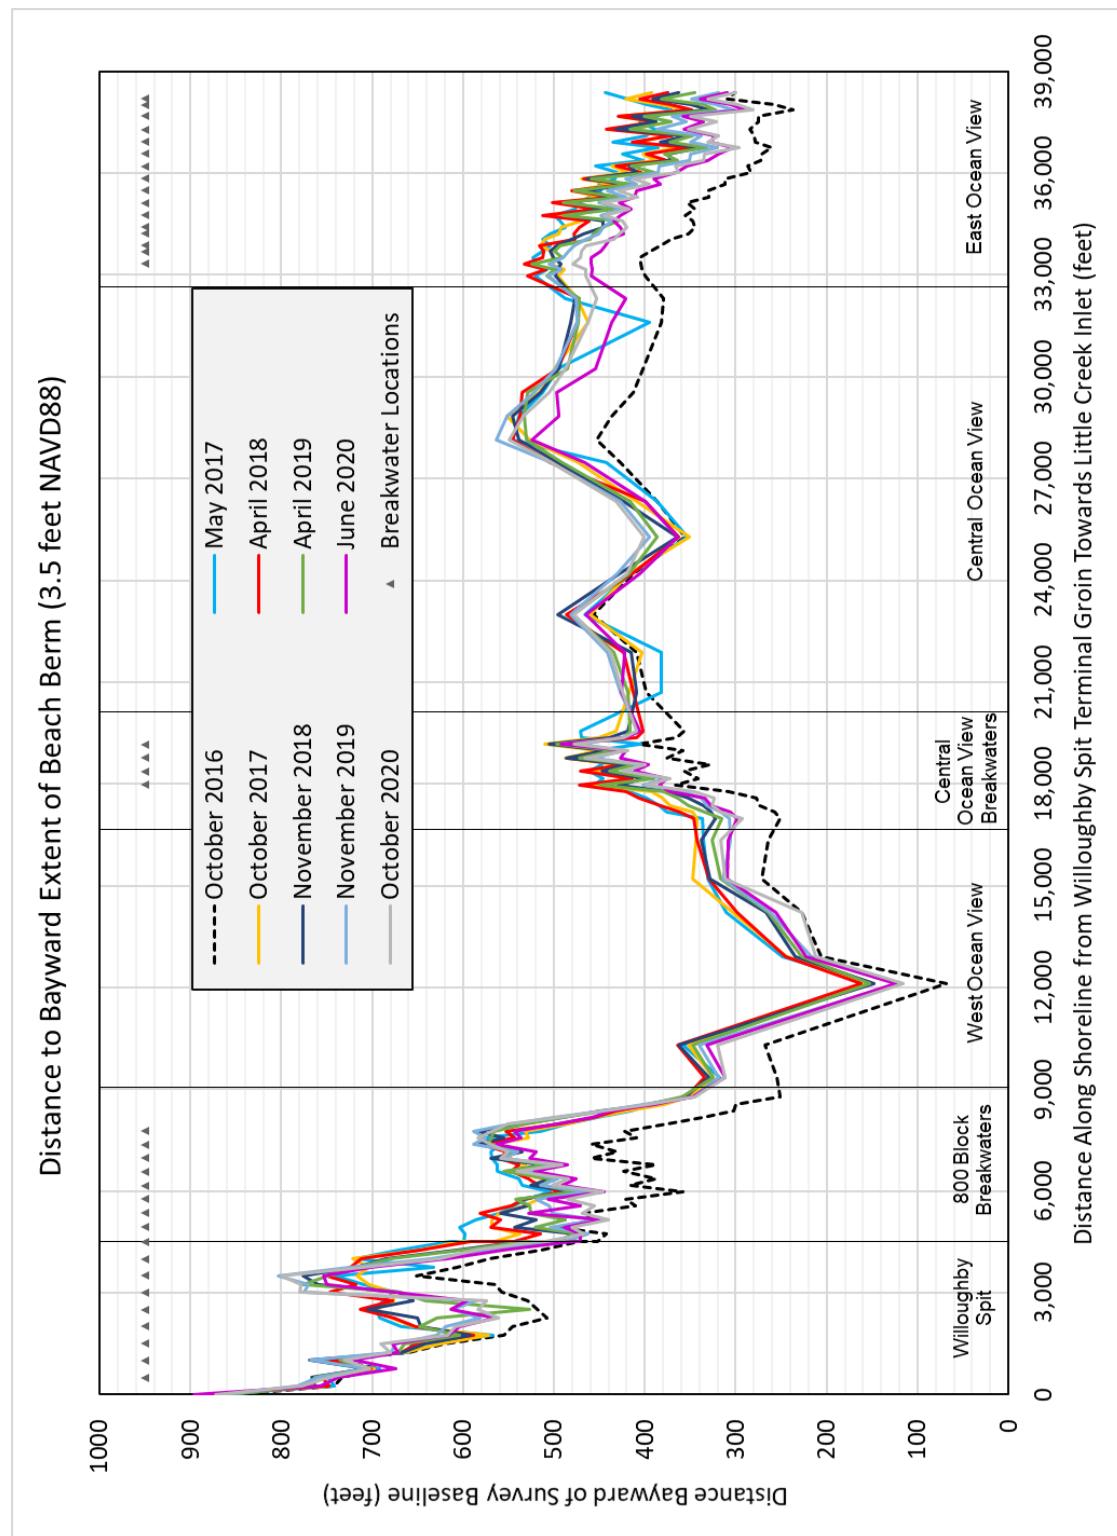
The berm continued to retreat significantly from stations 40+00 to 51+41, in the vicinity of 11th View street from midway along Toler Place to the 800 Block breakwaters. The breakwater at 11th View Street was modified and a new breakwater added between this one and the 800 Block breakwaters, with construction taking place between March 2020 and July 2020. The beginnings of sand accretion in the lee of these breakwaters was observed during a site visit in June 2020. The survey data captured in October 2020 indicates a seaward progression of the MHW shoreline directly behind the newly constructed breakwater from June 2020 to October 2020. This region gained volume in the beach and dune above 0 feet NAVD88 over both the seasonal comparison (June 2020 - October 2020) and yearly comparison (November 2019 - October 2020) indicating that this section of shoreline is gradually recovering. Further analysis of the survey data shows continuation of MHW shoreline retreat on both eastward and westward of the breakwater.

Figure 7-2: Position of the Bayward Extent of the +3.5 ft NAVD88 Beach Berm Contour Relative to Pre- and Post-Construction of the Federal Project

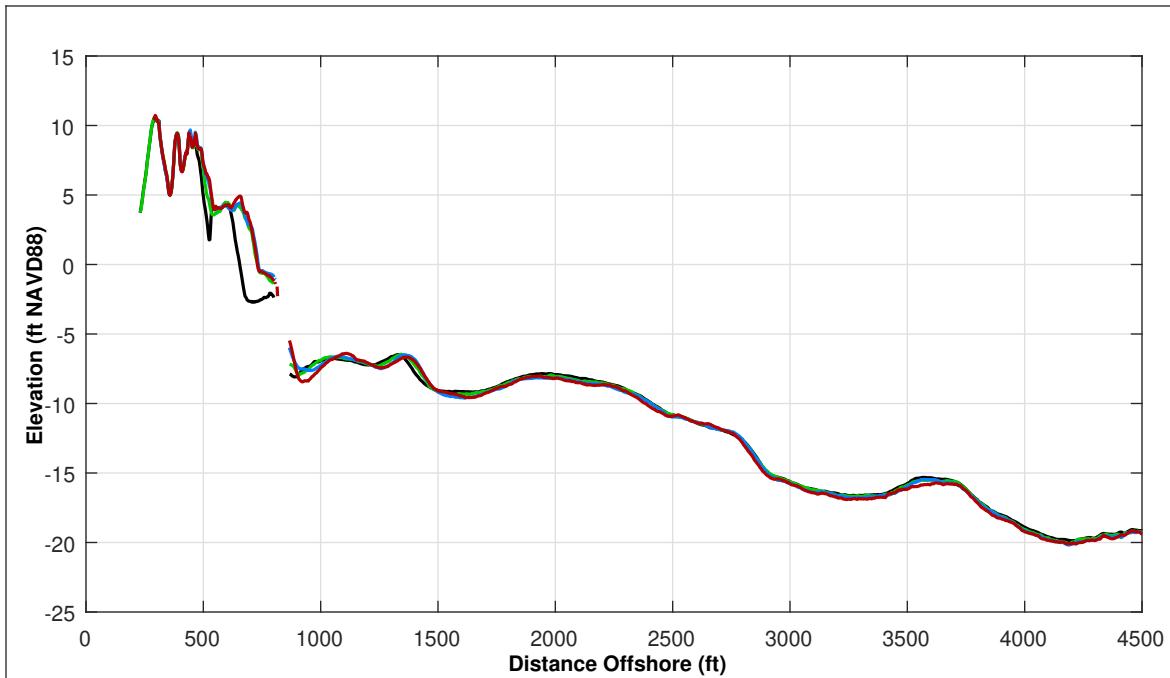
Survey Transect 15+00	OCT 2020 - NOV 2019	OCT 2020 - JUN 2020
Shoreline Change at MHW (0.98 ft NAVD88)	4.56 ft	-3.56 ft
Volume Change Above -15 ft NAVD88	-2.92 cy/ft	-2.73 cy/ft
Volume Change Above 0 ft NAVD88	4.15 cy/ft	0.93 cy/ft
Distance from USACE Design Template @ 3.5 feet NAVD88:		N/A

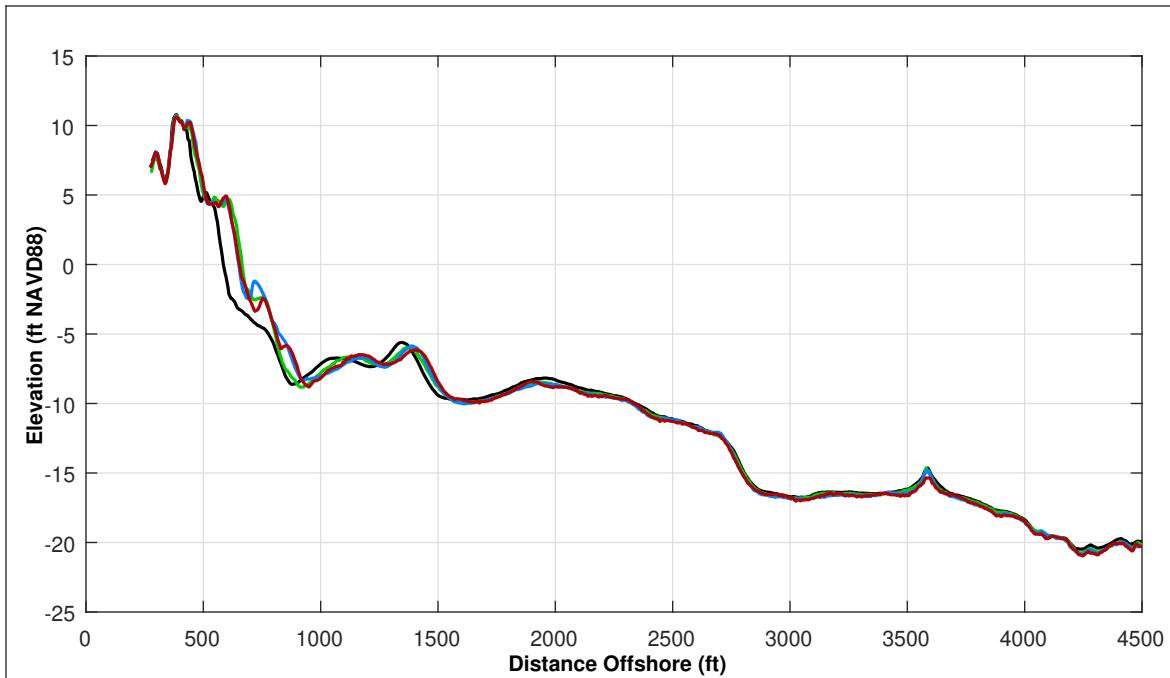
Survey Transect 17+50	OCT 2020 - NOV 2019	OCT 2020 - JUN 2020
Shoreline Change at MHW (0.98 ft NAVD88)	-13.04 ft	2.90 ft
Volume Change Above -15 ft NAVD88	-0.24 cy/ft	-1.52 cy/ft
Volume Change Above 0 ft NAVD88	-0.83 cy/ft	-0.07 cy/ft
Distance from USACE Design Template @ 3.5 feet NAVD88:		+ 12.0 ft

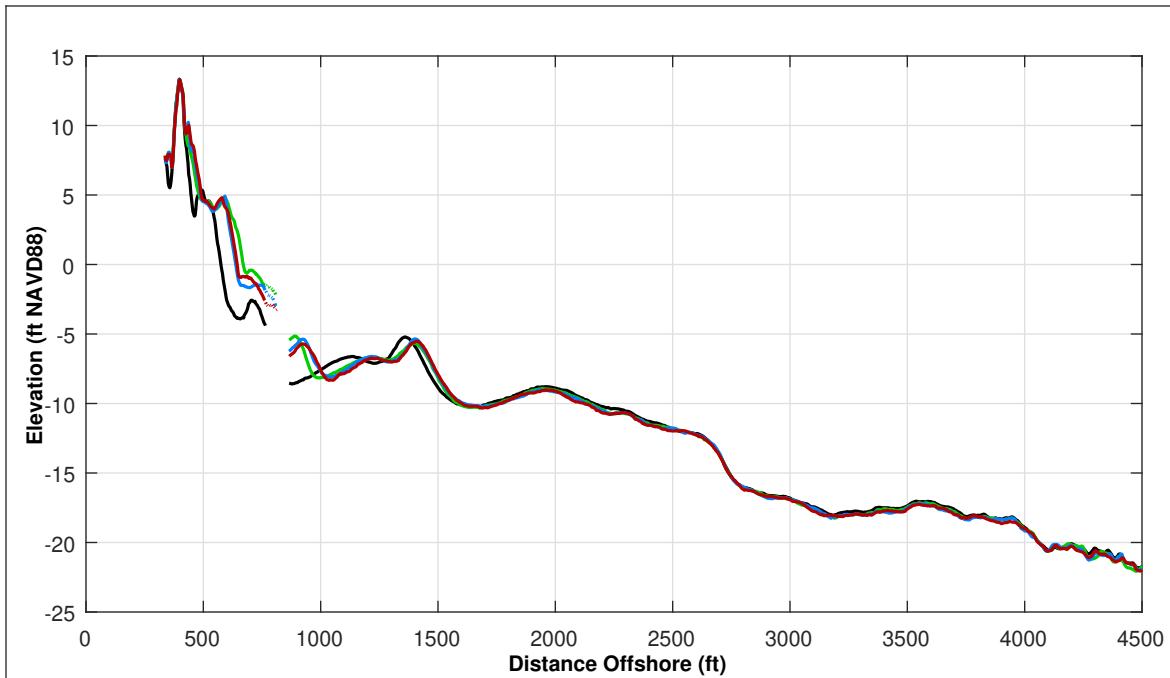
Survey Transect 20+00	OCT 2020 - NOV 2019	OCT 2020 - JUN 2020
Shoreline Change at MHW (0.98 ft NAVD88)	-25.13 ft	6.92 ft
Volume Change Above -15 ft NAVD88	-9.22 cy/ft	-2.45 cy/ft
Volume Change Above 0 ft NAVD88	-0.84 cy/ft	1.83 cy/ft
Distance from USACE Design Template @ 3.5 feet NAVD88:		+ 7.0 ft

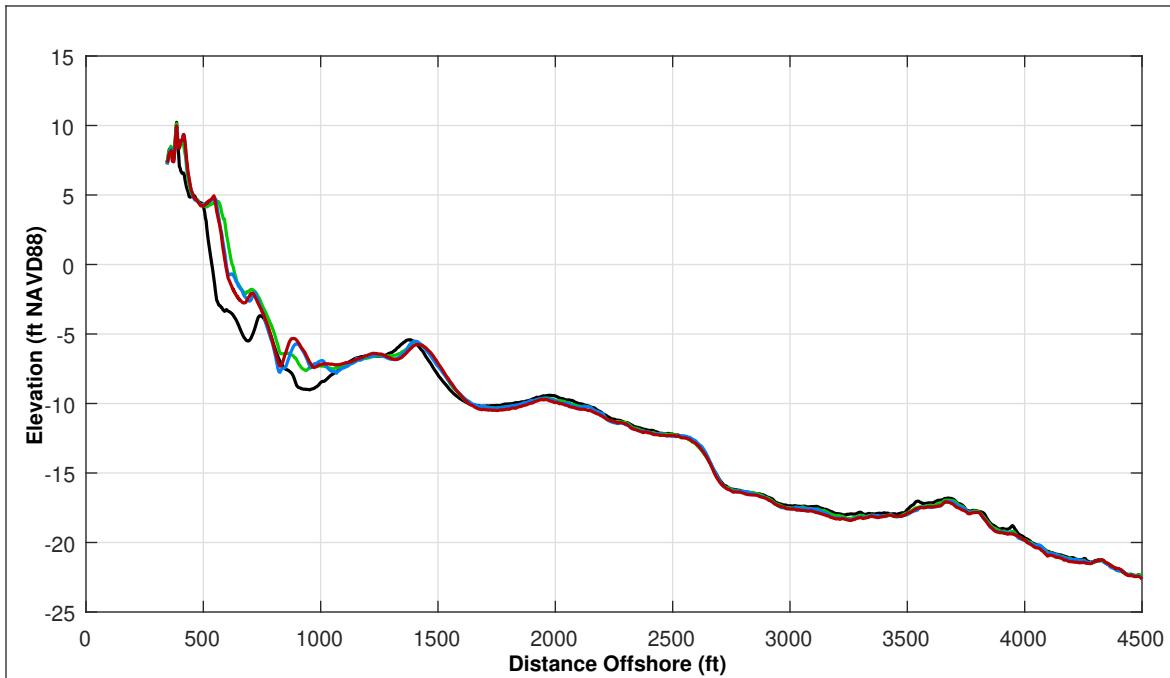
Survey Transect 22+50	OCT 2020 - NOV 2019	OCT 2020 - JUN 2020
Shoreline Change at MHW (0.98 ft NAVD88)	-25.77 ft	-4.65 ft
Volume Change Above -15 ft NAVD88	-9.07 cy/ft	-2.58 cy/ft
Volume Change Above 0 ft NAVD88	-2.95 cy/ft	-0.48 cy/ft
Distance from USACE Design Template @ 3.5 feet NAVD88:	-4.0 ft

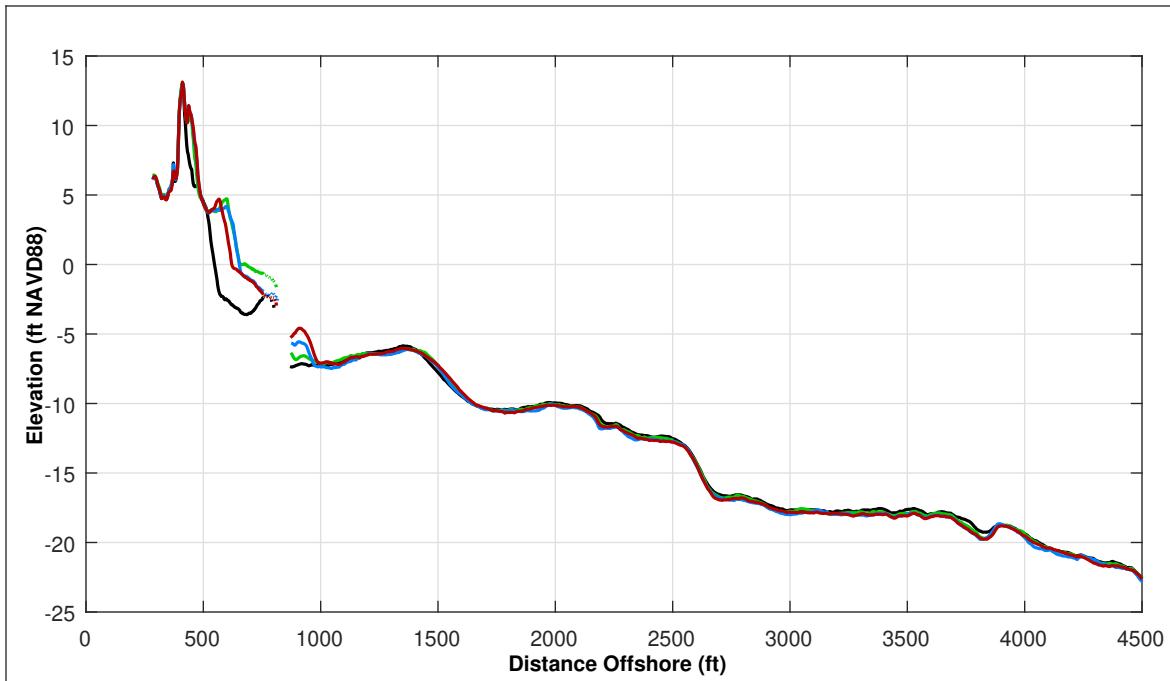
Survey Transect 25+00	OCT 2020 - NOV 2019	OCT 2020 - JUN 2020
Shoreline Change at MHW (0.98 ft NAVD88)	-31.18 ft	-29.56 ft
Volume Change Above -15 ft NAVD88	-7.77 cy/ft	3.88 cy/ft
Volume Change Above 0 ft NAVD88	-3.59 cy/ft	-4.12 cy/ft
Distance from USACE Design Template @ 3.5 feet NAVD88:		+ 10.0 ft

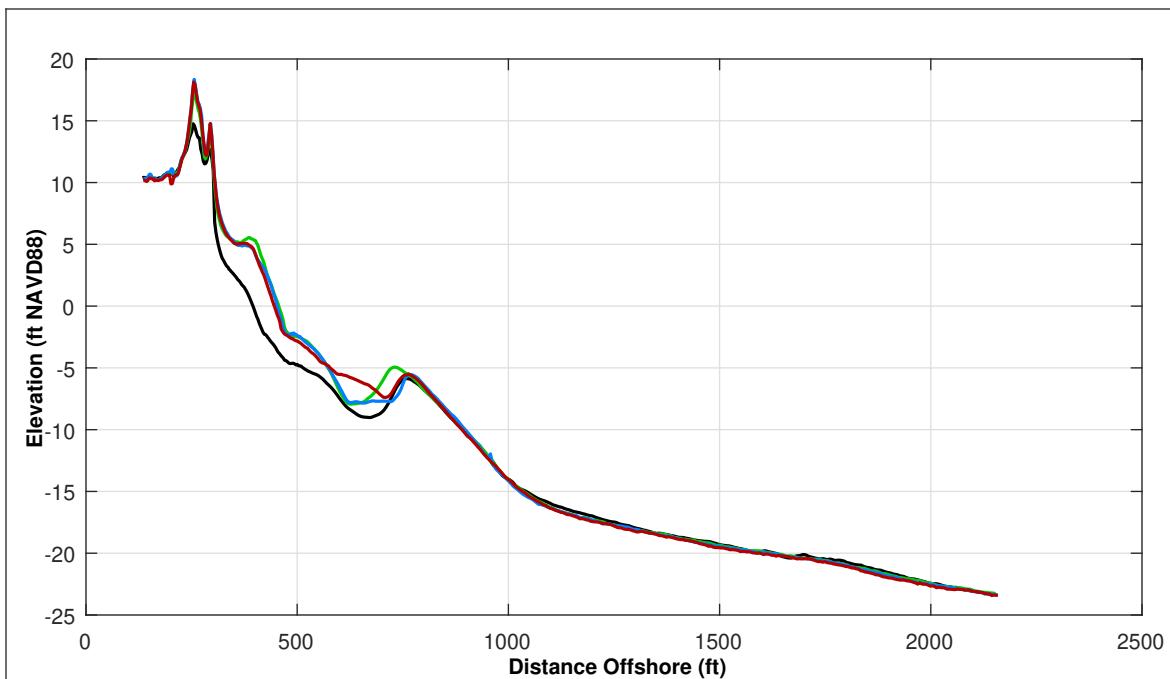
Survey Transect 353+03	OCT 2020 - NOV 2019	OCT 2020 - JUN 2020
Shoreline Change at MHW (0.98 ft NAVD88)	-9.51 ft	-8.02 ft
Volume Change Above -15 ft NAVD88	-1.56 cy/ft	2.24 cy/ft
Volume Change Above 0 ft NAVD88	-1.41 cy/ft	-2.11 cy/ft
Distance from USACE Design Template @ 3.5 feet NAVD88:	+ 23.0 ft

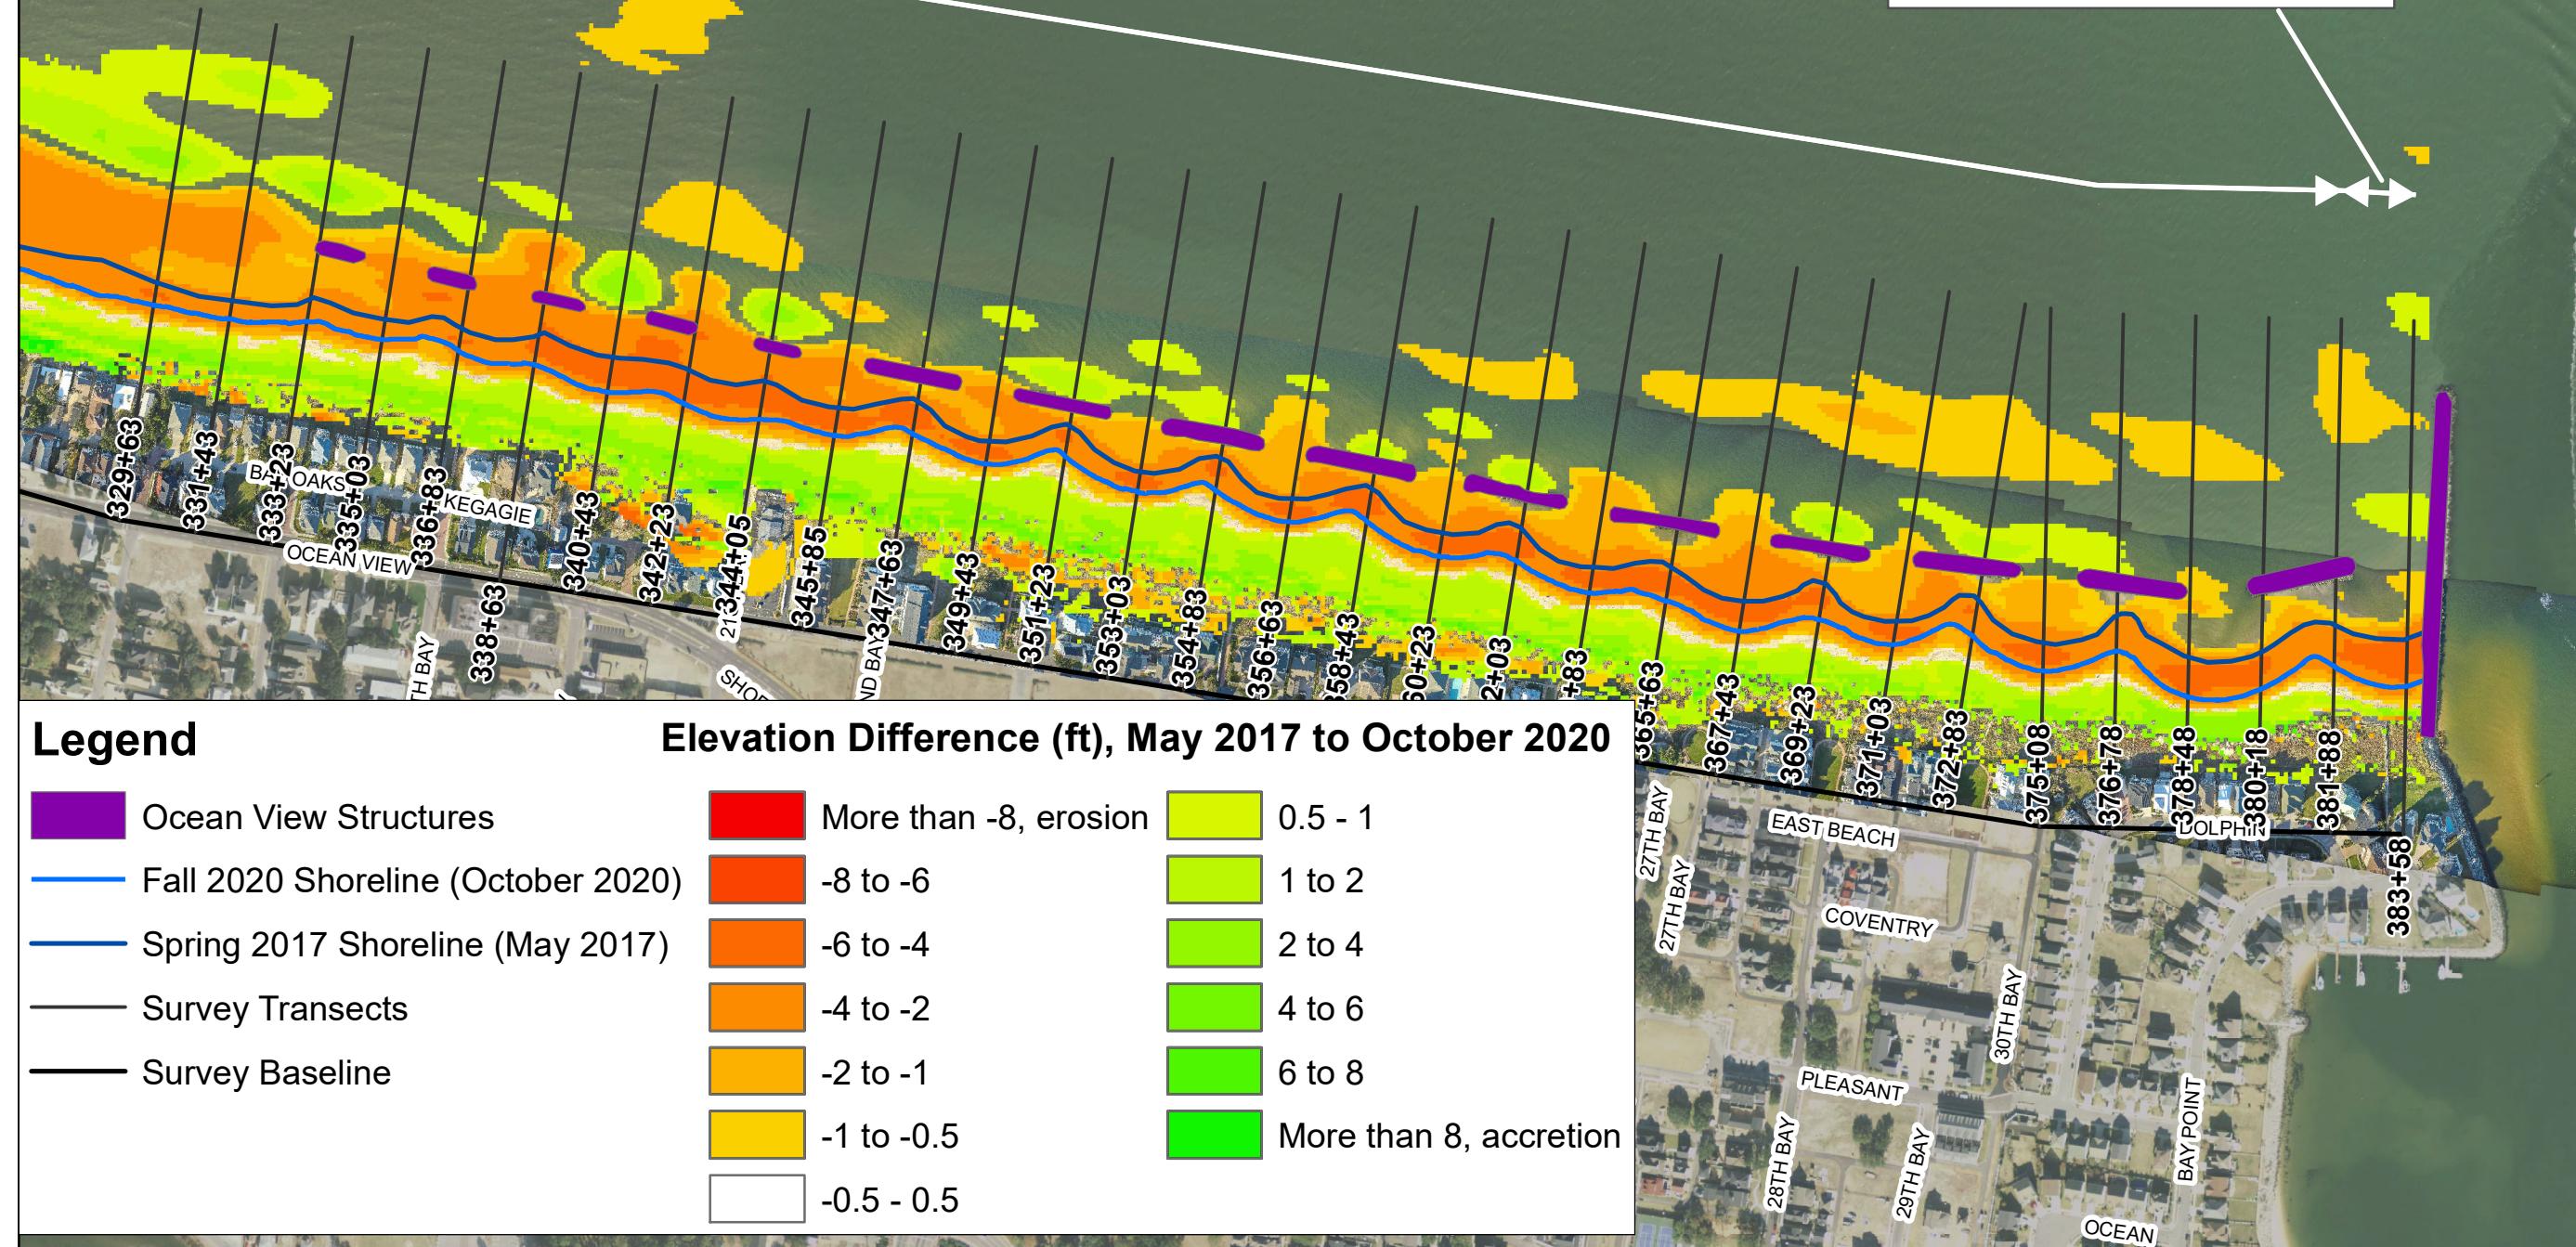
The berm edge is at or slightly bayward of the Design Template. Reasonable variations in profile observed between stations at breakwaters vs. stations in gaps between breakwaters.

In the breakwater gaps, where the lower beach slope either close to or reached the Nourishment Template, indicating that nourishment would be beneficial in this reach

Profile has retreat to or landward of the Nourishment Template, indicating the need for renourishment in this reach.
