PERIODIC SURVEY EVALUATION: OCEAN VIEW BEACH

City of Norfolk, Virginia | Fall 2021 | PN: 10390-32

Periodic Survey Evaluation: Ocean View Beach Fall 2021

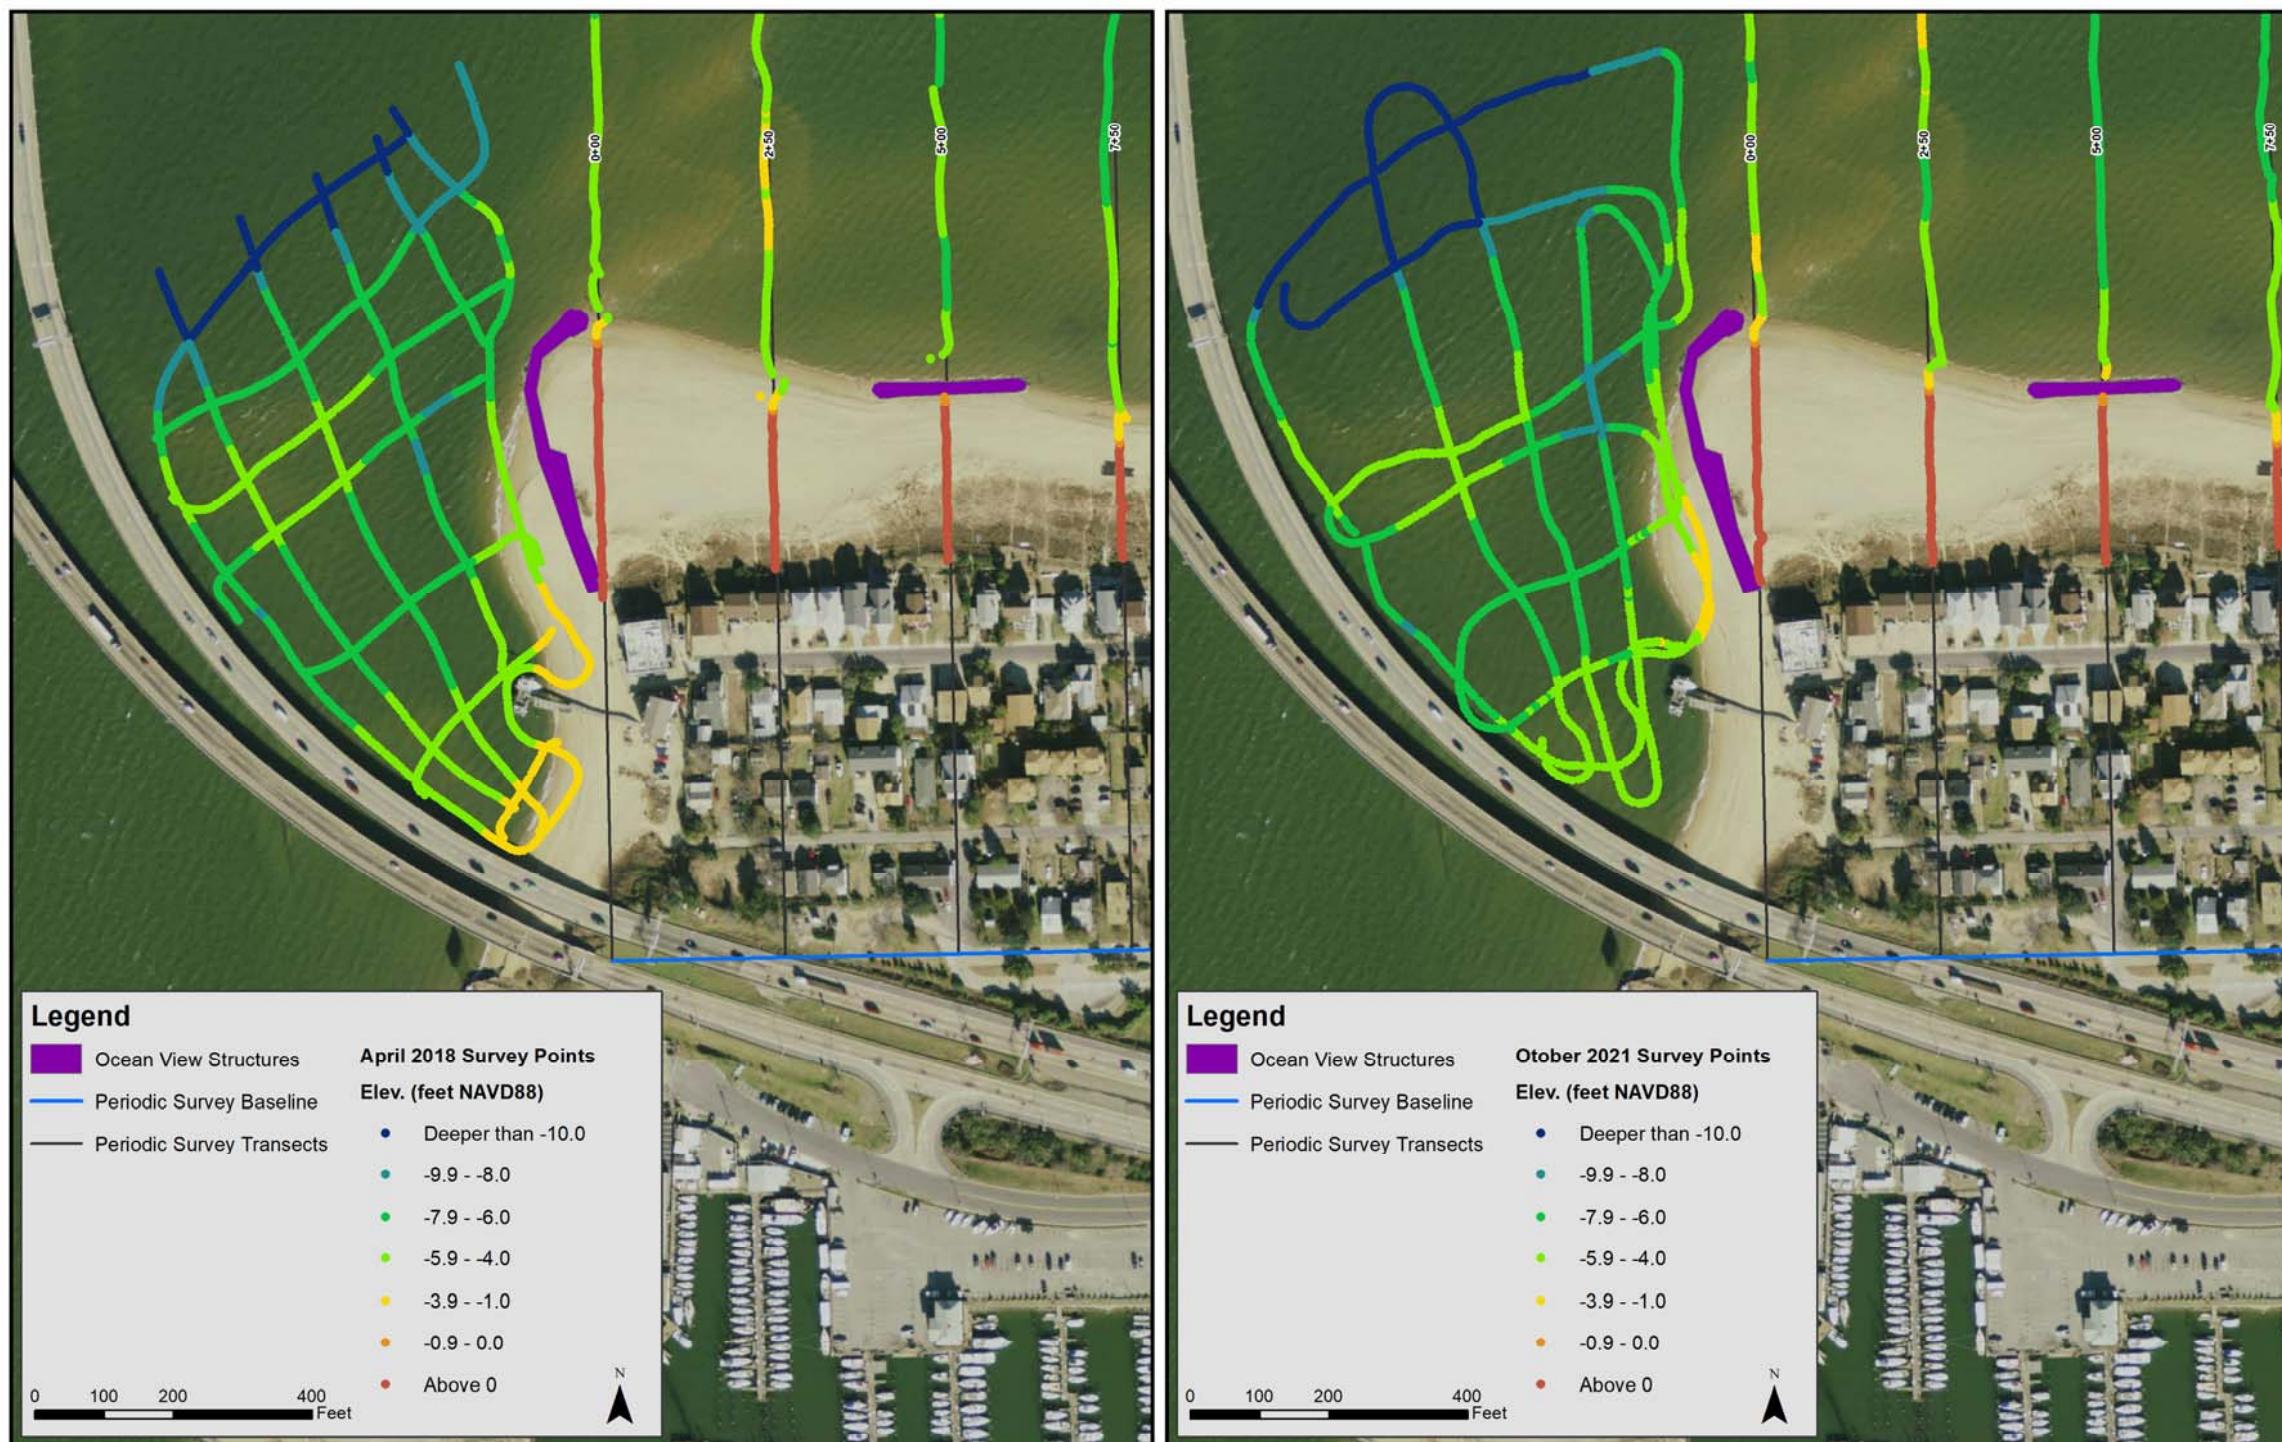
Figure 6-1: Spring 2018 and Fall 2021 Survey Depths West of the Willoughby Spit Terminal Groin

Two surveys in April 2018 and October 2021 as shown in Figure 6-1 were used to evaluate the depths near the pier. The left and right panels of Figure 6-1 show the April 2018 and October 2021 survey point depths, respectively, between the terminal groin and the pier and the relatively deeper waters near the Hampton Roads Bridge Tunnel. In both surveys, depths near the pier were deeper than -4.0 feet NAVD88, which is approximately 2.5 feet deeper than local Mean Low Water (MLW). Bed elevations were consistently at or deeper than this elevation from the pier to the deeper water at the end of the spit.

In addition, no significant change in bed elevation was seen between the April 2018 and October 2021 survey data. Thus, the surveys indicate that the depths between the terminal groin and the pier were relatively stable between April 2018 and October 2021.

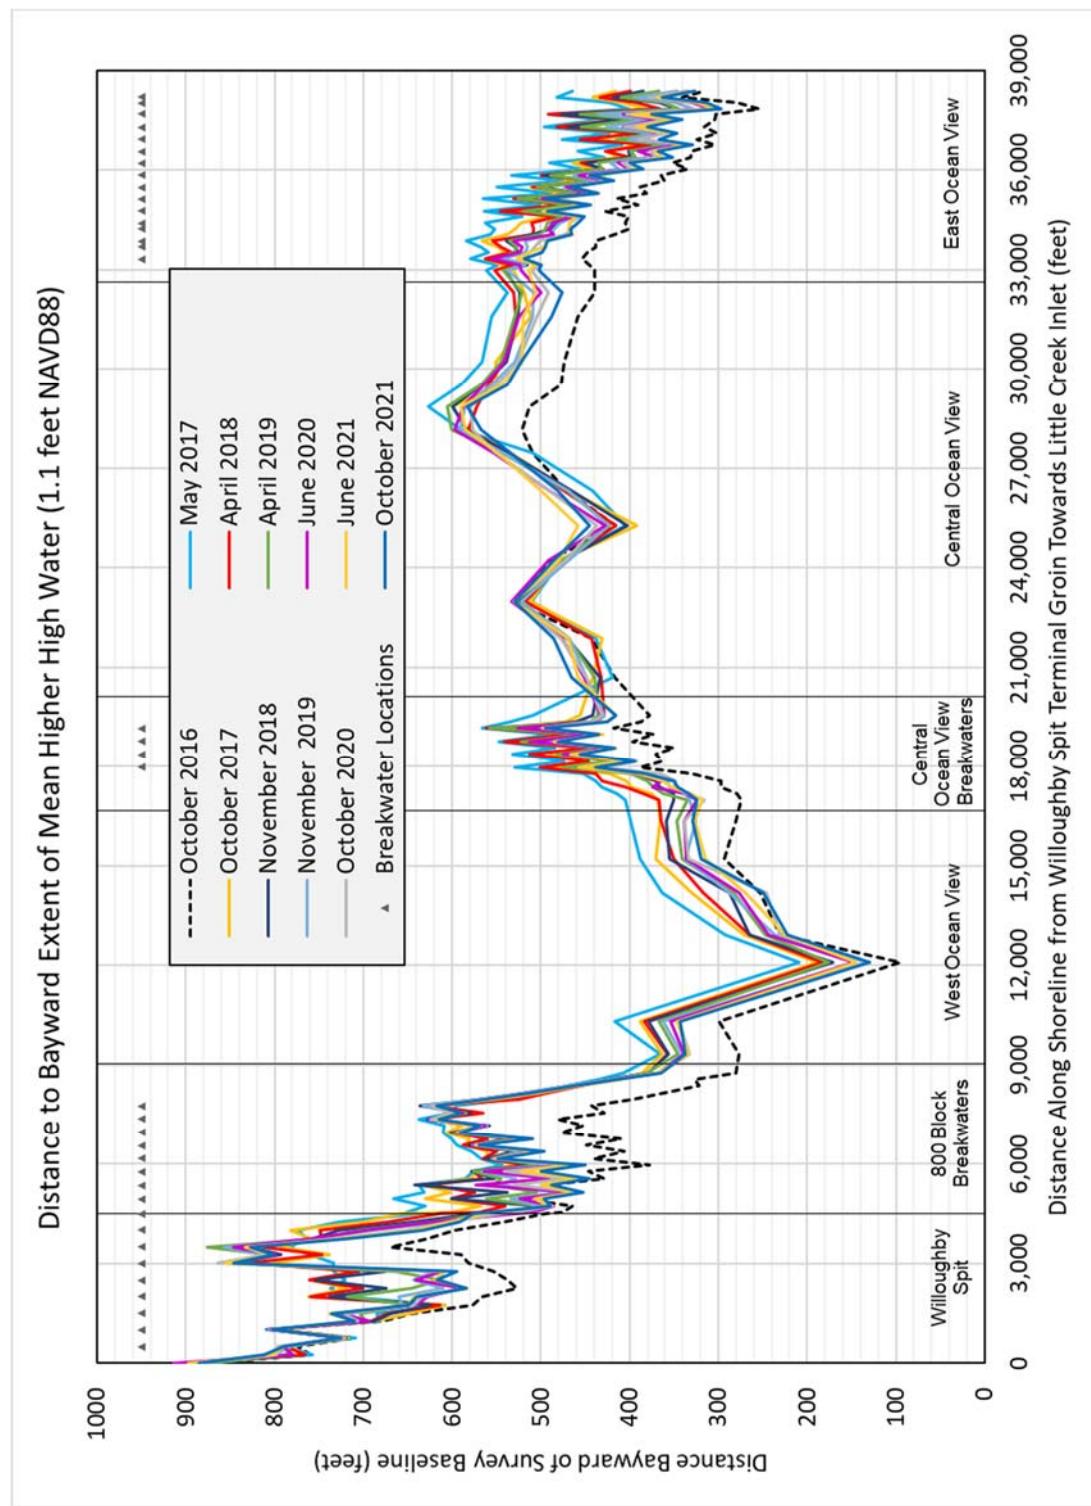
Figure 7-1: Position of the Mean Higher High Water (+1.1 ft NAVD88) Contour Relative to Pre- and Post-Construction of the Federal Project

The movement of the shoreline is consistent with the shoreline changes tabulated by Ocean View region earlier in this report (Table 1-2). The chart in Figure 7-1 shows shoreline position rather than shoreline change rate as a means of illustrating the beach planform remaining in the project relative to its construction design. The chart illustrates that the MHHW contour changed less in both the six months from June 2021 and October 2021 and over the year from October 2020 to October 2021, compared to the changes observed in the first year post-construction (May 2017 to April 2018). This is consistent with typical expectations of a beach nourishment project's evolution.

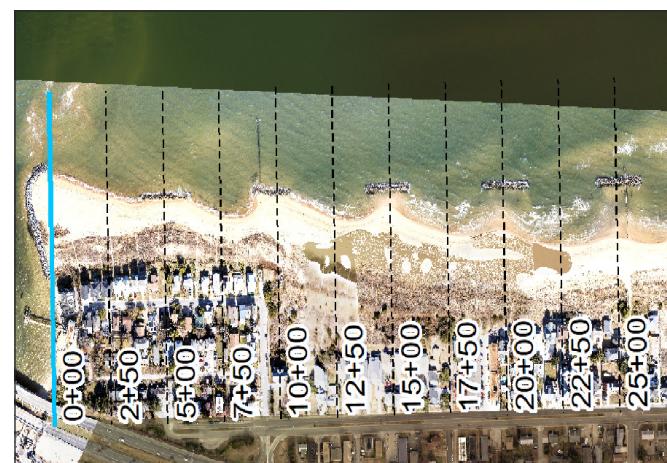
Survey Transect 0+00	OCT 2021 - OCT 2020	OCT 2021 - JUN 2021
Shoreline Change at MHW (0.98 ft NAVD88)	-5.06 ft	-12.62 ft
Volume Change Above -15 ft NAVD88	-30.11 cy/ft	-19.55 cy/ft
Volume Change Above 0 ft NAVD88	-2.16 cy/ft	-4.15 cy/ft
Distance from USACE Design Template @ 3.5 feet NAVD88:		N/A

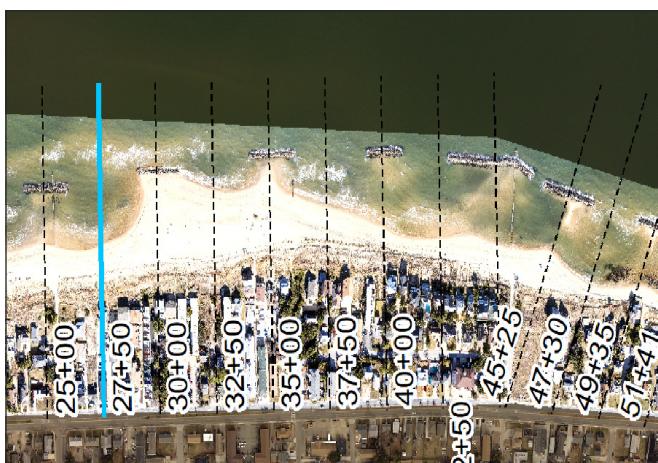
Survey Transect 30+00	OCT 2021 - OCT 2020	OCT 2021 - JUN 2021
Shoreline Change at MHW (0.98 ft NAVD88)	-20.09 ft	-10.58 ft
Volume Change Above -15 ft NAVD88	-2.07 cy/ft	-1.23 cy/ft
Volume Change Above 0 ft NAVD88	-2.22 cy/ft	-3.29 cy/ft
Distance from USACE Design Template @ 3.5 feet NAVD88:	+ 60.0 ft

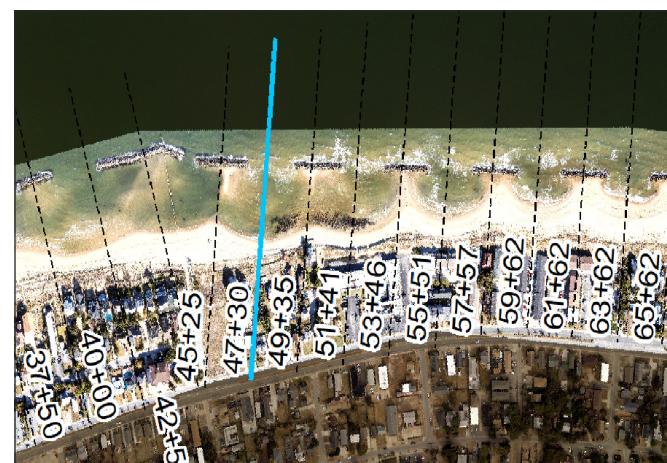
Survey Transect 49+35	OCT 2021 - OCT 2020	OCT 2021 - JUN 2021
Shoreline Change at MHW (0.98 ft NAVD88)	-3.64 ft	-10.50 ft
Volume Change Above -15 ft NAVD88	0.53 cy/ft	-4.50 cy/ft
Volume Change Above 0 ft NAVD88	-0.77 cy/ft	-1.08 cy/ft
Distance from USACE Design Template @ 3.5 feet NAVD88:	-84.0 ft

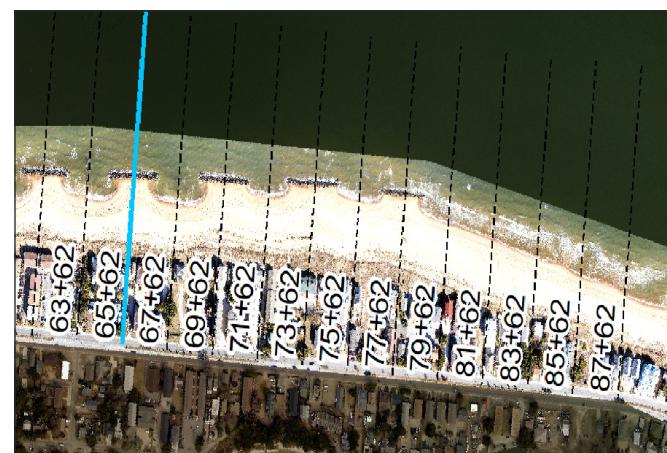
Survey Transect 67+62	OCT 2021 - OCT 2020	OCT 2021 - JUN 2021
Shoreline Change at MHW (0.98 ft NAVD88)	0.26 ft	-5.46 ft
Volume Change Above -15 ft NAVD88	-6.04 cy/ft	-6.82 cy/ft
Volume Change Above 0 ft NAVD88	-0.64 cy/ft	-1.32 cy/ft
Distance from USACE Design Template @ 3.5 feet NAVD88:	+ 46.0 ft

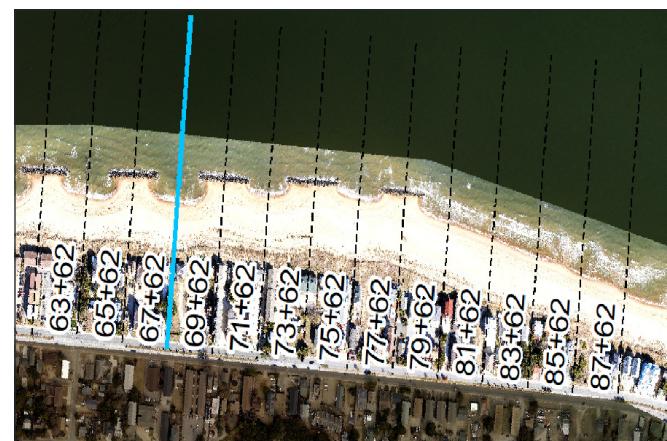
Survey Transect 69+62	OCT 2021 - OCT 2020	OCT 2021 - JUN 2021
Shoreline Change at MHW (0.98 ft NAVD88)	-3.07 ft	-2.42 ft
Volume Change Above -15 ft NAVD88	0.31 cy/ft	-2.61 cy/ft
Volume Change Above 0 ft NAVD88	-0.18 cy/ft	-0.74 cy/ft
Distance from USACE Design Template @ 3.5 feet NAVD88:	+ 31.0 ft

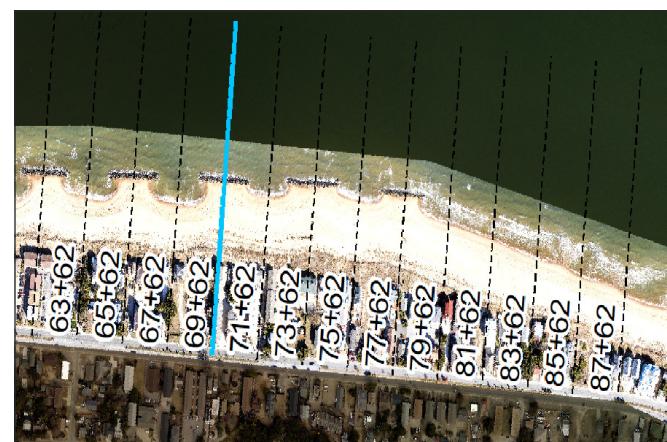
Survey Transect 71+62	OCT 2021 - OCT 2020	OCT 2021 - JUN 2021
Shoreline Change at MHW (0.98 ft NAVD88)	1.57 ft	-5.68 ft
Volume Change Above -15 ft NAVD88	-0.81 cy/ft	-0.69 cy/ft
Volume Change Above 0 ft NAVD88	0.06 cy/ft	-0.88 cy/ft
Distance from USACE Design Template @ 3.5 feet NAVD88:	+ 59.0 ft

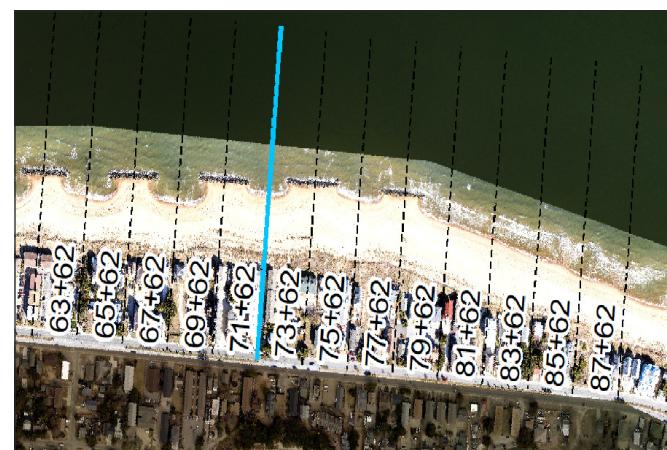
Survey Transect 73+62	OCT 2021 - OCT 2020	OCT 2021 - JUN 2021
Shoreline Change at MHW (0.98 ft NAVD88)	-10.57 ft	-2.80 ft
Volume Change Above -15 ft NAVD88	-0.52 cy/ft	-0.86 cy/ft
Volume Change Above 0 ft NAVD88	-0.76 cy/ft	-1.22 cy/ft
Distance from USACE Design Template @ 3.5 feet NAVD88:	+ 63.0 ft

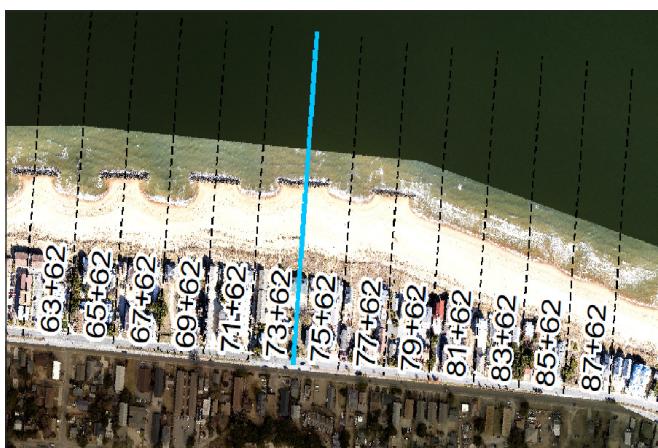
Survey Transect 75+62	OCT 2021 - OCT 2020	OCT 2021 - JUN 2021
Shoreline Change at MHW (0.98 ft NAVD88)	-13.44 ft	-3.58 ft
Volume Change Above -15 ft NAVD88	-1.90 cy/ft	4.14 cy/ft
Volume Change Above 0 ft NAVD88	-2.16 cy/ft	-1.54 cy/ft
Distance from USACE Design Template @ 3.5 feet NAVD88:	+ 97.0 ft

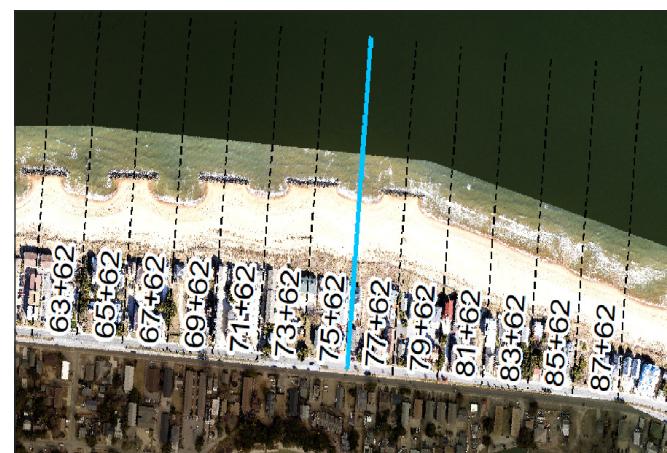
Survey Transect 77+62	OCT 2021 - OCT 2020	OCT 2021 - JUN 2021
Shoreline Change at MHW (0.98 ft NAVD88)	-6.25 ft	1.24 ft
Volume Change Above -15 ft NAVD88	-2.16 cy/ft	0.29 cy/ft
Volume Change Above 0 ft NAVD88	-0.49 cy/ft	-0.01 cy/ft
Distance from USACE Design Template @ 3.5 feet NAVD88:	+ 91.0 ft

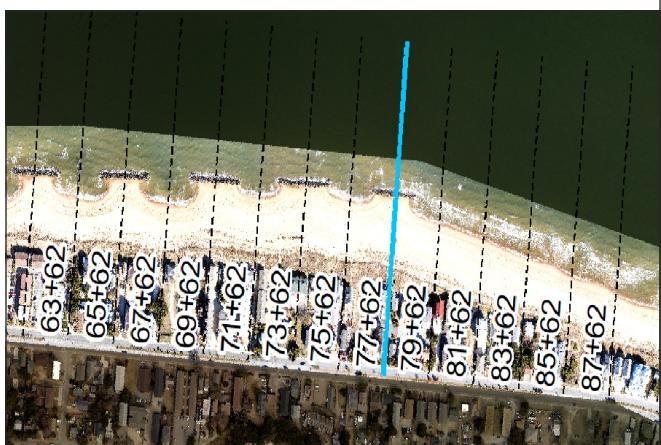
Survey Transect 79+62	OCT 2021 - OCT 2020	OCT 2021 - JUN 2021
Shoreline Change at MHW (0.98 ft NAVD88)	-9.11 ft	9.69 ft
Volume Change Above -15 ft NAVD88	-1.27 cy/ft	3.83 cy/ft
Volume Change Above 0 ft NAVD88	-1.62 cy/ft	2.01 cy/ft
Distance from USACE Design Template @ 3.5 feet NAVD88:	+ 112.0 ft

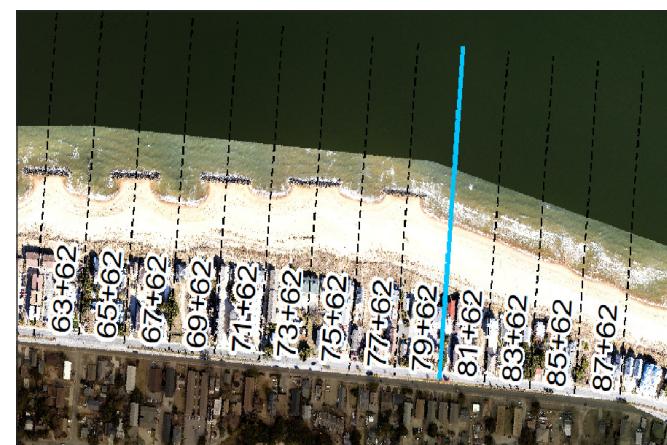
Survey Transect 81+62	OCT 2021 - OCT 2020	OCT 2021 - JUN 2021
Shoreline Change at MHW (0.98 ft NAVD88)	-4.73 ft	10.08 ft
Volume Change Above -15 ft NAVD88	-3.01 cy/ft	2.64 cy/ft
Volume Change Above 0 ft NAVD88	-0.42 cy/ft	1.18 cy/ft
Distance from USACE Design Template @ 3.5 feet NAVD88:	+ 95.0 ft

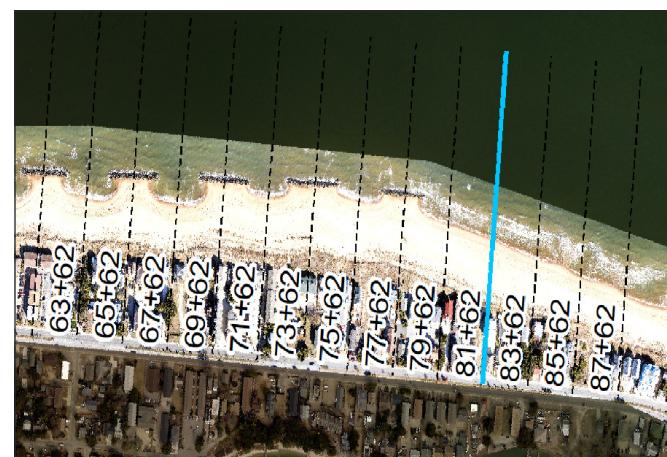
Survey Transect 83+62	OCT 2021 - OCT 2020	OCT 2021 - JUN 2021
Shoreline Change at MHW (0.98 ft NAVD88)	-4.50 ft	4.74 ft
Volume Change Above -15 ft NAVD88	-3.49 cy/ft	-0.24 cy/ft
Volume Change Above 0 ft NAVD88	-0.46 cy/ft	-0.33 cy/ft
Distance from USACE Design Template @ 3.5 feet NAVD88:	+ 72.0 ft

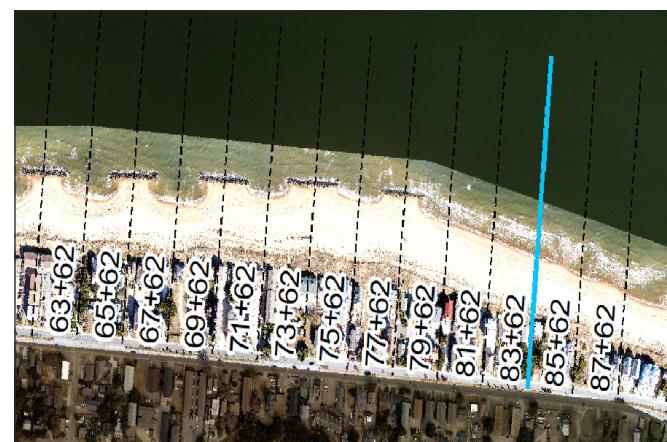
Survey Transect 85+62	OCT 2021 - OCT 2020	OCT 2021 - JUN 2021
Shoreline Change at MHW (0.98 ft NAVD88)	-3.08 ft	0.79 ft
Volume Change Above -15 ft NAVD88	-5.31 cy/ft	1.97 cy/ft
Volume Change Above 0 ft NAVD88	-0.82 cy/ft	2.19 cy/ft
Distance from USACE Design Template @ 3.5 feet NAVD88:		+ 29.0 ft

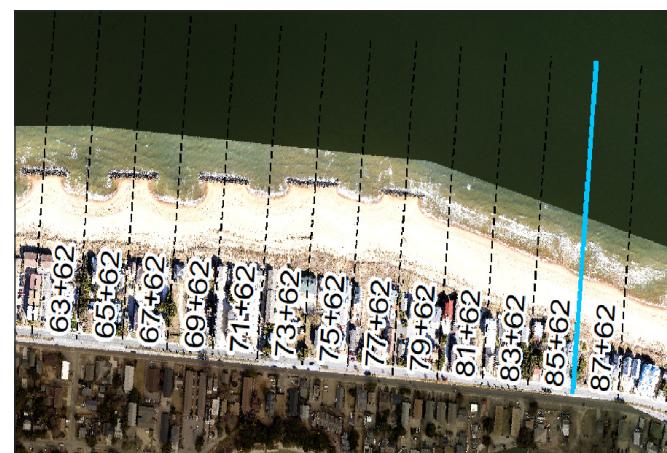
Survey Transect 87+62	OCT 2021 - OCT 2020	OCT 2021 - JUN 2021
Shoreline Change at MHW (0.98 ft NAVD88)	-0.55 ft	-5.23 ft
Volume Change Above -15 ft NAVD88	-1.04 cy/ft	-2.28 cy/ft
Volume Change Above 0 ft NAVD88	-0.64 cy/ft	-0.73 cy/ft
Distance from USACE Design Template @ 3.5 feet NAVD88:	+ 30.0 ft

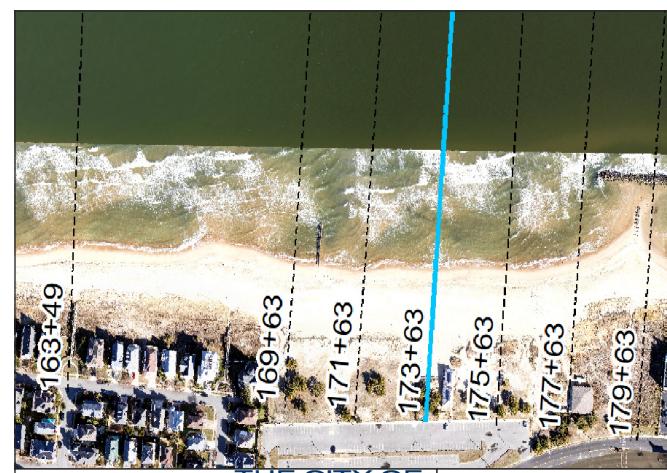
Survey Transect	OCT 2021 - OCT 2020	OCT 2021 - JUN 2021
175+63		
Shoreline Change at MHW (0.98 ft NAVD88)	1.35 ft	-12.32 ft
Volume Change Above -15 ft NAVD88	2.19 cy/ft	-3.56 cy/ft
Volume Change Above 0 ft NAVD88	2.29 cy/ft	-2.07 cy/ft
Distance from USACE Design Template @ 3.5 feet NAVD88:		-11.0 ft

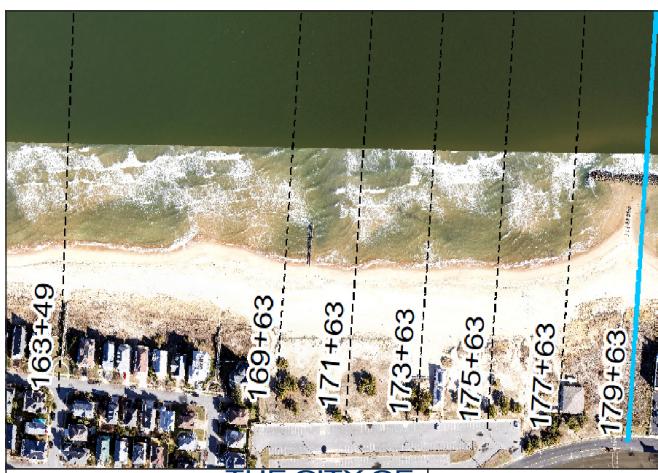
Survey Transect 179+63	OCT 2021 - OCT 2020	OCT 2021 - JUN 2021
Shoreline Change at MHW (0.98 ft NAVD88)	6.41 ft	-19.14 ft
Volume Change Above -15 ft NAVD88	1.96 cy/ft	-3.87 cy/ft
Volume Change Above 0 ft NAVD88	2.60 cy/ft	-1.41 cy/ft
Distance from USACE Design Template @ 3.5 feet NAVD88:		-16.0 ft

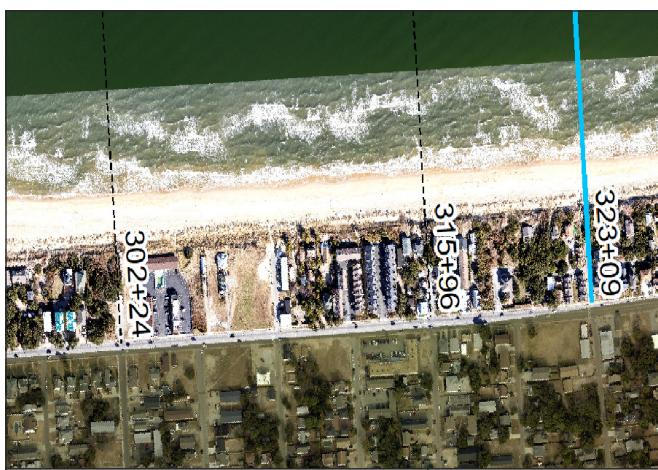
Survey Transect 329+63	OCT 2021 - OCT 2020	OCT 2021 - JUN 2021
Shoreline Change at MHW (0.98 ft NAVD88)	-7.07 ft	-11.55 ft
Volume Change Above -15 ft NAVD88	0.62 cy/ft	-3.91 cy/ft
Volume Change Above 0 ft NAVD88	-1.16 cy/ft	-2.57 cy/ft
Distance from USACE Design Template @ 3.5 feet NAVD88:	-12.0 ft

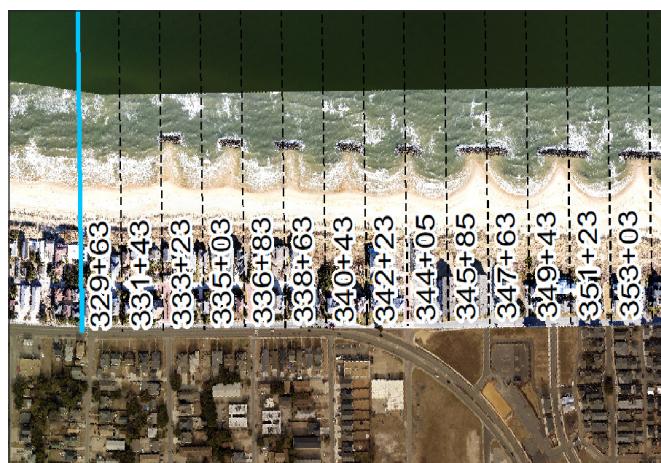
Survey Transect 331+43	OCT 2021 - OCT 2020	OCT 2021 - JUN 2021
Shoreline Change at MHW (0.98 ft NAVD88)	1.05 ft	-5.72 ft
Volume Change Above -15 ft NAVD88	0.68 cy/ft	-6.45 cy/ft
Volume Change Above 0 ft NAVD88	-0.28 cy/ft	-2.93 cy/ft
Distance from USACE Design Template @ 3.5 feet NAVD88:	-16.0 ft

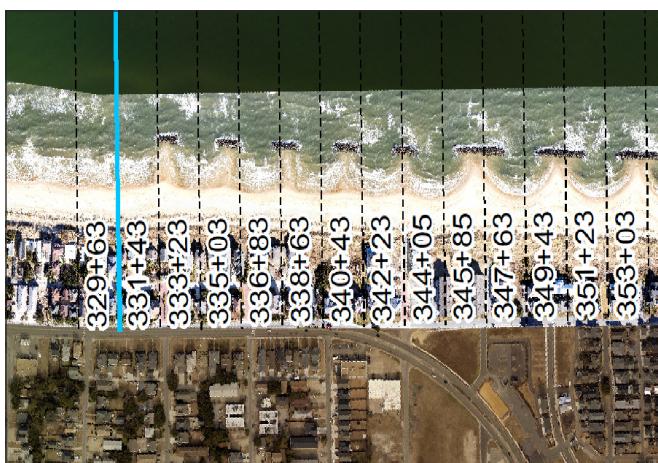
Survey Transect 333+23	OCT 2021 - OCT 2020	OCT 2021 - JUN 2021
Shoreline Change at MHW (0.98 ft NAVD88)	1.24 ft	-8.39 ft
Volume Change Above -15 ft NAVD88	-3.30 cy/ft	-2.10 cy/ft
Volume Change Above 0 ft NAVD88	0.04 cy/ft	-2.97 cy/ft
Distance from USACE Design Template @ 3.5 feet NAVD88:	-7.0 ft

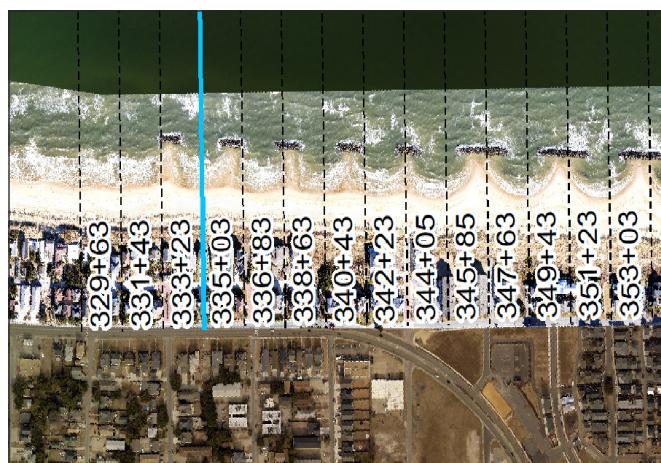
Survey Transect 336+83	OCT 2021 - OCT 2020	OCT 2021 - JUN 2021
Shoreline Change at MHW (0.98 ft NAVD88)	-12.95 ft	-1.64 ft
Volume Change Above -15 ft NAVD88	-7.64 cy/ft	-6.79 cy/ft
Volume Change Above 0 ft NAVD88	-2.33 cy/ft	-2.05 cy/ft
Distance from USACE Design Template @ 3.5 feet NAVD88:	-19.0 ft

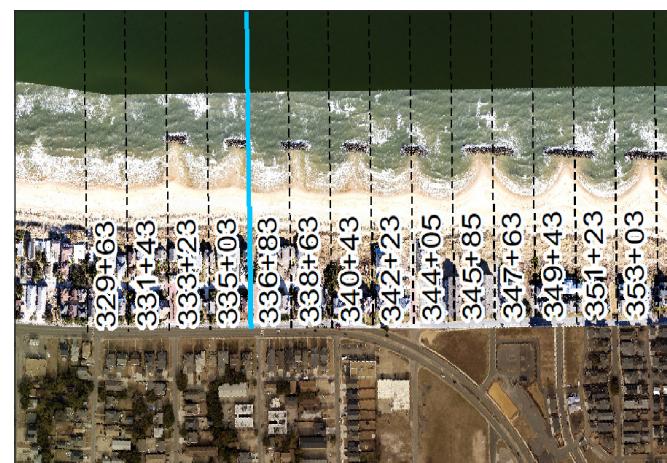
Survey Transect 338+63	OCT 2021 - OCT 2020	OCT 2021 - JUN 2021
Shoreline Change at MHW (0.98 ft NAVD88)	-9.49 ft	-1.65 ft
Volume Change Above -15 ft NAVD88	5.50 cy/ft	-3.65 cy/ft
Volume Change Above 0 ft NAVD88	-3.48 cy/ft	-2.31 cy/ft
Distance from USACE Design Template @ 3.5 feet NAVD88:	-18.0 ft

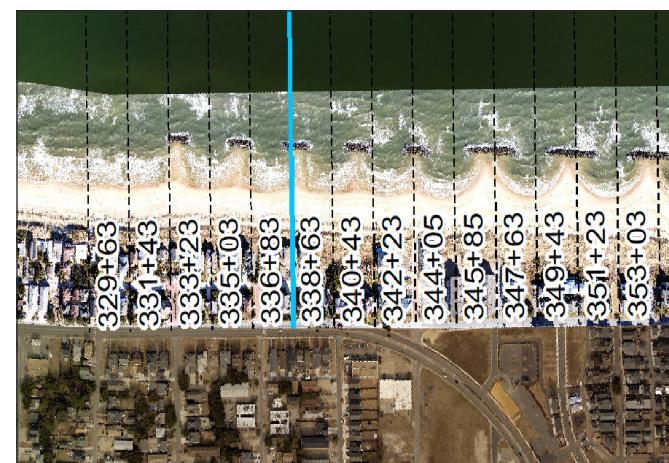
Survey Transect 340+43	OCT 2021 - OCT 2020	OCT 2021 - JUN 2021
Shoreline Change at MHW (0.98 ft NAVD88)	-7.83 ft	1.41 ft
Volume Change Above -15 ft NAVD88	-10.26 cy/ft	-5.33 cy/ft
Volume Change Above 0 ft NAVD88	-1.52 cy/ft	-2.10 cy/ft
Distance from USACE Design Template @ 3.5 feet NAVD88:	-21.0 ft

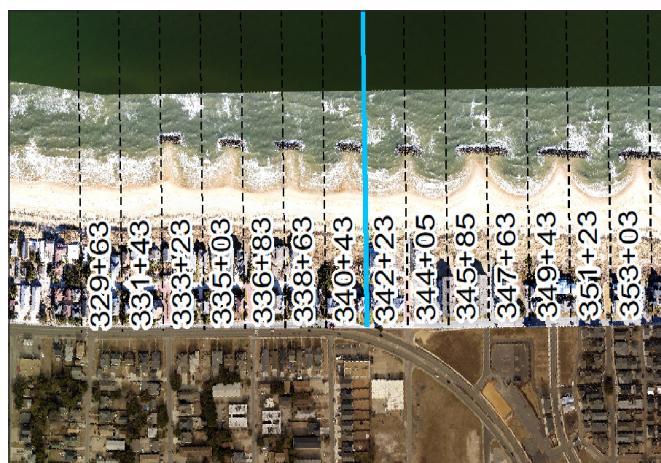
Survey Transect 344+05	OCT 2021 - OCT 2020	OCT 2021 - JUN 2021
Shoreline Change at MHW (0.98 ft NAVD88)	-9.79 ft	-9.37 ft
Volume Change Above -15 ft NAVD88	-8.02 cy/ft	-6.69 cy/ft
Volume Change Above 0 ft NAVD88	-4.15 cy/ft	-4.06 cy/ft
Distance from USACE Design Template @ 3.5 feet NAVD88:	-7.0 ft

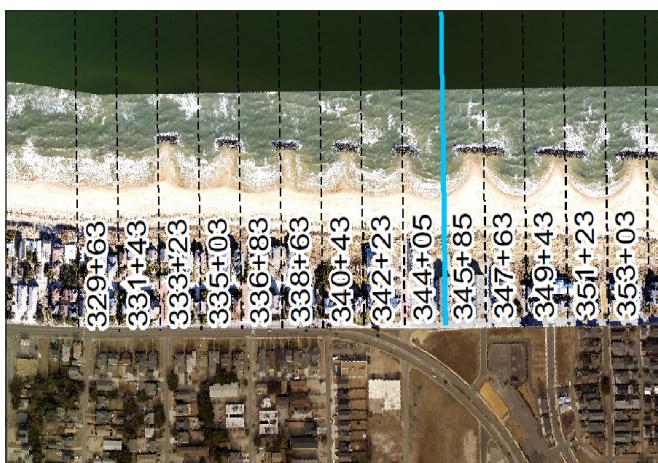
Survey Transect 347+63	OCT 2021 - OCT 2020	OCT 2021 - JUN 2021
Shoreline Change at MHW (0.98 ft NAVD88)	9.19 ft	-4.04 ft
Volume Change Above -15 ft NAVD88	0.42 cy/ft	-5.68 cy/ft
Volume Change Above 0 ft NAVD88	0.69 cy/ft	-1.83 cy/ft
Distance from USACE Design Template @ 3.5 feet NAVD88:	+ 8.0 ft

The berm edge is at or slightly landward of the Design Template. Exception are 347+63, 351+23, 354+83 and 358+43, where the berm edge is bayward of Design Template. Reasonable variations in profile observed between stations at breakwaters vs. stations in gaps between breakwaters. In the breakwater gaps, the lower beach slope either close to or reached the Nourishment Template, indicating that nourishment would be beneficial in this reach.

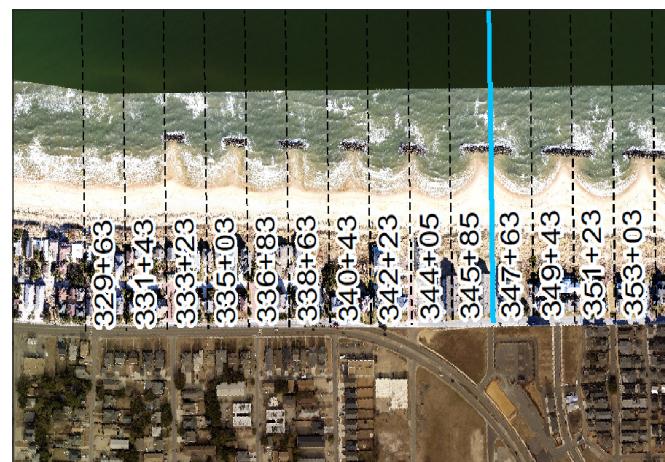
Survey Transect 349+43	OCT 2021 - OCT 2020	OCT 2021 - JUN 2021
Shoreline Change at MHW (0.98 ft NAVD88)	-0.70 ft	-10.50 ft
Volume Change Above -15 ft NAVD88	-2.78 cy/ft	-7.72 cy/ft
Volume Change Above 0 ft NAVD88	1.41 cy/ft	-2.02 cy/ft
Distance from USACE Design Template @ 3.5 feet NAVD88:	-3.0 ft

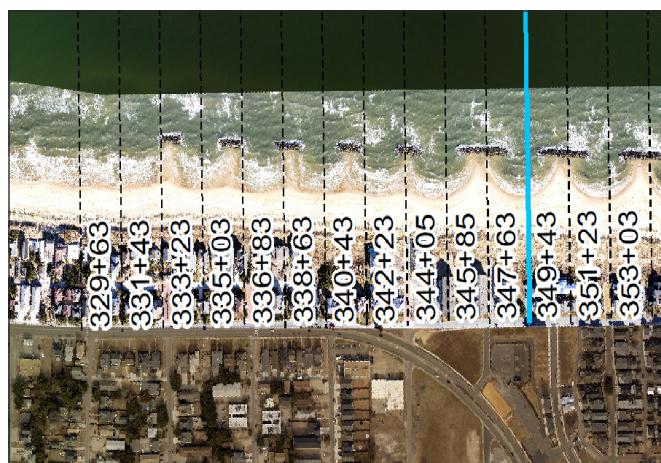
Survey Transect 351+23	OCT 2021 - OCT 2020	OCT 2021 - JUN 2021
Shoreline Change at MHW (0.98 ft NAVD88)	9.21 ft	12.30 ft
Volume Change Above -15 ft NAVD88	2.07 cy/ft	-0.68 cy/ft
Volume Change Above 0 ft NAVD88	3.62 cy/ft	-0.72 cy/ft
Distance from USACE Design Template @ 3.5 feet NAVD88:	+ 11.0 ft

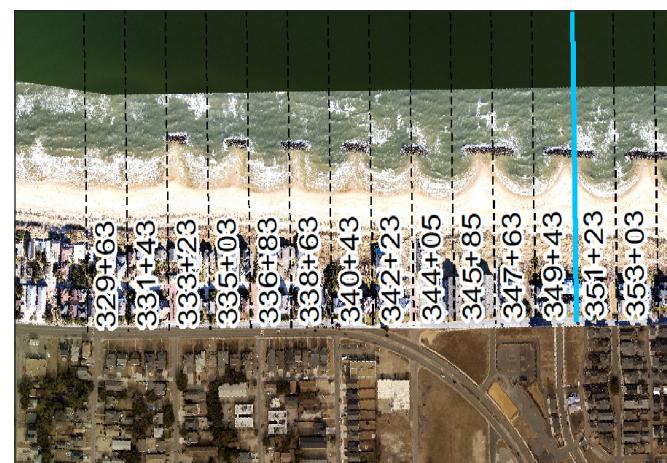
Survey Transect 353+03	OCT 2021 - OCT 2020	OCT 2021 - JUN 2021
Shoreline Change at MHW (0.98 ft NAVD88)	1.08 ft	-2.38 ft
Volume Change Above -15 ft NAVD88	-2.75 cy/ft	-4.63 cy/ft
Volume Change Above 0 ft NAVD88	1.61 cy/ft	-0.57 cy/ft
Distance from USACE Design Template @ 3.5 feet NAVD88:	+ 7.0 ft

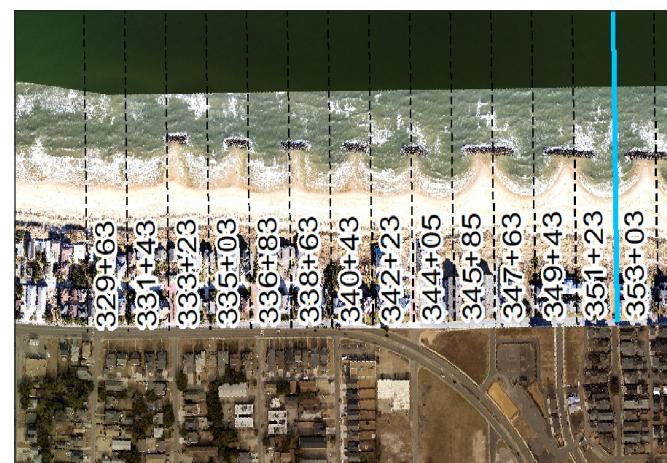
Survey Transect 354+83	OCT 2021 - OCT 2020	OCT 2021 - JUN 2021
Shoreline Change at MHW (0.98 ft NAVD88)	0.49 ft	2.82 ft
Volume Change Above -15 ft NAVD88	-0.68 cy/ft	-1.68 cy/ft
Volume Change Above 0 ft NAVD88	-0.16 cy/ft	-0.50 cy/ft
Distance from USACE Design Template @ 3.5 feet NAVD88:	+ 15.0 ft

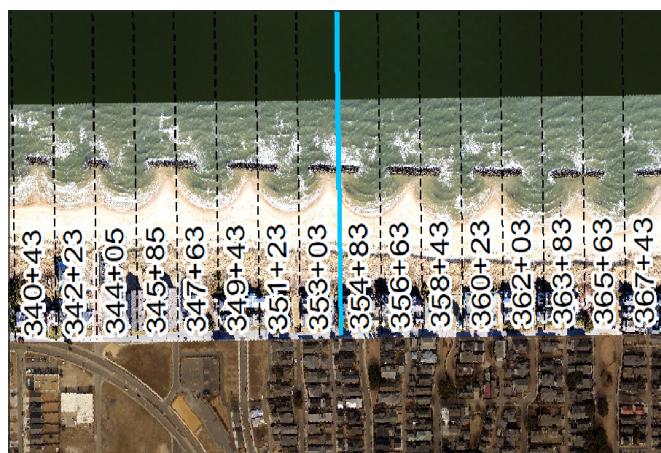
Survey Transect 356+63	OCT 2021 - OCT 2020	OCT 2021 - JUN 2021
Shoreline Change at MHW (0.98 ft NAVD88)	-4.63 ft	-6.27 ft
Volume Change Above -15 ft NAVD88	-1.28 cy/ft	-1.99 cy/ft
Volume Change Above 0 ft NAVD88	0.27 cy/ft	-1.87 cy/ft
Distance from USACE Design Template @ 3.5 feet NAVD88:	+ 10.0 ft

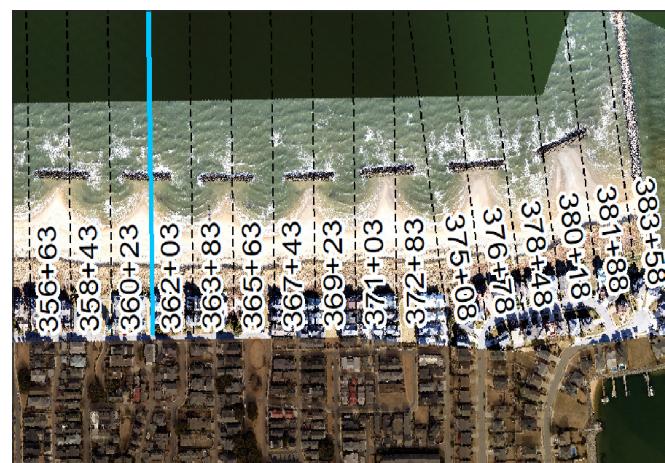
Survey Transect 363+83	OCT 2021 - OCT 2020	OCT 2021 - JUN 2021
Shoreline Change at MHW (0.98 ft NAVD88)	-20.13 ft	-12.62 ft
Volume Change Above -15 ft NAVD88	-2.48 cy/ft	-7.07 cy/ft
Volume Change Above 0 ft NAVD88	-3.18 cy/ft	-4.22 cy/ft
Distance from USACE Design Template @ 3.5 feet NAVD88:	-19.0 ft

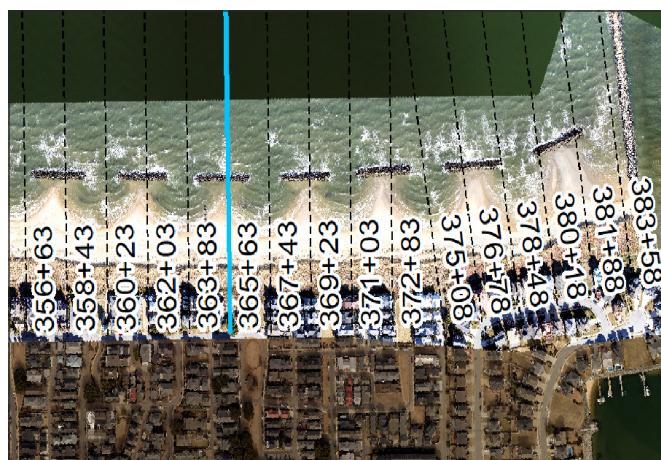
Survey Transect 367+43	OCT 2021 - OCT 2020	OCT 2021 - JUN 2021
Shoreline Change at MHW (0.98 ft NAVD88)	-8.54 ft	-8.19 ft
Volume Change Above -15 ft NAVD88	4.76 cy/ft	-2.12 cy/ft
Volume Change Above 0 ft NAVD88	0.47 cy/ft	-2.40 cy/ft
Distance from USACE Design Template @ 3.5 feet NAVD88:	-24.0 ft

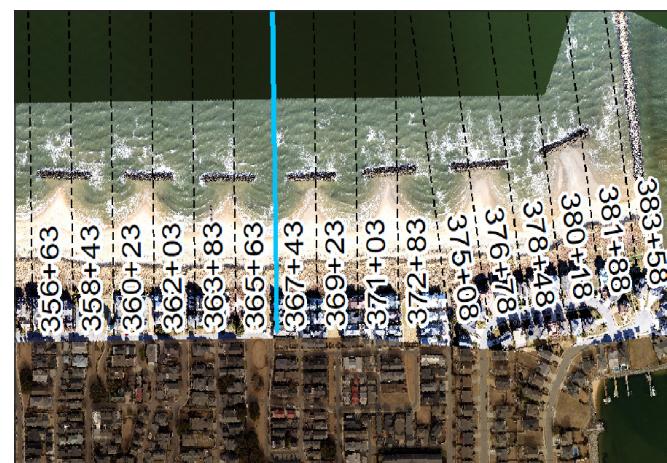
Survey Transect 369+23	OCT 2021 - OCT 2020	OCT 2021 - JUN 2021
Shoreline Change at MHW (0.98 ft NAVD88)	-25.31 ft	2.13 ft
Volume Change Above -15 ft NAVD88	-5.76 cy/ft	-6.56 cy/ft
Volume Change Above 0 ft NAVD88	-1.70 cy/ft	-1.79 cy/ft
Distance from USACE Design Template @ 3.5 feet NAVD88:	-16.0 ft

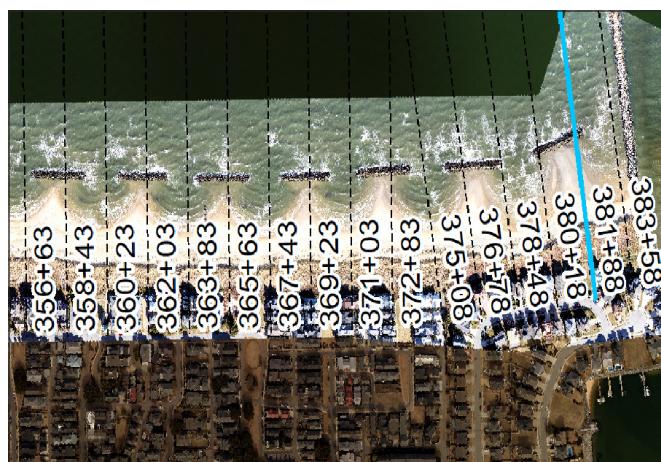
Survey Transect 383+58	OCT 2021 - OCT 2020	OCT 2021 - JUN 2021
Shoreline Change at MHW (0.98 ft NAVD88)	-10.77 ft	0.10 ft
Volume Change Above -15 ft NAVD88	1.54 cy/ft	-1.35 cy/ft
Volume Change Above 0 ft NAVD88	-0.41 cy/ft	-0.24 cy/ft
Distance from USACE Design Template @ 3.5 feet NAVD88:	-60.0 ft

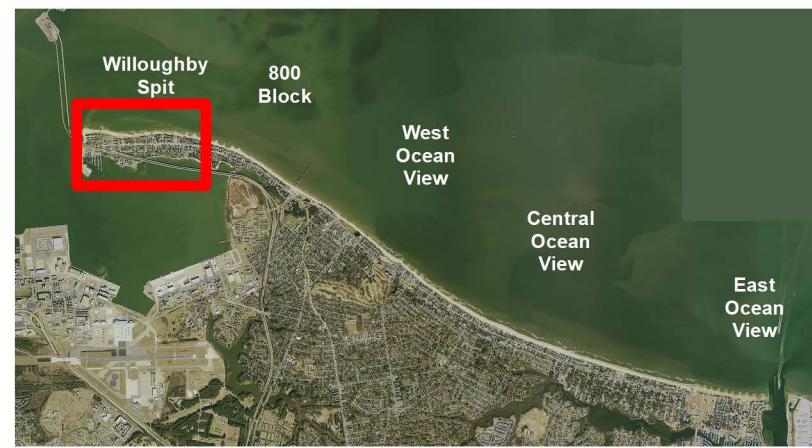
Appendix E: Maps of Elevation Change, October 2020 to October 2021

Shoreline Aerial Photo Date: Dec. 2021
Background Aerial Photo Date: 2018

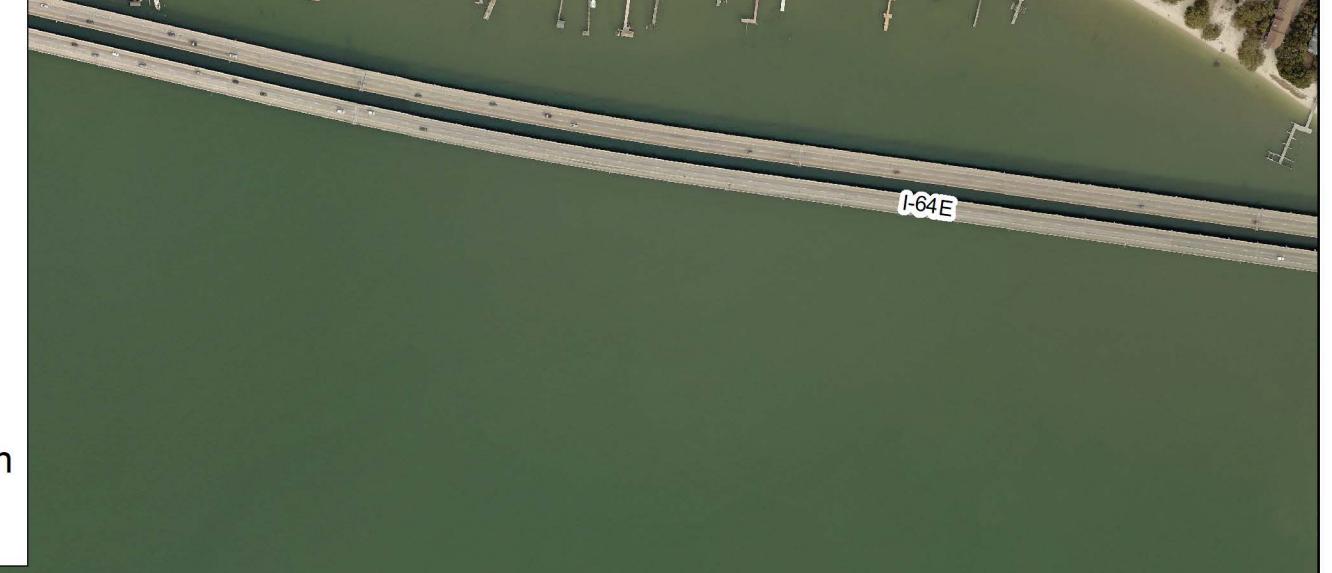
Elevation Difference (ft), Jun. 2021 to Oct. 2021

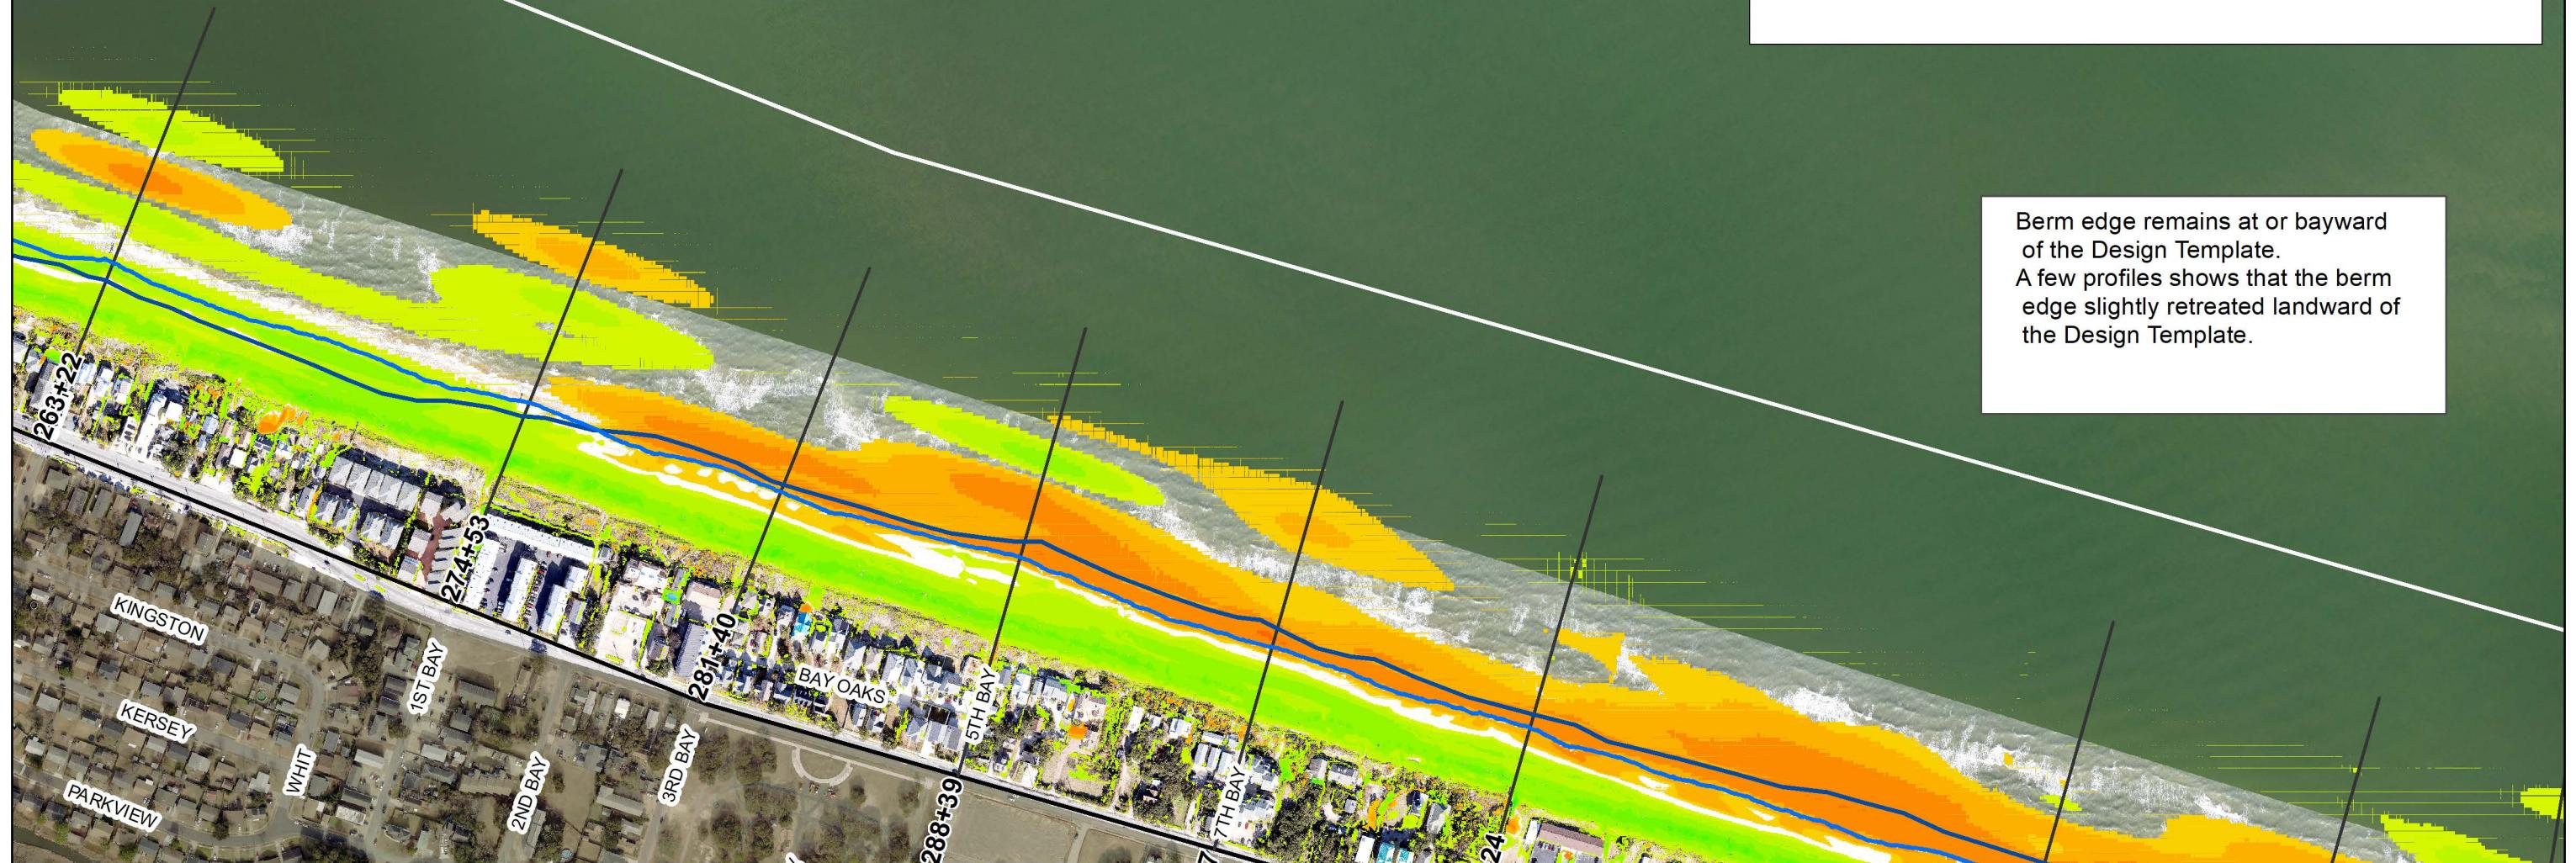
Berm edge remains at or bayward of the Design Template.
A few profiles shows that the berm edge slightly retreated landward of the Design Template.
