PERIODIC SURVEY EVALUATION: OCEAN VIEW BEACH

City of Norfolk, Virginia | Fall 2021 | PN: 10390-32

Periodic Survey Evaluation: Ocean View Beach Fall 2021

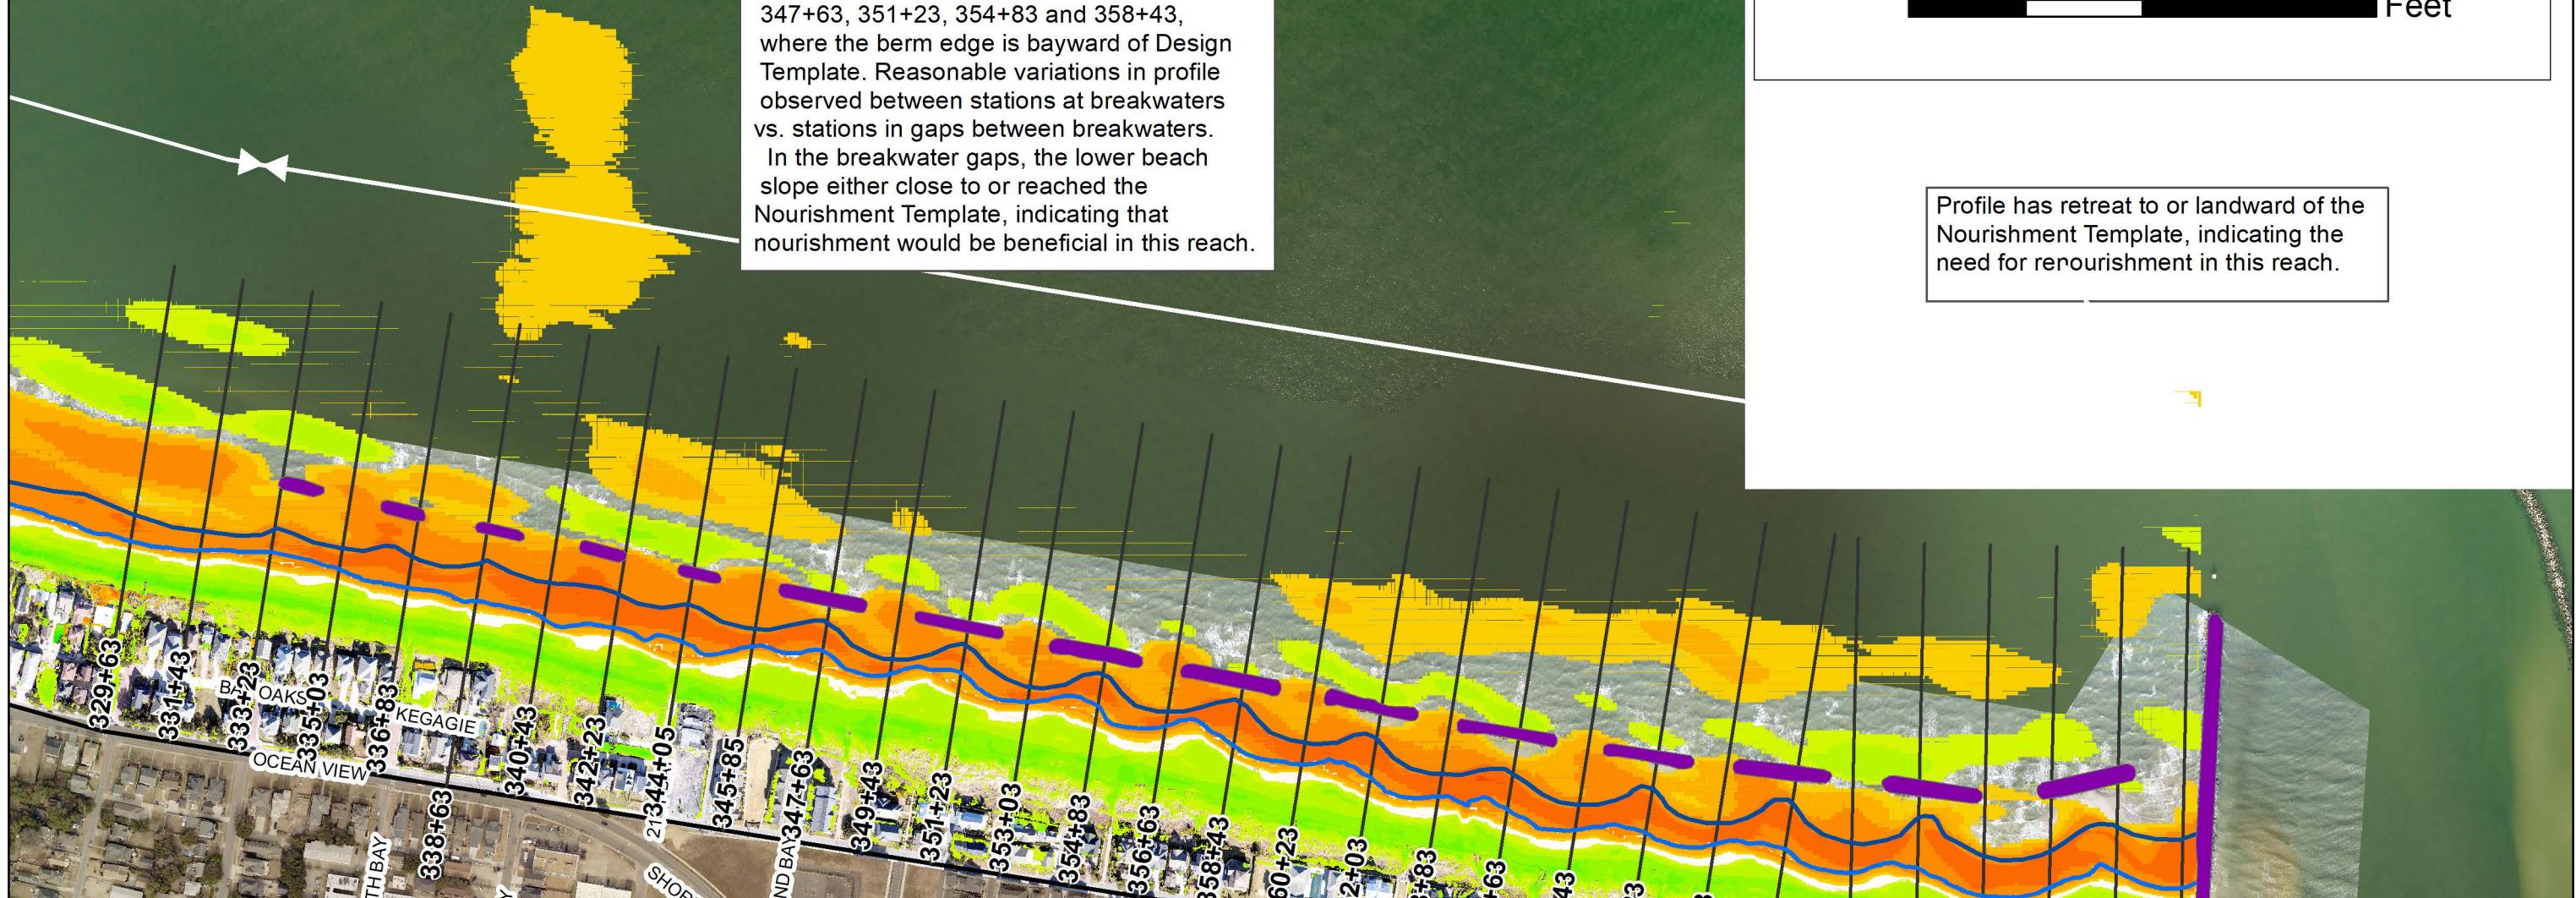
The berm edge is at or slightly landward of the Design Template. Exception are 347+63, 351+23, 354+83 and 358+43, where the berm edge is bayward of Design Template. Reasonable variations in profile observed between stations at breakwaters vs. stations in gaps between breakwaters. In the breakwater gaps, the lower beach slope either close to or reached the Nourishment Template, indicating that nourishment would be beneficial in this reach.

Profile has retreat to or landward of the Nourishment Template, indicating the need for rer nourishment in this reach.
