# PERIODIC SURVEY EVALUATION: OCEAN VIEW BEACH

City of Norfolk, Virginia | Spring 2022 | PN: 10390-32

# Periodic Survey Evaluation: Ocean View Beach Spring 2022

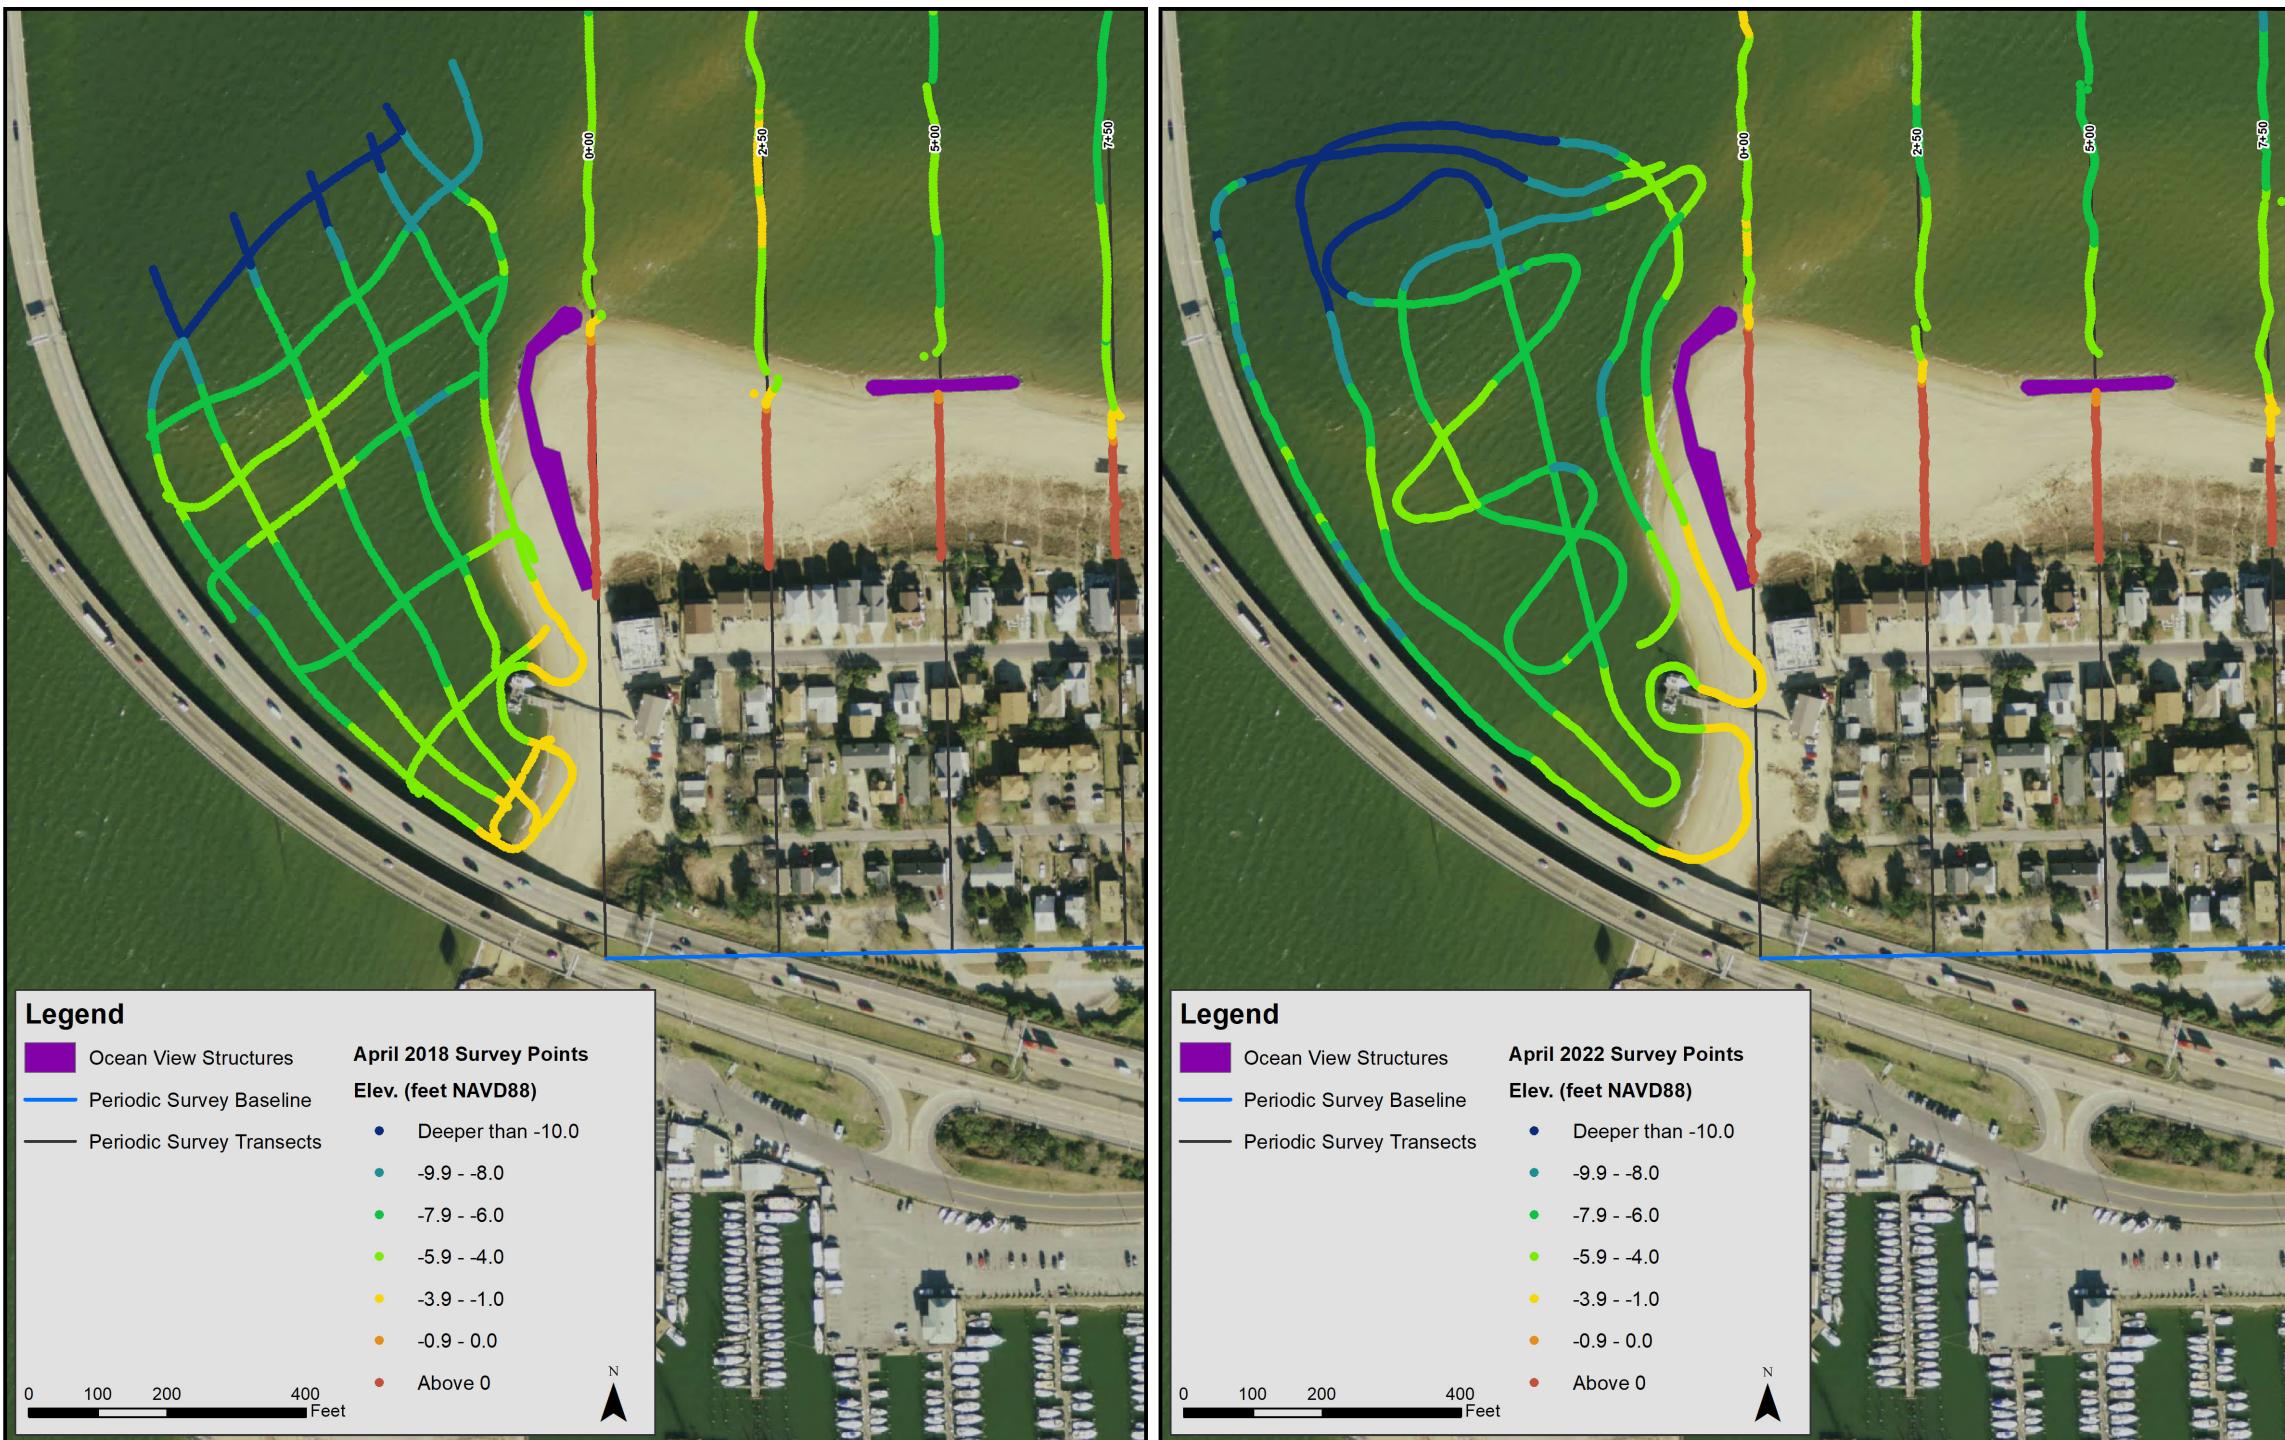
Two surveys in April 2018 and April 2022 as shown in Figure 6-1 were used to evaluate the depths near the pier. The left and right panels of Figure 6-1 show the April 2018 and April 2022 survey point depths, respectively, between the terminal groin and the pier and the relatively deeper waters near the Hampton Roads Bridge Tunnel. In both surveys, depths near the pier were deeper than -4.0 feet NAVD88, which is approximately 2.5 feet deeper than local Mean Low Water (MLW). Bed elevations were consistently at or deeper than this elevation from the pier to the deeper water at the end of the spit.

In addition, no significant change in bed elevation was seen between the April 2018 and April 2022 survey data. Thus, the surveys indicate that the depths between the terminal groin and the pier were relatively stable between April 2018 and April 2022.

Figure 6-1: Spring 2018 and Spring 2022 Survey Depths West of the Willoughby Spit Terminal Groin
