# PERIODIC SURVEY EVALUATION: OCEAN VIEW BEACH

City of Norfolk, Virginia | Spring 2023 | PN: 10390-47

# Periodic Survey Evaluation: Ocean View Beach Spring 2023

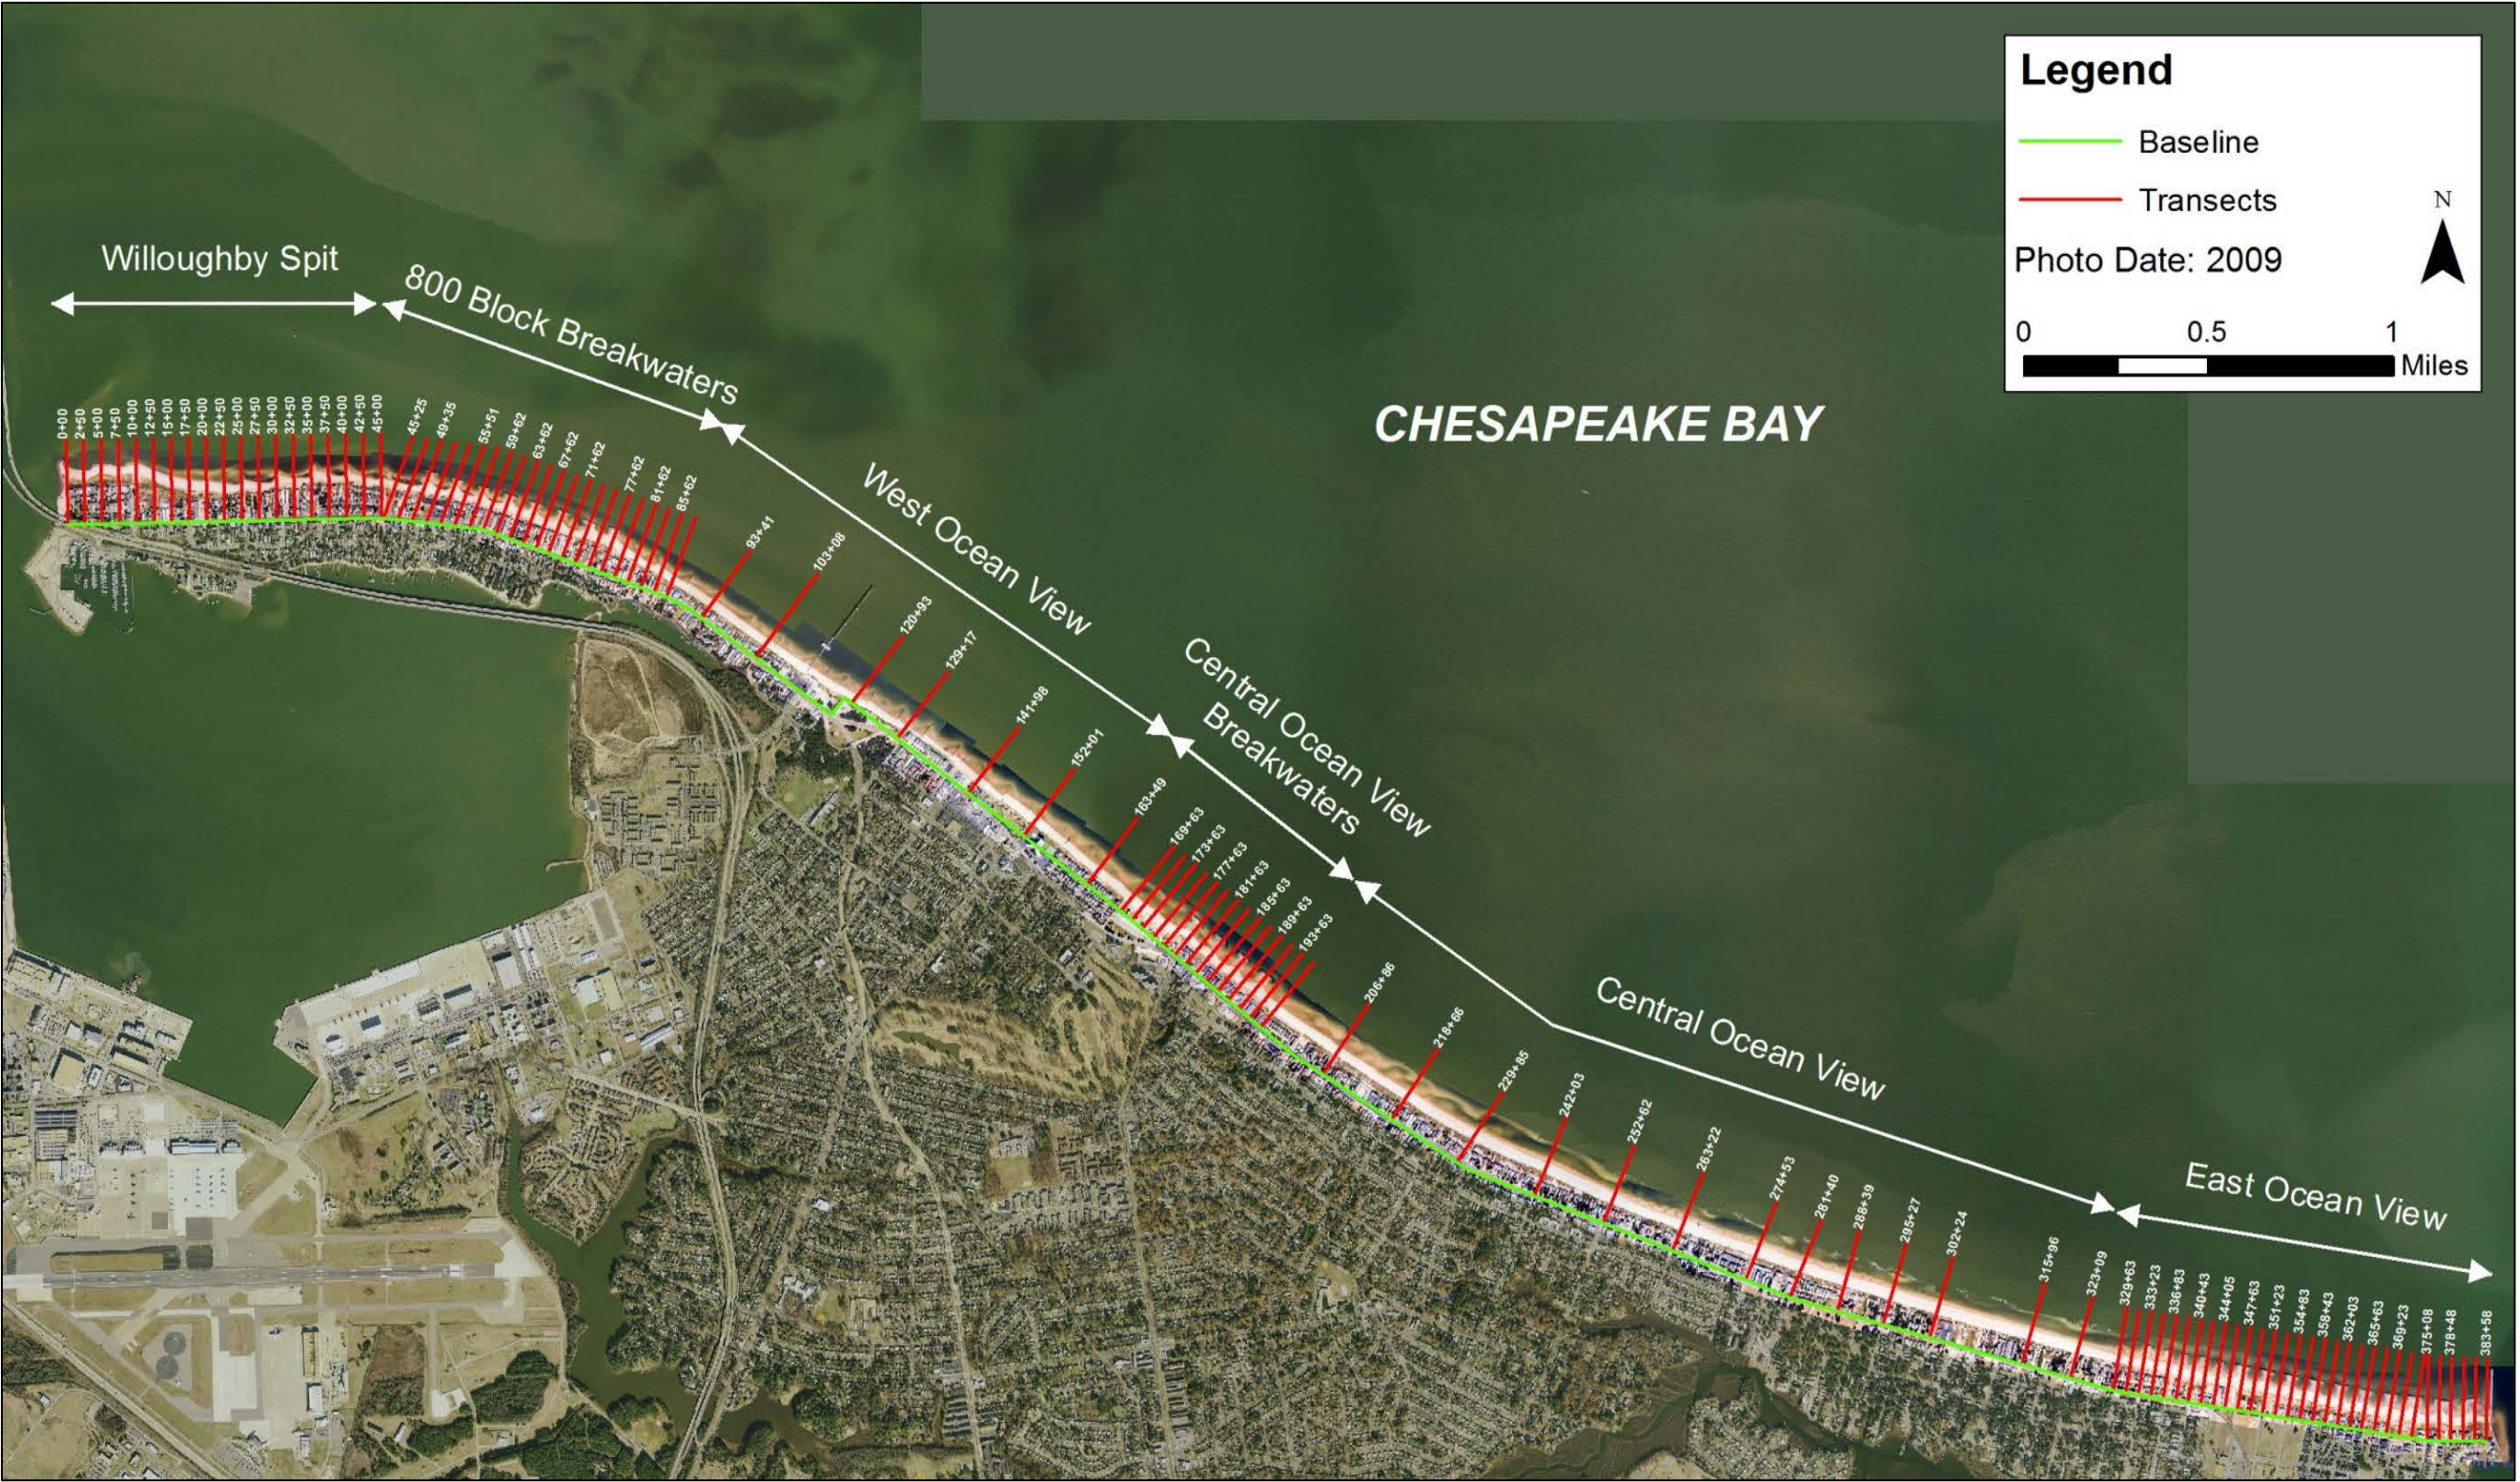
Figure 3-1: Survey Baseline and Transects

A baseline and transect locations were established with the first survey in September 2005 and have been used for each subsequent survey. Shoreline changes at Mean High Water (MHW) and volumetric changes above 0 feet NAVD88 and -15 feet NAVD88 are calculated at each transect. Differences in the region above 0 feet NAVD88 are indicative of changes to the dune and subaerial beach berm, while the differences above -15 feet NAVD88 indicate changes in the nearshore zone. Comparison of yearly surveys (i.e. November 2022 to May 2023) eliminates seasonal variation of profiles in volumetric change analyses. Consecutive survey comparisons (spring to spring and spring to fall) are useful to assess the direct impact of extreme events which have occurred during the six months between surveys. This report documents the data sources, methods, and results of a periodic surveying evaluation performed to compare the May 2023 survey data with previous surveys taken in April 2022 (spring to spring comparison) and November 2022 (most recent periodic survey comparison) in the Ocean View Beach area between Willoughby Spit and Little Creek Inlet.

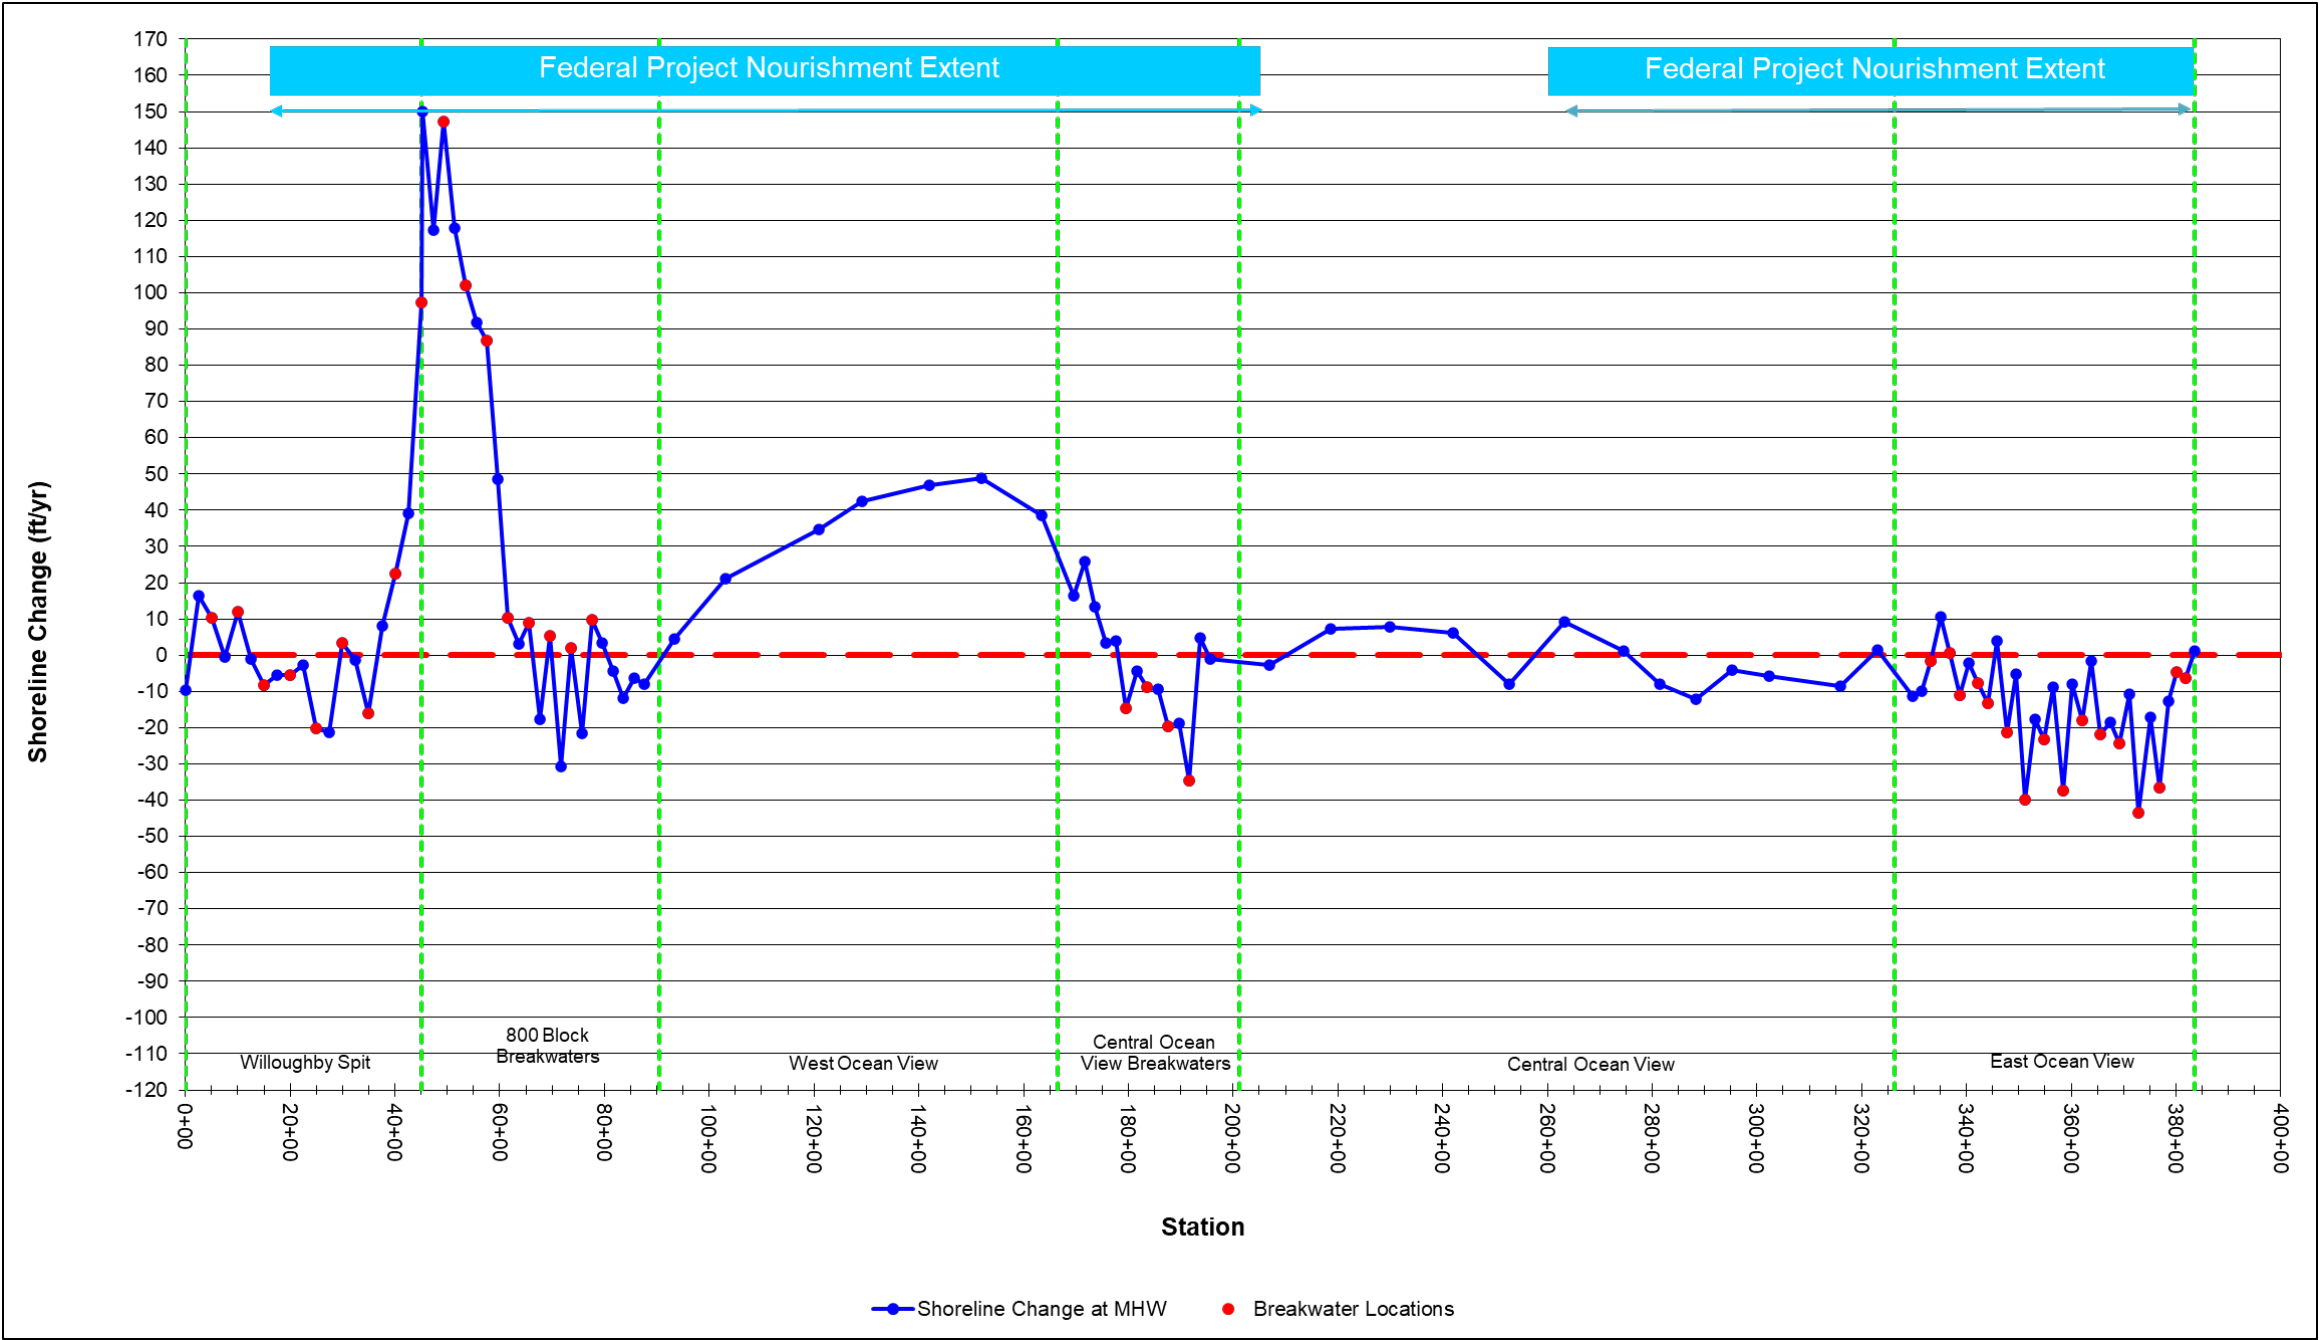
As illustrated in Table 1-1, the Ocean View shoreline has experienced overall advancement at MHW from April 2022 to May 2023 with a length-weighted average change rate of 9.60 ft/yr. The beach and dune above 0 feet NAVD88 gained sediment at a rate of 116,020 cy/yr from April 2022 to May 2023. The beach and dune above -15 feet NAVD88 gained sediment at a rate of 357,430 cy/yr over the same period.

Figure 5-14: Shoreline Change Rate (ft/yr) at Mean High Water (+0.98 ft NAVD88) for April 2022 to May 2023 (Note: Positive = Accretion, Negative = Erosion)

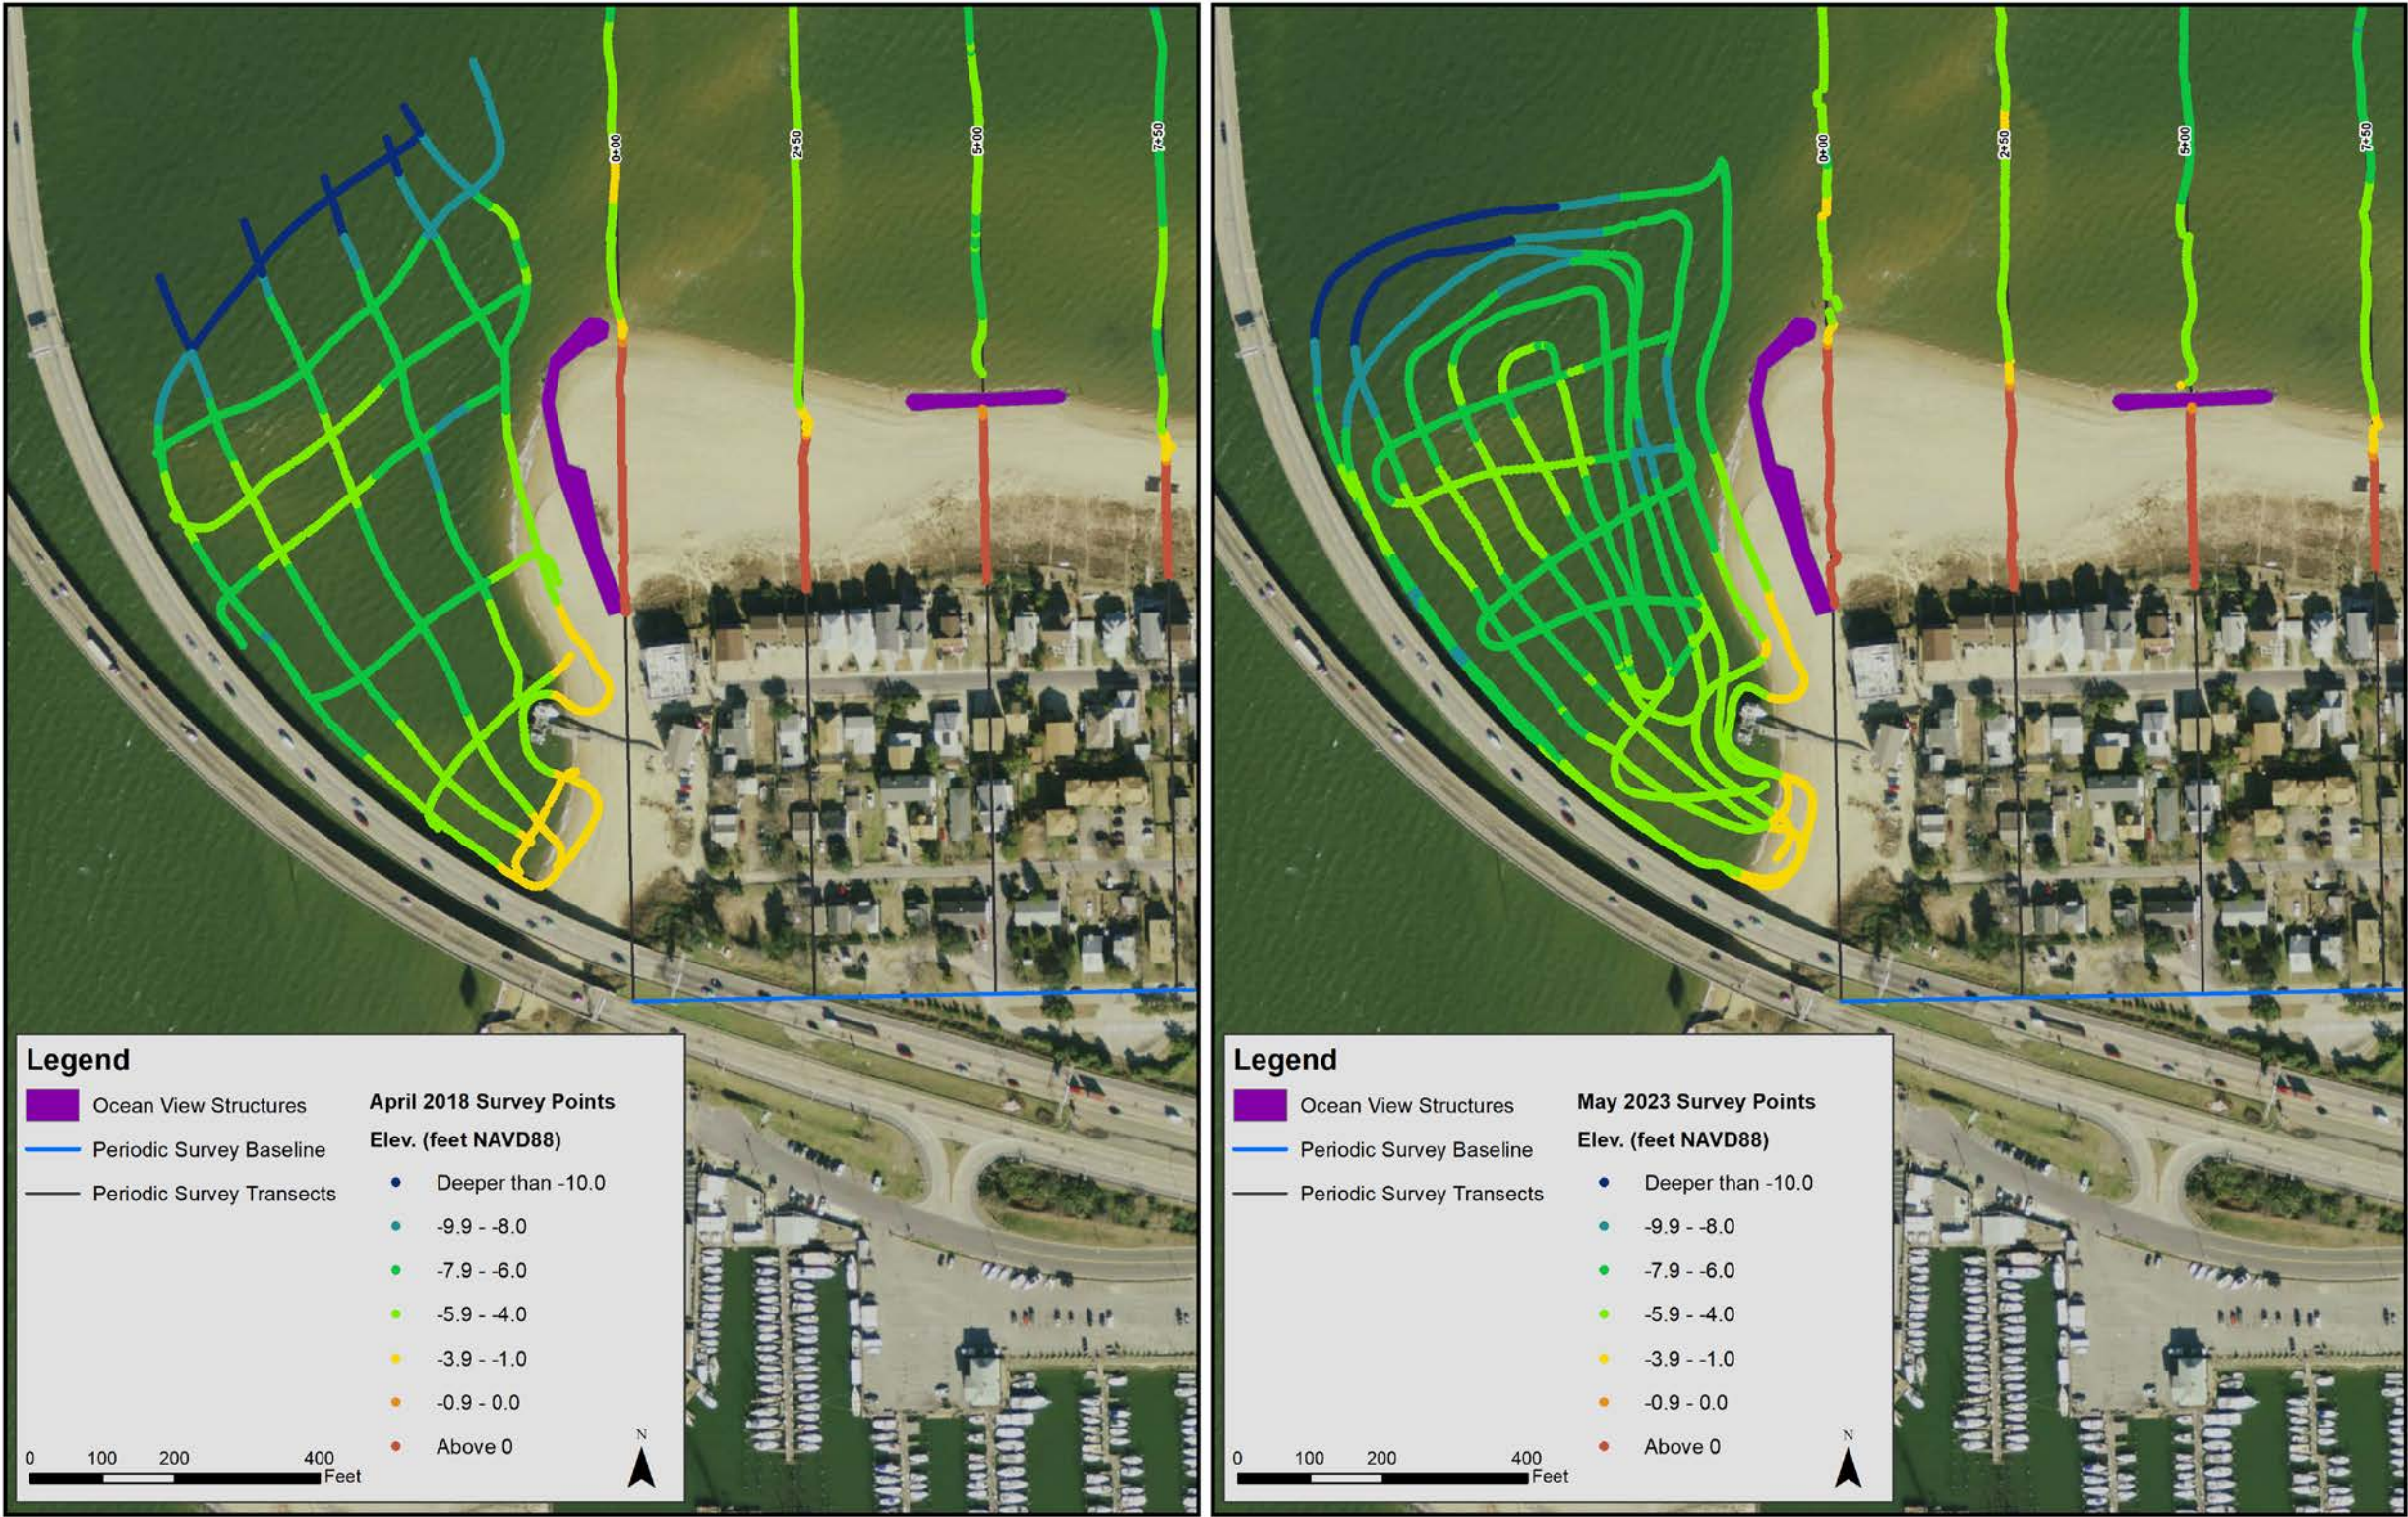
In addition, no significant change in bed elevation was seen between the April 2018 and May 2023 survey data. Thus, the surveys indicate that the depths between the terminal groin and the pier were relatively stable between April 2018 and May 2023.

Figure 6-1: Spring 2018 and Spring 2023 Survey Depths West of the Willoughby Spit Terminal Groin
