# PERIODIC SURVEY EVALUATION: OCEAN VIEW BEACH

City of Norfolk, Virginia | Fall 2023 | PN: 231247-01

# Periodic Survey Evaluation: Ocean View Beach Fall 2023

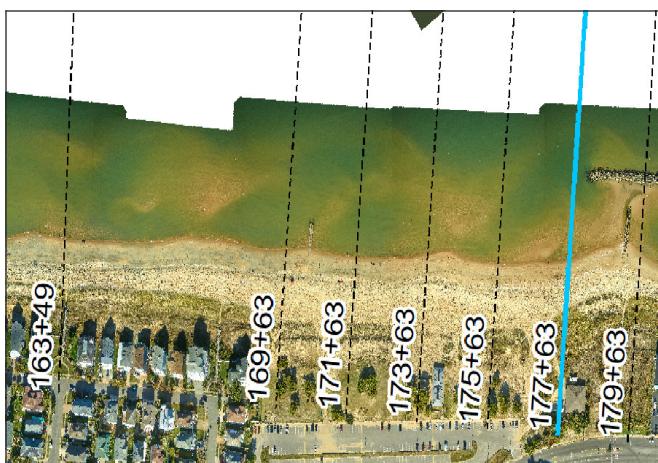
Survey Transect 179+63	NOV 2023 - NOV 2022	NOV 2023 - MAY 2023
Shoreline Change at MHW (0.98 ft NAVD88)	-10.89 ft	-18.12 ft
Volume Change Above -15 ft NAVD88	-2.38 cy/ft	-5.21 cy/ft
Volume Change Above 0 ft NAVD88	-0.59 cy/ft	-2.56 cy/ft
Distance from USACE Design Template @ 3.5 feet NAVD88:	-28.0 ft
